NHDOT North Hampton – Rye 42312

NH Rt 1A Coastal Revetment Resilience/Conceptual Design
2022 Climate Summit – NH Coastal Adaptation Workgroup
September 29, 2022

Project Overview – History

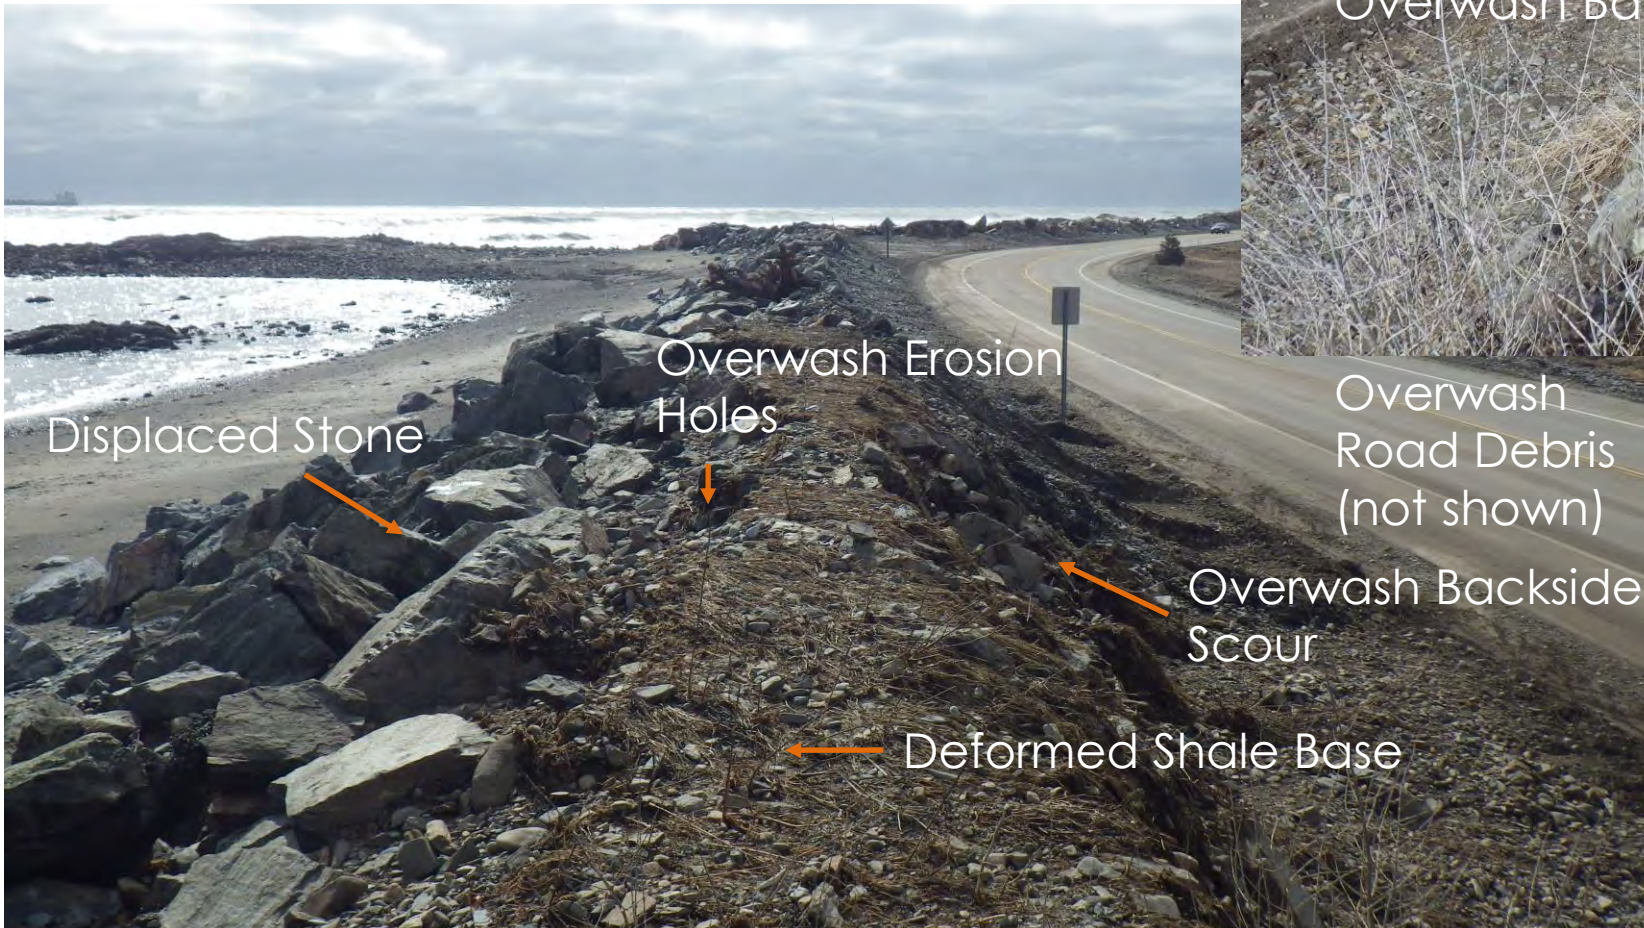
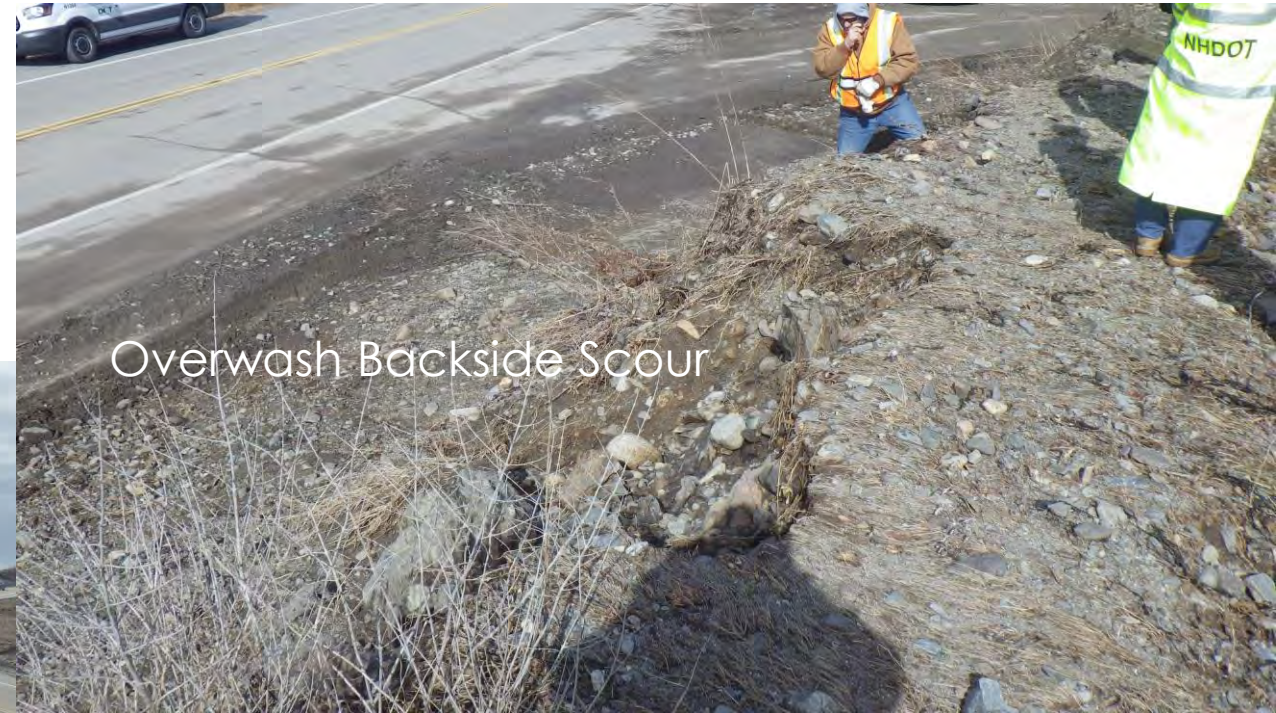
Section 1 – Post Storm Observations – March 5, 2018

Overwash
Road Debris
(not shown)

Overwash Backside
Scour

Deformed Shale Base
