**Addressing a
Perched, Flood-prone
Crossing for Coastal
Resilience in Newmarket**

**Pete Steckler
The Nature Conservancy**

Bay Road's Crossing of Lubberland Creek: August 13, 2015

LUBBERLAND CREEK RESTORATION BAY ROAD CULVERT ASSESSMENT NEWMARKET, NH

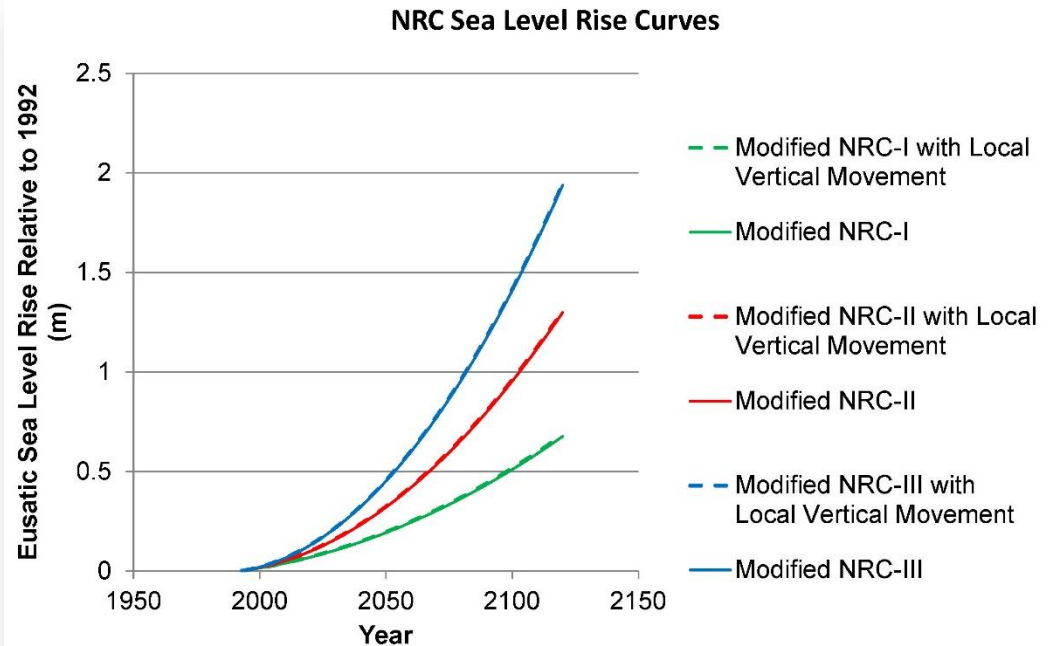
Source : Figure B-11, Scenarios for GMSL Sea Level Rise (Based on Updates to NRC 1987 Equation)

Year	NRC-II Sea Level Rise (Ft)
2065	1.33
2115	3.74

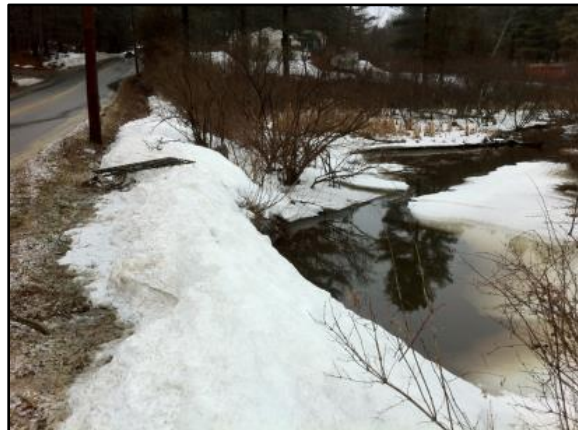
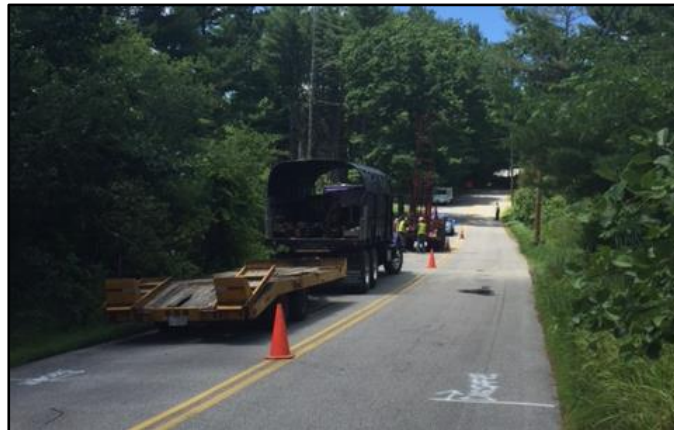
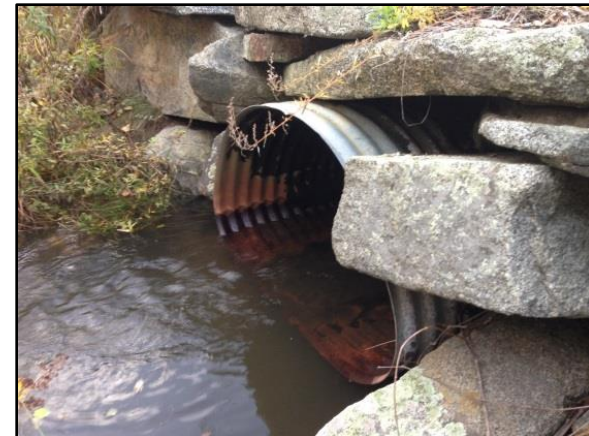
REPORTED EVENTS SINCE 2006 WHEN ROADWAY OVERTOPPED

Date	Event Recurrence Interval
May 14, 2006	10 year Event
April 16, 2007	25 year Event
March 14, 2010	10 year Event
March 30, 2010	5 year Event
