# **GREAT BAY LIVING SHORELINE PROJECT**

## **CHAPMAN'S LANDING - STRATHAM, NEW HAMPSHIRE DESIGN BASIS MEMO**

**Prepared for:** New Hampshire Fish & Game

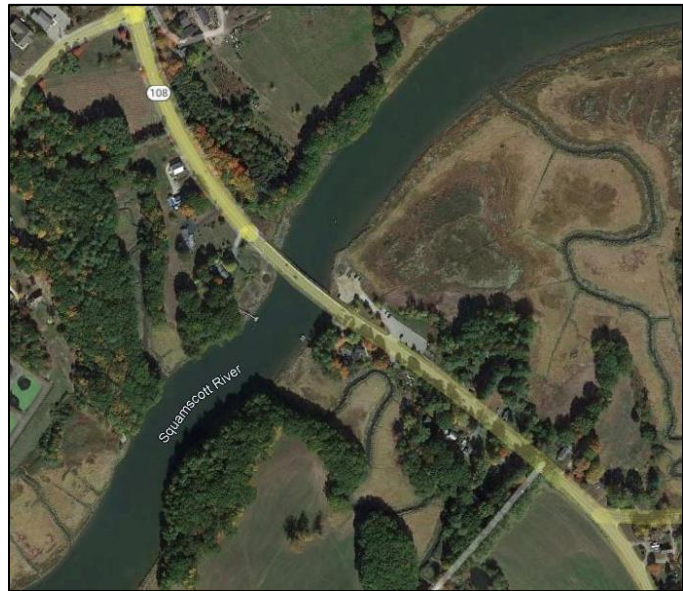
Chapman's Landing Site

The Chapman's Landing site is located on the north side of NH Route 108 (College Road) in Stratham, New Hampshire. It borders the Squamscott River and is located adjacent to the NH Route 108 bridge. The property is owned by the NH Fish and Game Department (NHF&G) and is operated as a public boat ramp. It is one of the few places in Great Bay where you can launch boats at both low and high tide. There are two parking lots at the site, restrooms, and the Great Bay Community Wildlife Garden. The site is also used as fishing access point. The lower gravel parking lot was built in the early 1990's. The upper paved parking lot was added in the early 2000's.

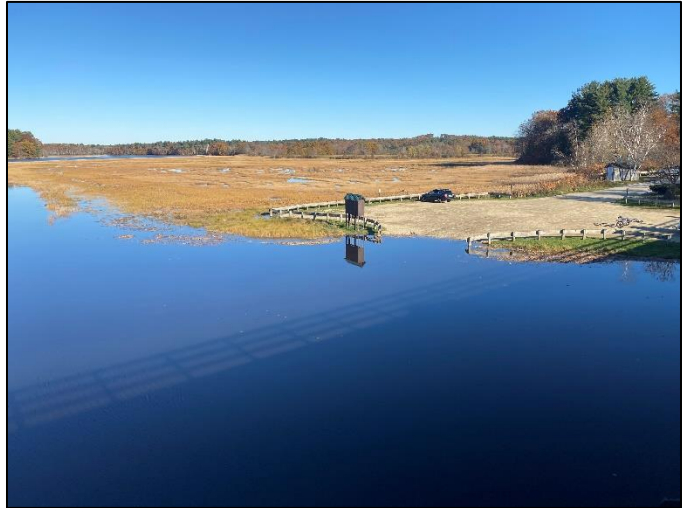
*2021 King Tide at Chapman's Landing*

The salt marsh exhibits a pronounced, elevated levee along its bank of the Squamscott River, either formed by sediment deposited by the river or constructed historically for agriculture and/or flood control. This levee is dominated by a suite of high marsh species: salt meadow hay (*Spartina patens*), salt grass (*Distichlis spicata*), black rush (*Juncus gerardii*), sea lavender (*Limonium carolinianum*), and seaside goldenrod (*Solidago sempervirens*). Further south and toward the upland, the surface of the marsh slopes downward and transitions into a low marsh community dominated by the stunted form of cordgrass. The interior of the marsh is characterized by a mosaic of megapools—large areas of standing water—dominated by short-form cordgrass and glasswort (*Salicornia depressa*).

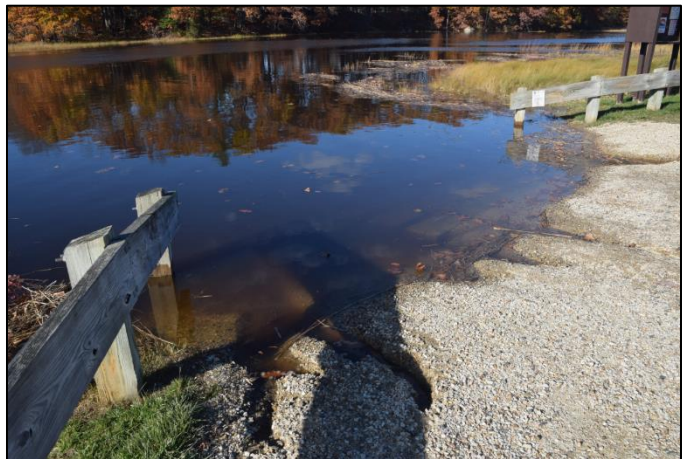
*Erosion channels above boat ramp*

There appear to be multiple facets causing erosion at Chapman's Landing. Erosion of sediment bounding the boat ramp is likely due to heavy rain events and subsequent runoff during heavy rain events. Within the marsh, there are several foot paths with remnants of flattened vegetation caused by anglers, birders, and others walking. Undercut banks are prevalent north of the boat ramp.

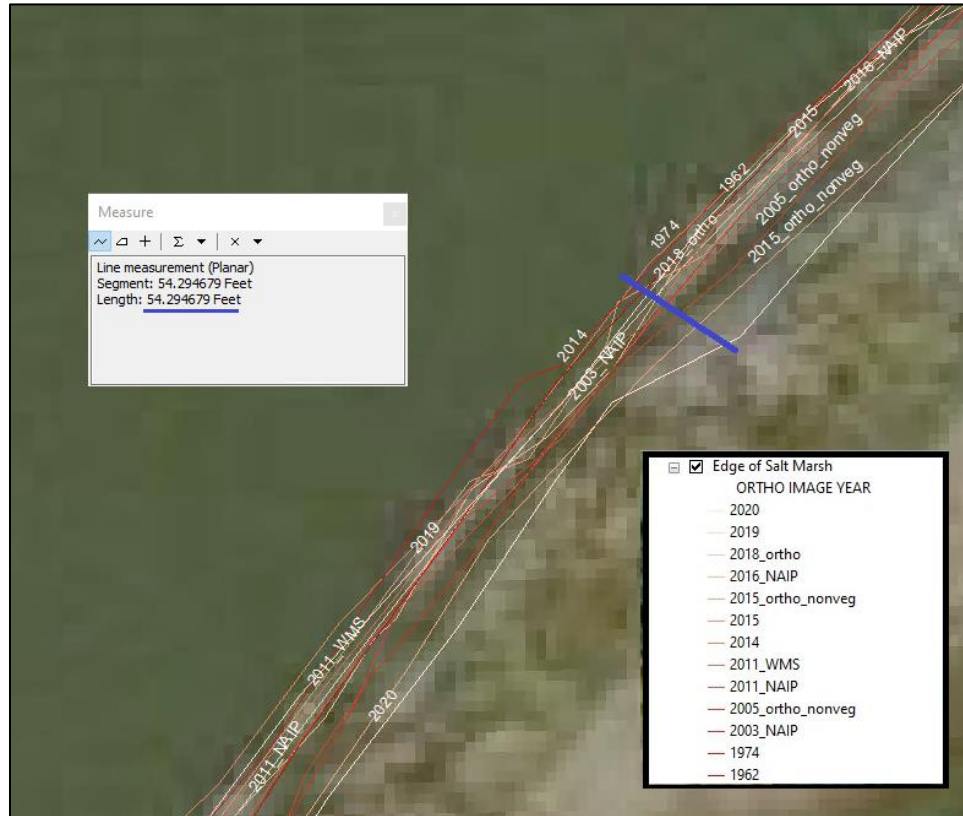
While no definitive rate or projectable trend in erosion rate could be discerned from the limited period of on-site data collection, the historic imagery makes it clear that net erosion appears to be on the order of centimeters or inches/year, rather than feet/year. As shown in the figure above, the total net shoreline change since 1962 (60 years ago) is less than 60 feet, or less than 1 foot per year.

Despite year-to-year fluctuations (net erosion or accretion) and mapping-based uncertainties (e.g., timing of orthoimagery not consistent with respect to seasonality, raster image resolution limitations, GIS user error in georeferencing), the project team's historic aerial imagery analysis shows that the lateral rate of shoreline change due to erosion has likely not exceeded 60 feet since 1962.

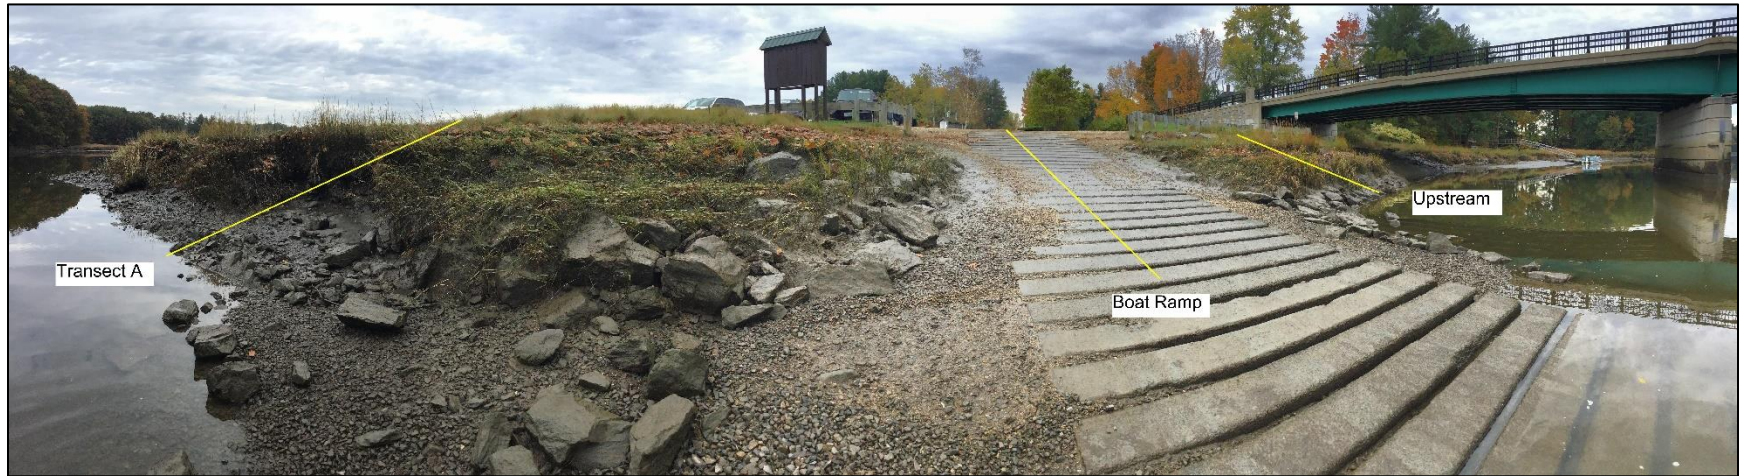
Approximate Cross-Section Locations – Near Boat Ramp

Upstream of Boat Ramp – This cross section is located approximately 30 feet south of the boat ramp. The bank is armored with riprap but also contains salt marsh vegetation, primarily cordgrass. As mentioned above, this section of the bank was stabilized with riprap in the early 2000's and planted with cordgrass. Since then, natural vegetation became established and now stabilizes the upper part of the bank.

Boat Ramp – This cross section is located at the existing boat ramp. Elevation measurements were also taken within the lower parking lot east of the boat ramp.

Transect A – This is the first of three transects within the proposed shoreline treatment area. Transect A is located approximately 25 feet north of the boat ramp. The salt marsh edge is eroded in this area and undercut, with a bank that is approximately 4 to 5 feet tall. Bedrock is present at the river edge, below the marsh peat. This bedrock is exposed during low tide. Vegetation below the bank is sparse and consists of scattered clumps of cordgrass. High marsh characterizes the top of the bank and is dominated by black rush, saltmarsh hay, salt grass, and sea lavender. This transect continues east

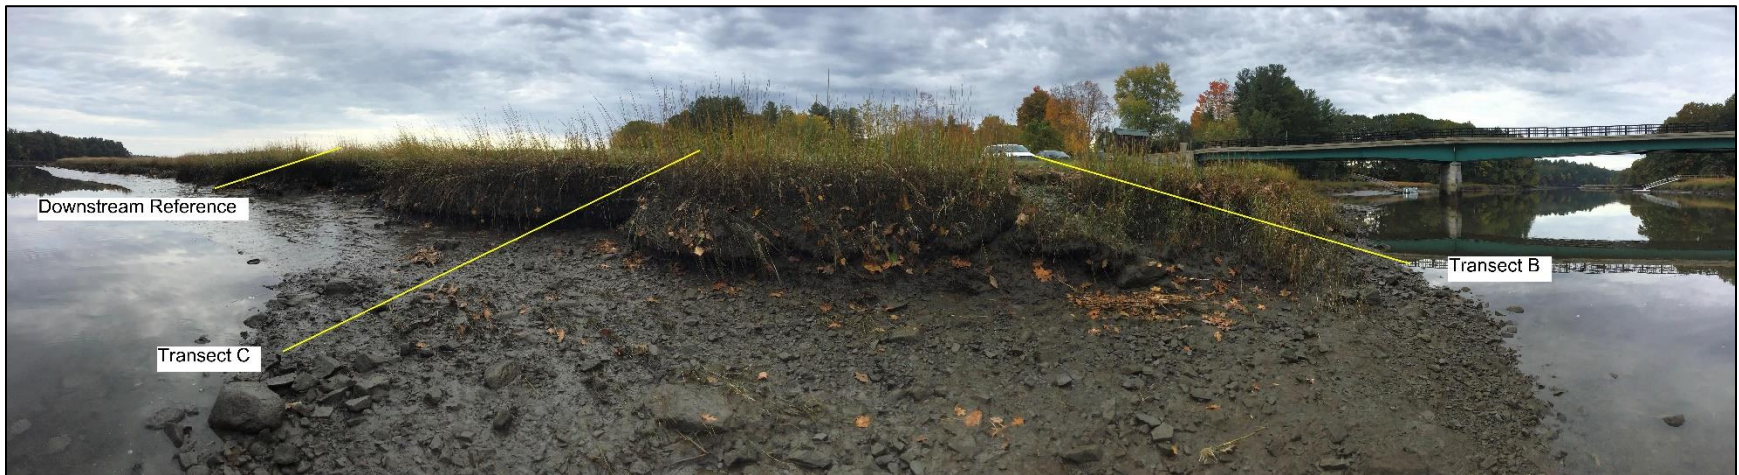
Approximate Cross-Section Locations – North (Downstream) of Boat Ramp

Transect B – This transect is located approximately 80 feet north of the boat ramp. It is located near a small point in the bank and continues inland to the parking lot. Similar to Transect A, the marsh edge in this area is eroded and undercut. Small clumps of the marsh edge appear to be sloughing off into the river. Bedrock is present at the river edge, below the marsh peat. This bedrock is exposed during low tide. Low marsh vegetation occupies a narrow area along the edge of the river. The marsh above the bank is well vegetated with high marsh species including salt meadow hay and salt grass. A robust, tall variety of salt meadow hay was noted about 30 to 50 feet inland from the bank. This area abuts the parking lot and may include fill placed on the marsh during former restoration projects. At the edge of the parking lot, salt grass and sand-spurry (*Spergularia* sp.) were observed in a frequently-mowed area.

Downstream Reference – Data was collected for a section of the marsh with minimal edge erosion. This transect is located northeast of the proposed shoreline treatment area, approximately 180 feet from the boat ramp. Along this area, the bank is characterized by the tall form of cordgrass. Moving west, the transect crosses an area dominated by short-form cordgrass, before transitioning to high marsh dominated by short-form cordgrass and salt meadow hay. The transect then crosses a worn footpath, where it transitions to low marsh dominated by short-form cordgrass and glasswort. Standing water is common in this area, and a megapool stands to the east of the transect.

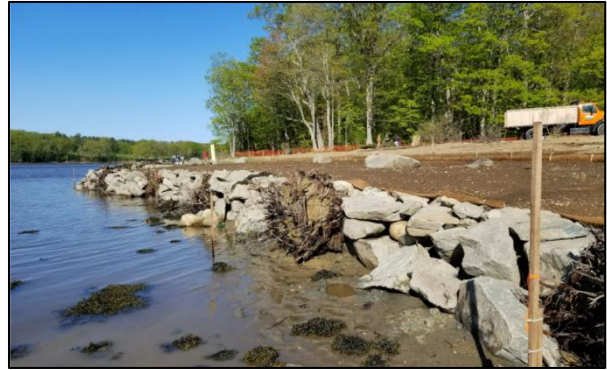
*Rock sill and roots wads at Wagon Hill Farm  
Living Shoreline*

The first treatment area extends the existing marsh surface to cover what may have been the extent of the historic marsh and is currently exposed bedrock. This would be accomplished by creating a rock sill along the edge of the bedrock area which is exposed during the mean low low tide (approximately -3.3 ft NAVD88). Root wads would be placed approximately every 5-10 feet within the rock sill, so that the roots would protrude from the rock sill and the trunk would be buried by fill, similar to that installed at the Wagon Hill Farm Living Shoreline (see photo to the right). The root wads would be held in place with cables attached to duckbill anchors, which would be anchored into the bedrock and/or the existing marsh on the uphill side. The root wads would help to add complexity to the rock sill, creating more diverse habitat and cover for wildlife.

The rock and root wad toe treatment/sill would be built to a height of approximately 2.3 ft NAVD88, or 2 feet above the current mean tide line of 0.3 ft, and would be keyed into the existing marsh by approximately 15 ft on the south and north ends. Keying in the rock and root wad sill would help to prevent erosion and undercutting of the living shoreline treatment area, in case there is significant erosion at either end of the treatment area. A coir blanket would be placed along the uphill (marsh side) of the rock and root wad sill in order to act as a filter to hold marsh soils in place while marsh vegetation is getting established. An excess of at least ten feet of coir blanket would be left at the top of the rock and root wad sill so that it can be placed on top of the fill in order to reduce erosion at the marsh/sill interface.

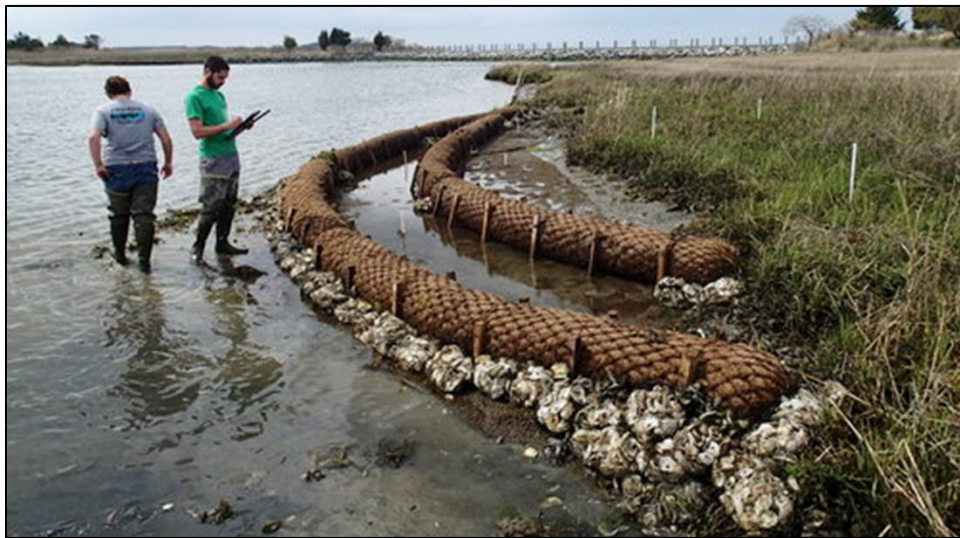
*Example of an oyster shell and coir log shoreline treatment*

A minimal treatment area consisting of placing rows of oyster shells and coir logs is proposed to the north of the treatment area described above. Three rows would be placed from the rock and root wad sill to the existing salt marsh edge. Each row would consist of a one-foot diameter coir log along with oyster shells in mesh bags as shown in the photo below. The coir logs and oyster shell bags would be secured to the existing mud flat using wooden stakes. This treatment area is intended to serve as a transition between the rock and root wad sill and the existing eroded marsh face. This would help to slow flows, accumulate sediment behind the rows of oyster shells and coir logs, and reduce erosion of the marsh edge.

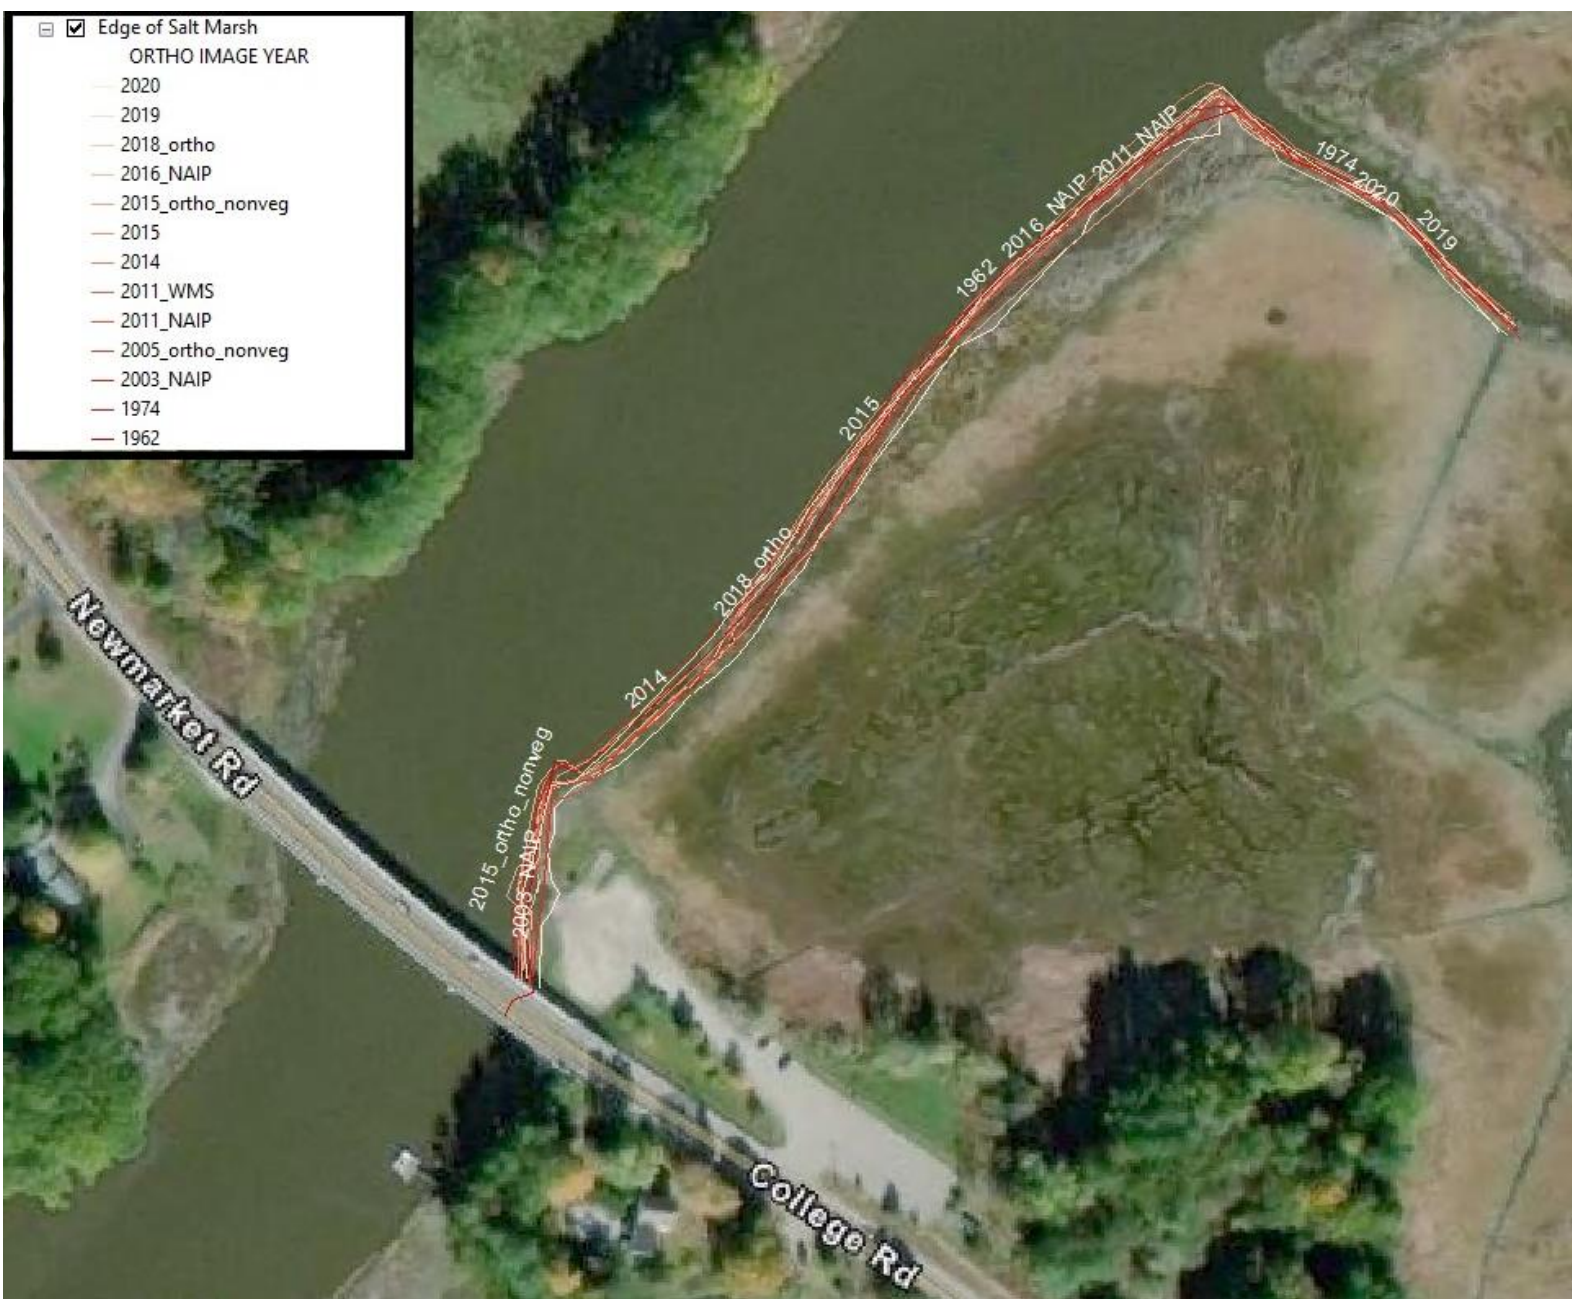
### **Orthoimagery & Shoreline Edge Overlays**

An overlay image comparing the shoreline edge across the 13 orthoimagery datasets along the entire base study area is provided in **Appendix B**.

Orthoimagery (downloaded via the NH GRANIT data clearinghouse) was used to assess the dynamic shoreline adjacent to the boat ramp at the site across multiple time horizons, dating back to 1962. Orthoimagery from 13 datasets were used to compare shoreline change by georeferencing the aerial imagery to static reference points (e.g., bridge piers, parking lot edges and curbing, and permanent structures). From each image, the shoreline (edge of salt marsh) was traced in ArcGIS to allow for inter-year and multi-decade comparisons.

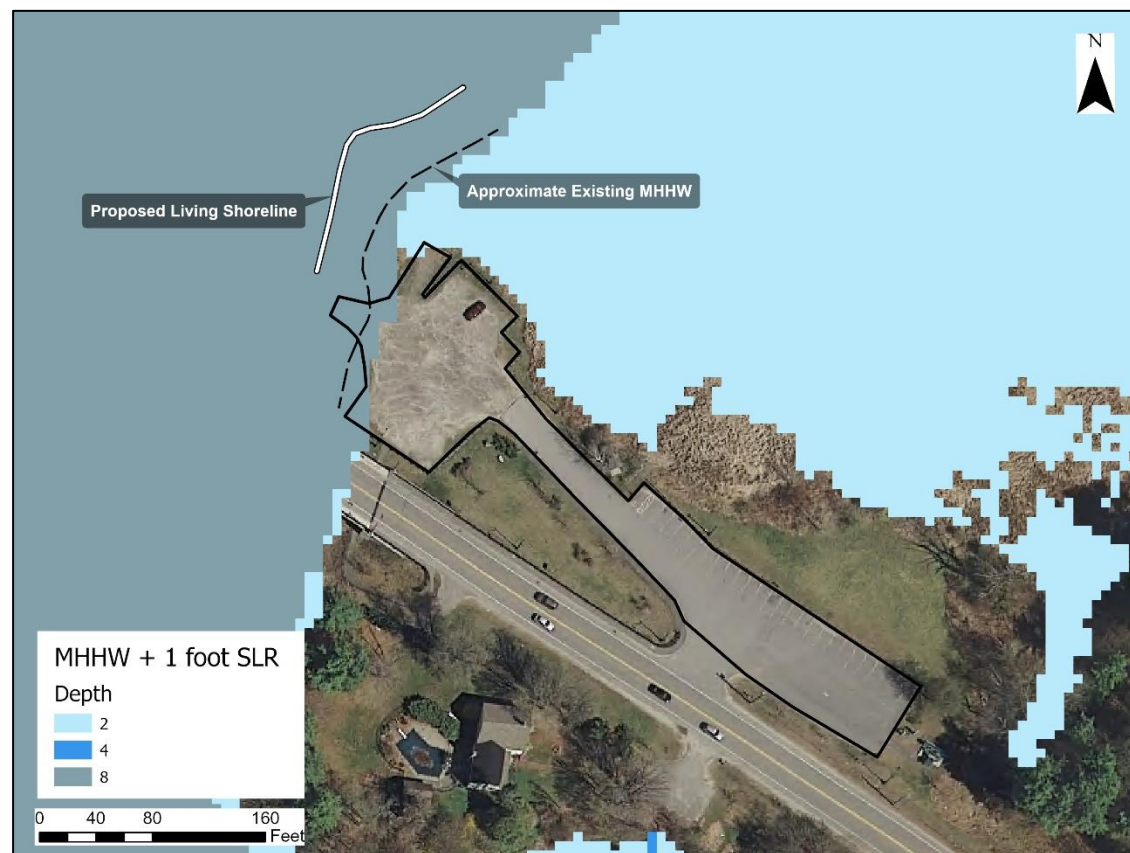
Chapman's Landing  
Stratham, NH

## Predicted Sea Level Rise

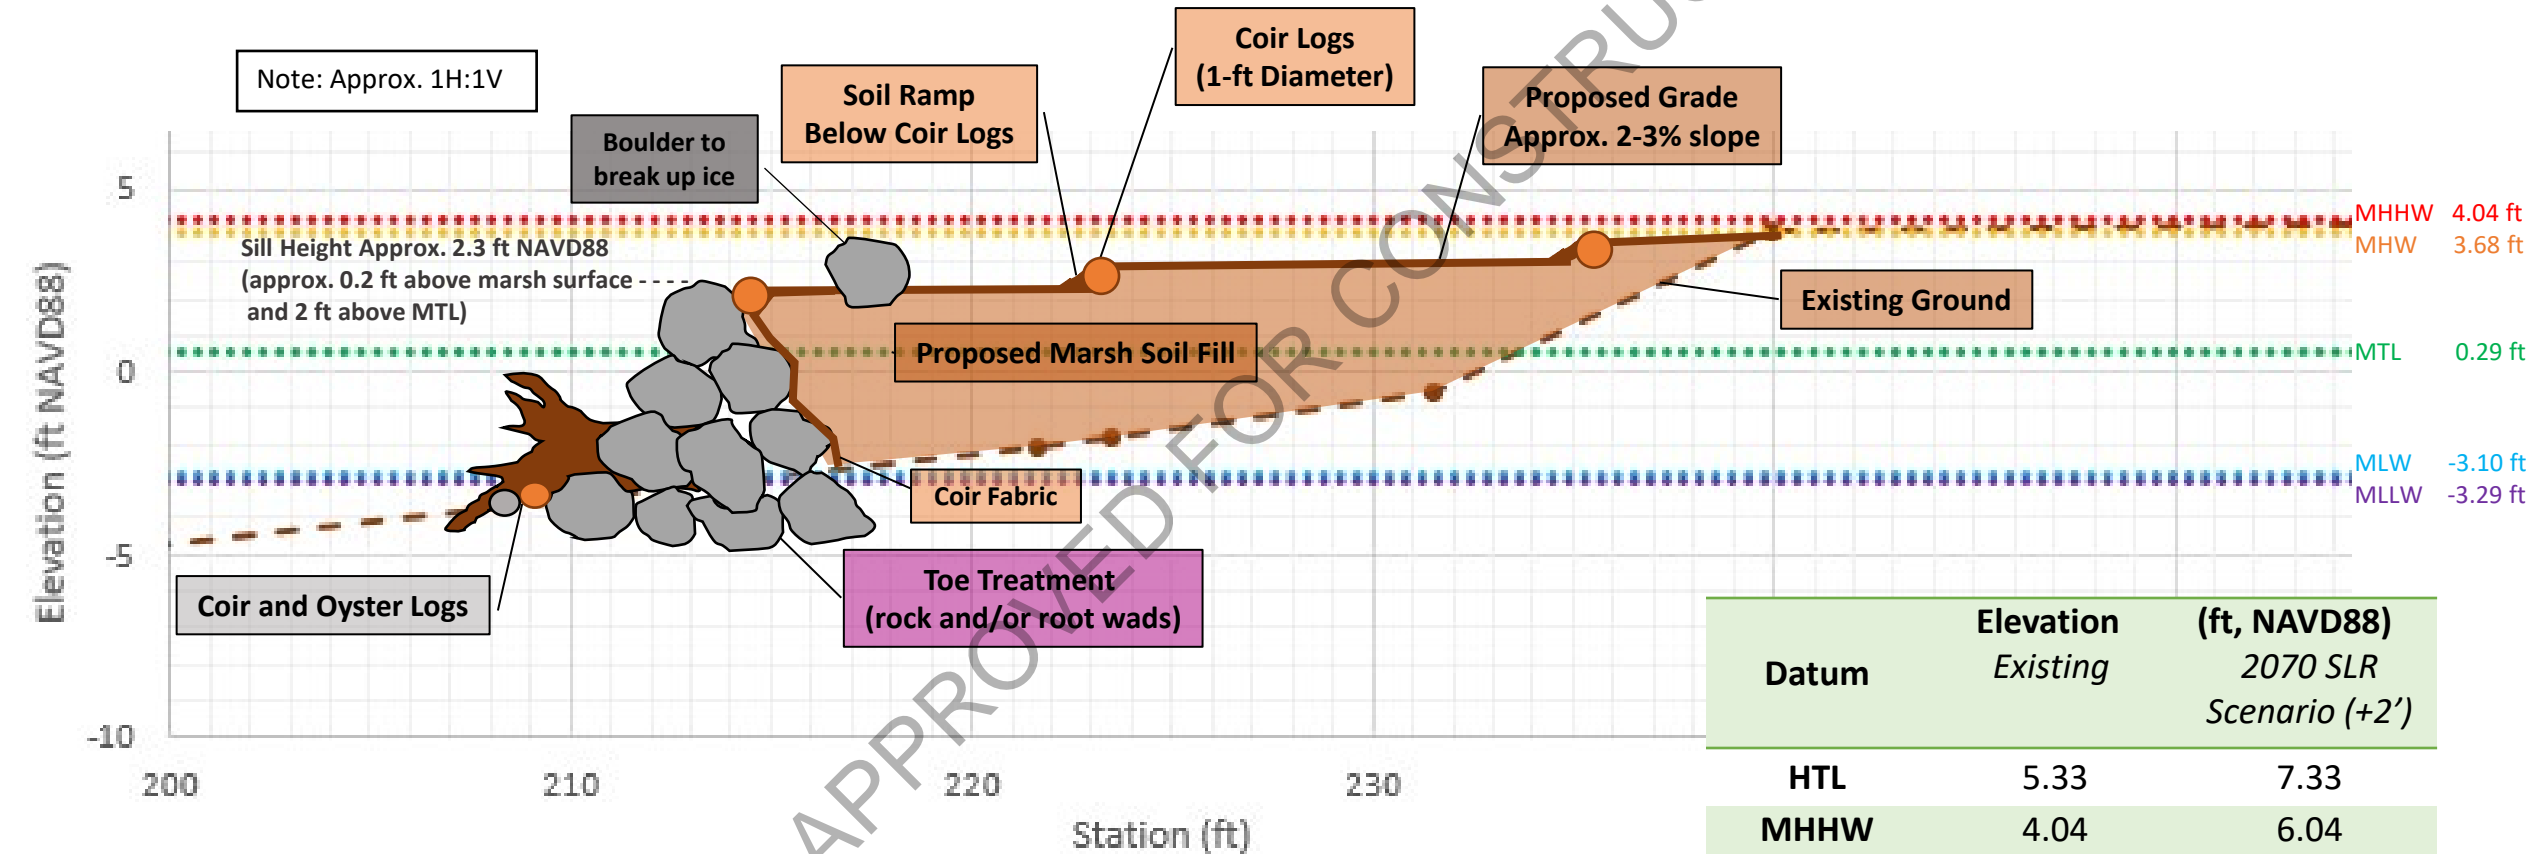
# Proposed Transect C

(approx. 100 ft downstream of boat ramp)

Datum	Elevation Existing (ft, NAVD88)	2070 SLR Scenario (+2') (ft, NAVD88)
HTL	5.33	7.33
MHHW	4.04	6.04
MHW	3.68	5.68
MTL	0.29	2.29
MLW	-3.10	-1.10
MLLW	-3.29	-1.29

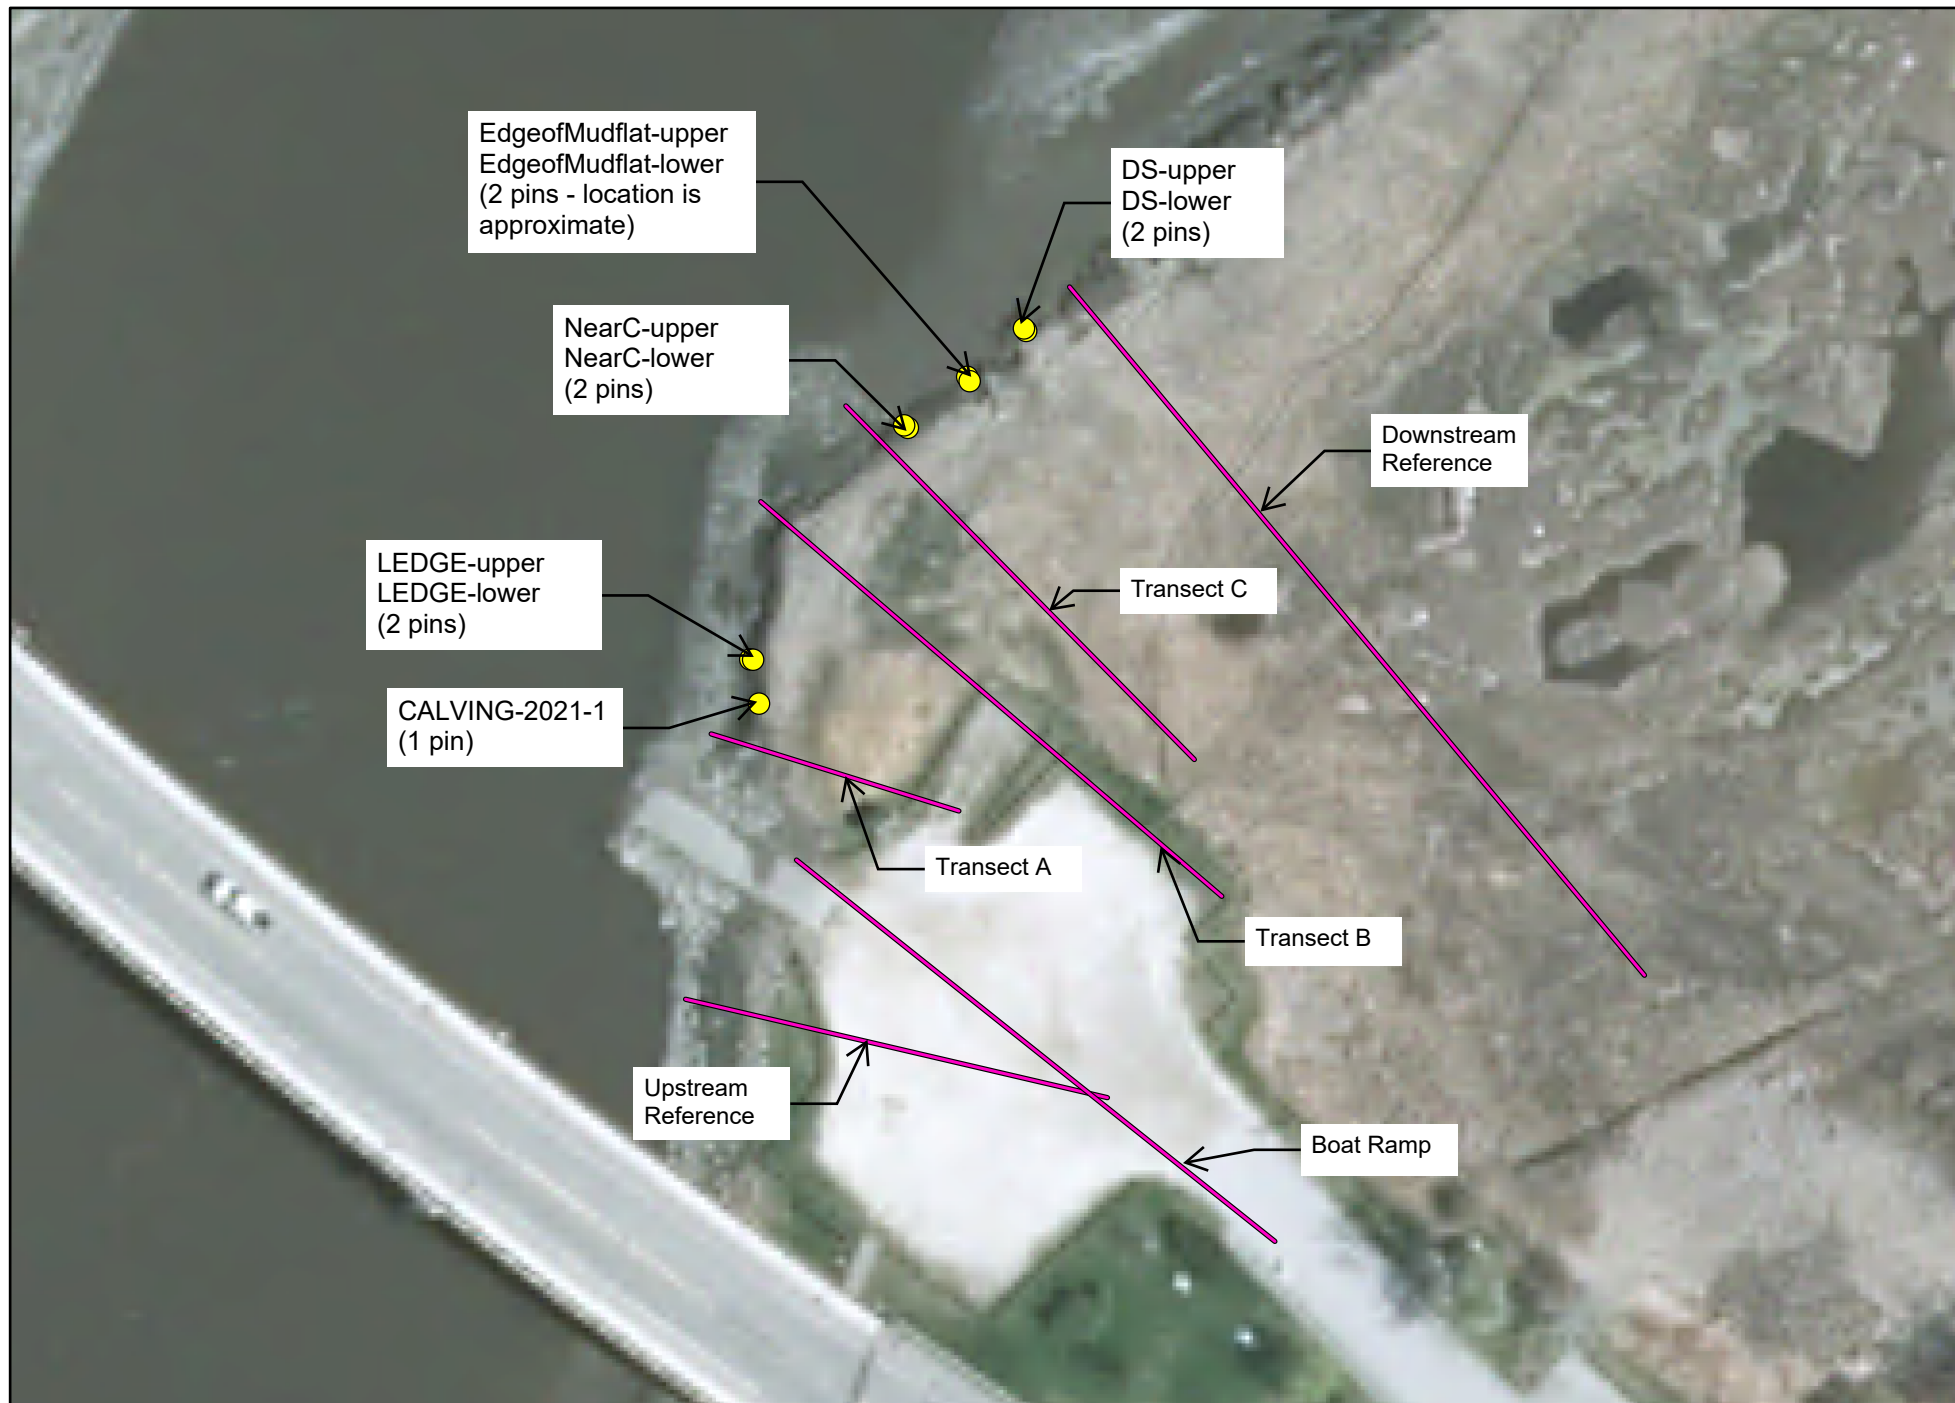
### Chapman's Landing Erosion Pin Locations

The erosion pins installed in September 2021 were measured in March 2022. The table and map in **Appendix G and H** show the erosion pin measurements and locations. These erosion pins are still in place and were re-set flush with the surface of the marsh soil after the March 2022 measurements. Over the approximate 6-month period from September to March, the extent of erosion ranged from 0 mm to 21 mm. Four of the nine pins had approximately 9-10 mm of measured erosion. If a similar rate of erosion occurs throughout the year, this data shows an erosion rate of 40 mm (1.6 in) or less per year.
