The Latest Developments in Non-structural Alternatives for Shoreline Stabilization

Based on SITE SPECIFIC Criteria

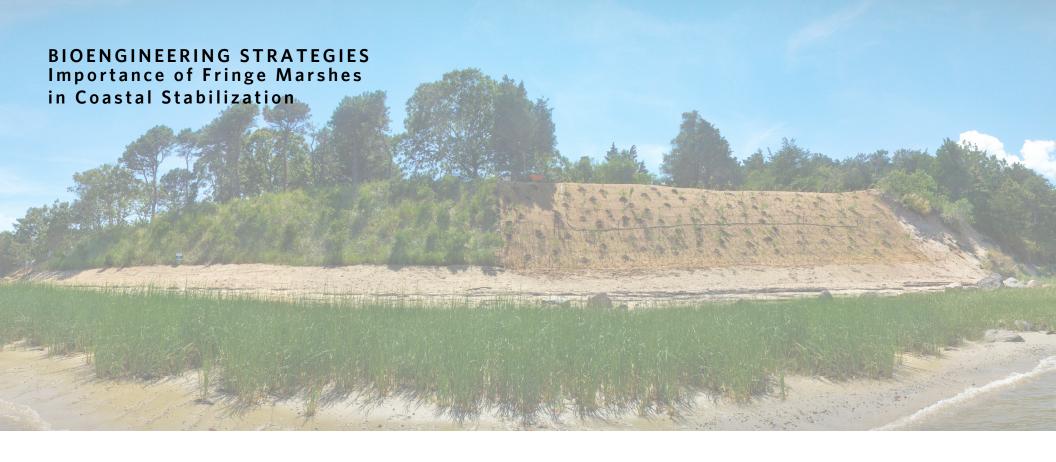
• Woven coir-filled mats used as a growing medium.

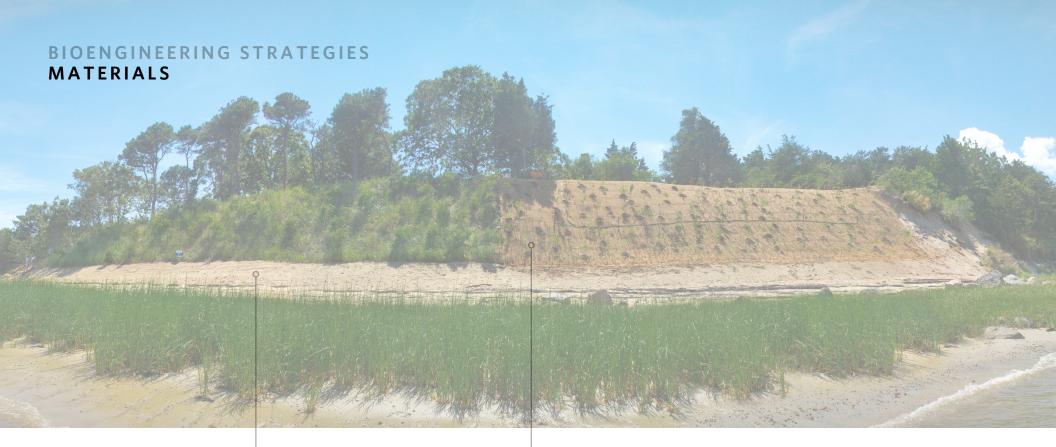
COIR FIBER ROLLS

Adds stability and protection to the toe of a bank and provides a window of opportunity to establish vegetation.

ROBUST ANCHORING SYSTEM

Erosion Control
BLANKETING

blanketing of natural fibers are used to stabilize soils allowing time for NATIVE SALT TOLERATE

- Resists degradation from the marine environment.
- Absorbs some of the force of wave energy unlike many hard solutions that deflect the energy of wave action to surrounding areas.
- Materials life-expectancy to stabilize sediments matches the time required to ESTABLISH NATIVE PLANTS.

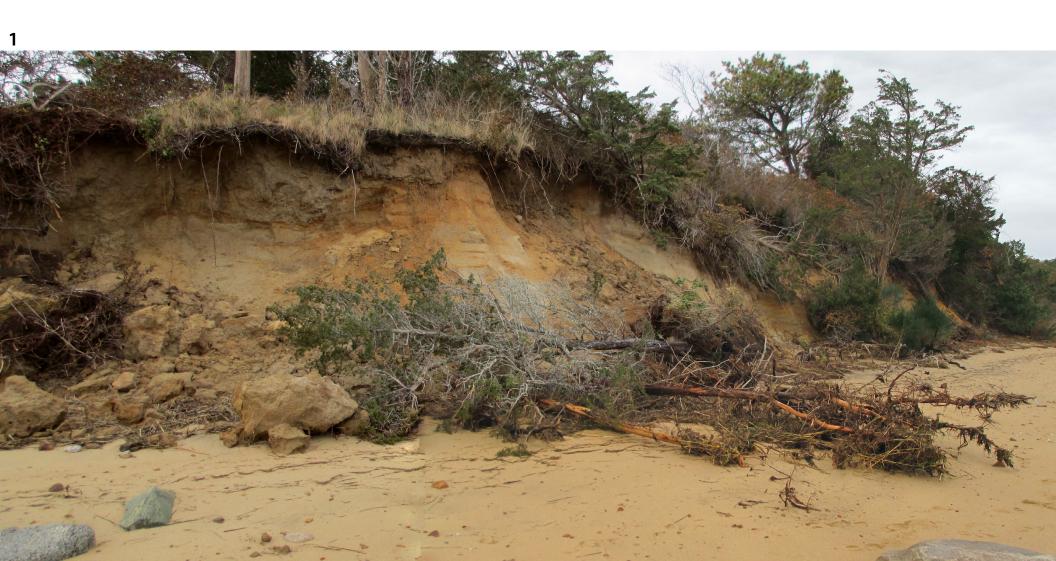
Importance of Establishing a Stable Slope

- Utilizing a portion of the upper bank can create a more stable slope angle.
- Adds increased stability and storm damage prevention to the bank.
- Without this step, an investment in bioengeneering can be lost due to bank collapses.

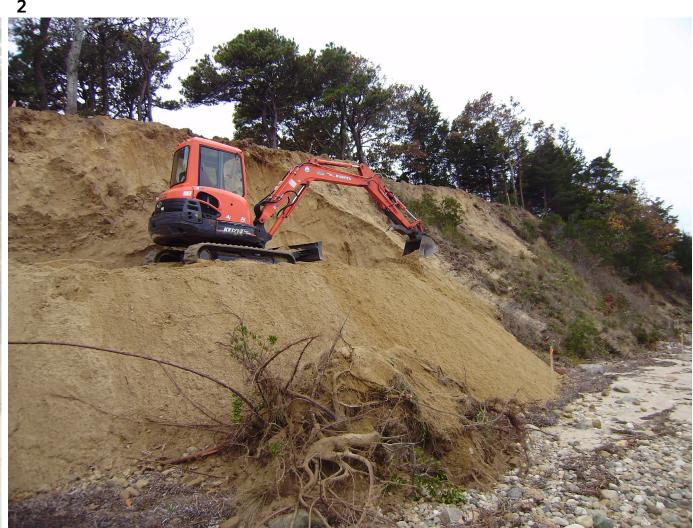
Stabilizing toe of bank - Fiber rolls

- Installation begins at the base of the array and proceeds up bank.
- Proper anchoring strategy to hold toe protection in place.
- Synthetic filter fabrics DO NOT ENHANCE success of a bioengineering project.

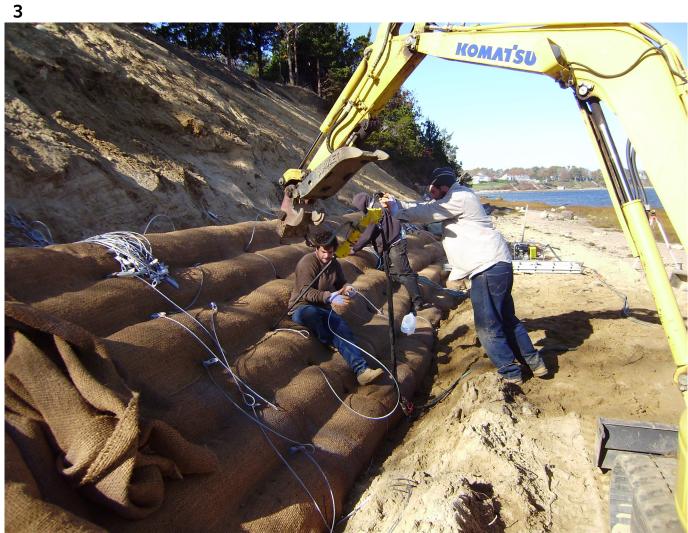
Stabilizing toe of bank - Pre-vegetated fiber rolls

- Use of pre-vegetated fiber rolls along top of array.
- Added vegetation to the root matrix.
- Full season of plant growth prior to installation.

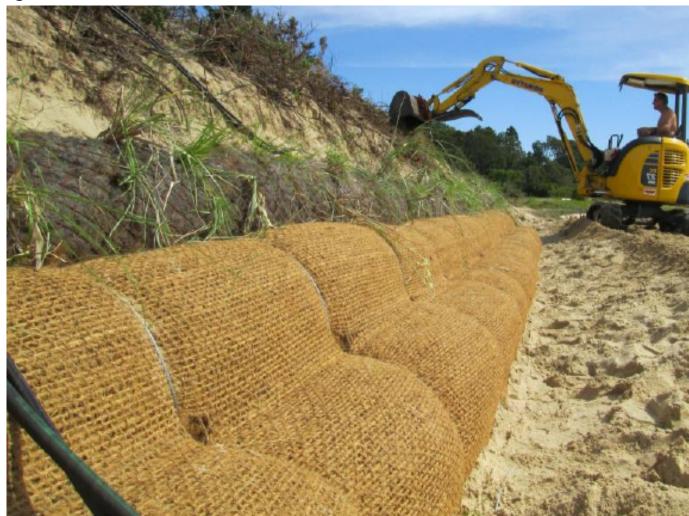
Stabilizing soils above toe protection

- Native salt tolerant grasses are seeded into the bank prior to installation of erosion control blankets.
- Protect soils from erosion and helps to retain moisture to promote seed germination.

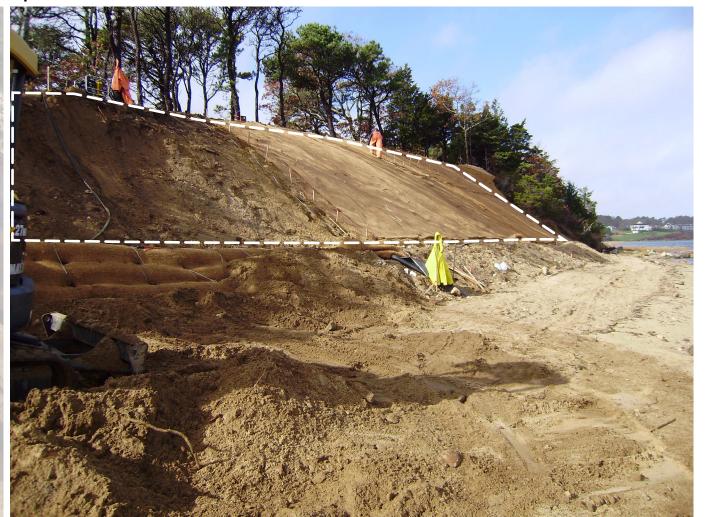
Sand cover for fiber rolls

- Sand nourishment protects coir fiber rolls from photo-degredation "Sun Block".
- Nourishment functions as sediment source to the adjacent coastal resource areas.

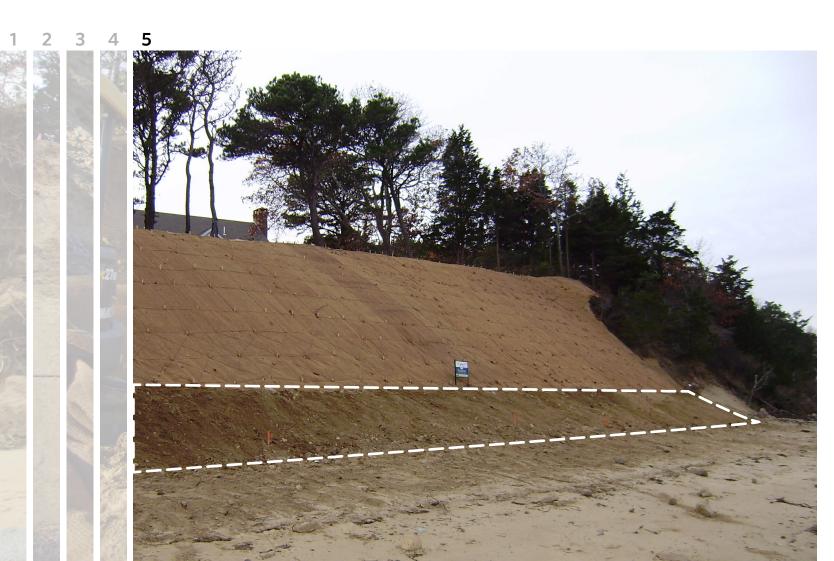
Native shrub species

- Native beach plum and bayberry planted through erosion control blanketing.
- Temporary above ground irrigation for plant establishment.

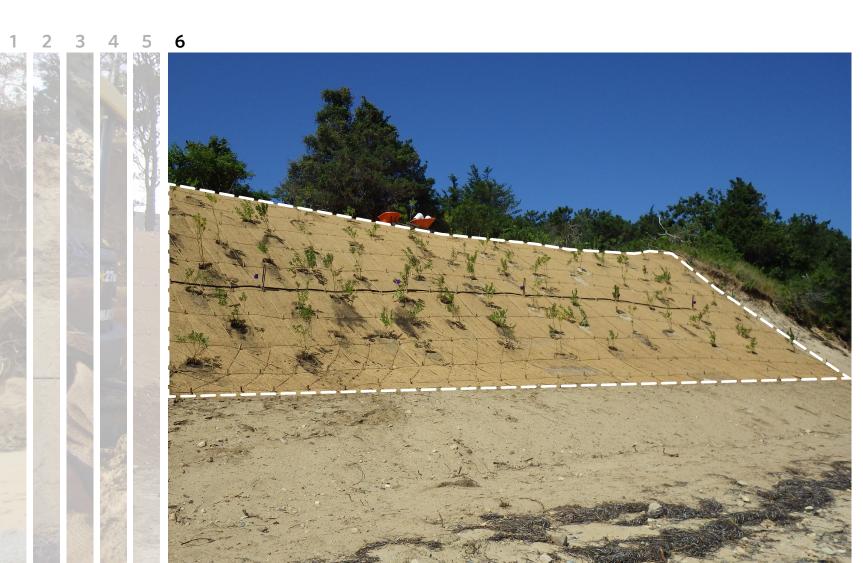
• Establishment of native vegetation after two seasons of growth.

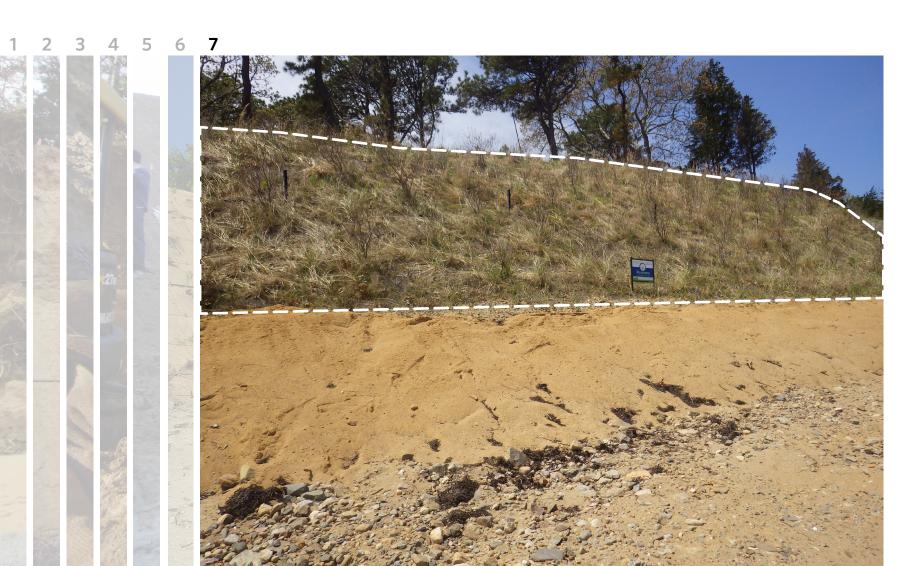
Condition of fiber roll array following Hurricane Sandy 11/2012

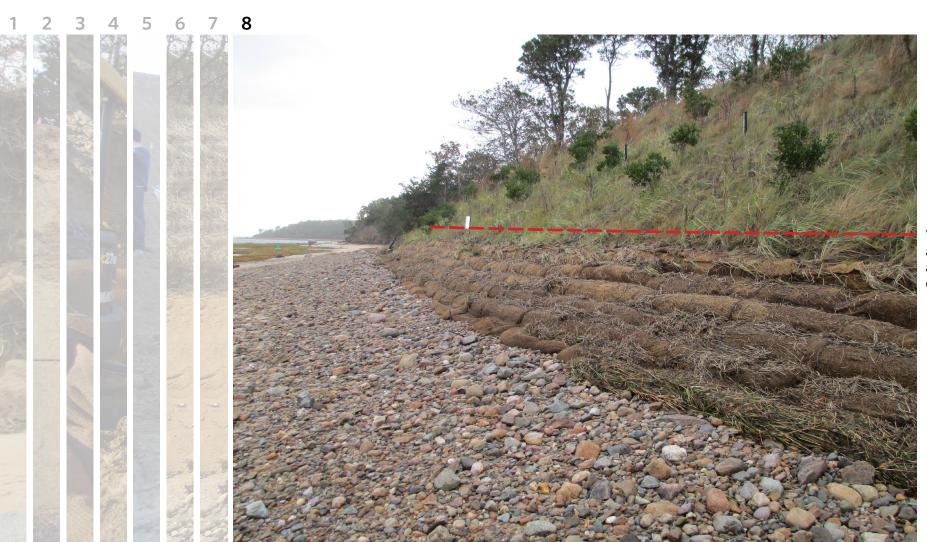
Waves reached above fiber roll array with no damage.

Condition of fiber roll array following named storm Nemo 2/2013

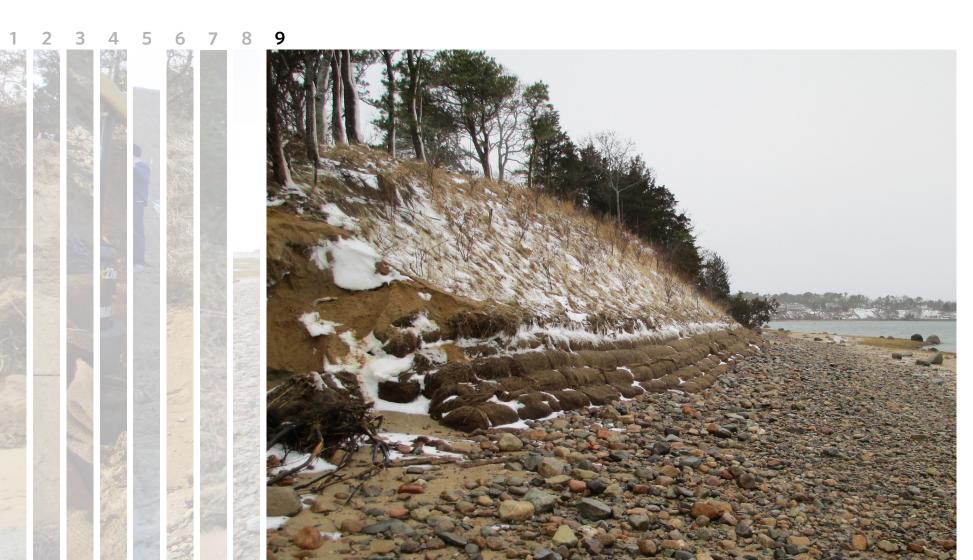
Condition of fiber roll array following named storm Nemo 2/2013

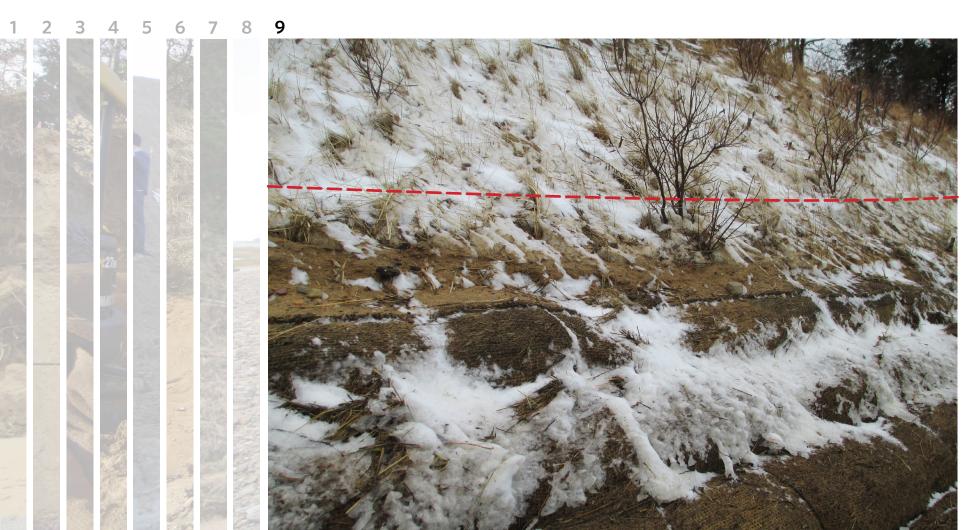
Waves reached above fiber roll array with no damage.

Fiber roll array increased in length by 90' 6/2013
