**GREAT BAY LIVING SHORELINE PROJECT**

**MOODY POINT – NEWMARKET, NEW HAMPSHIRE**  
**PRELIMINARY EROSION MITIGATION**  
**AND LIVING SHORELINE**  
DESIGN REPORT

**April 1, 2022**

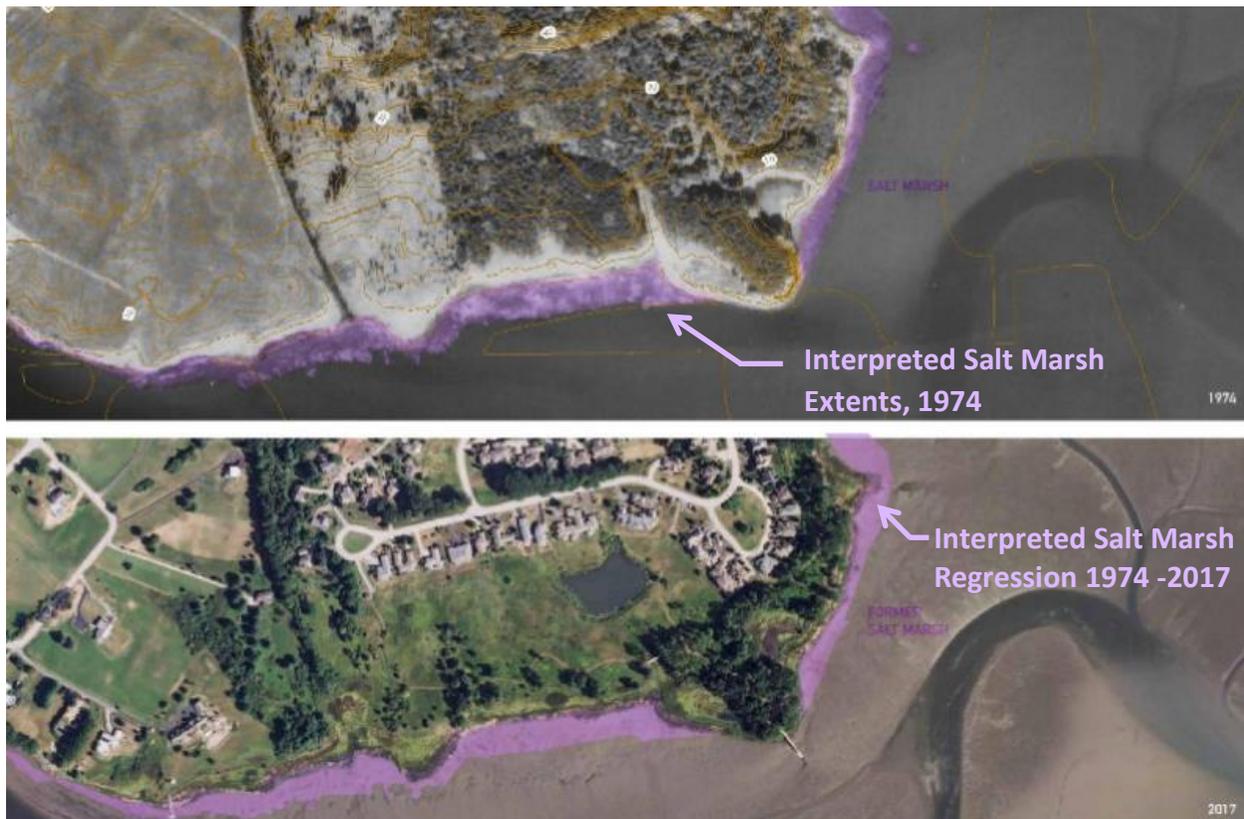
**Figure 9: Approximate Estimate of Salt Marsh Regression 1974 to 2017. (Images Source: NH GRANIT)**

A review of historic aerial imagery available on-line and through NH GRANIT provided limited assessment of the salt marsh changes over time. While areas of fragmented salt marsh were discernible, the image resolutions did not allow for definitive evaluation of salt marsh regression over time. As a rudimentary comparison, the approximate interpreted salt marsh area in 1974 was overlaid on the 2017 aerial image. It suggests that salt marsh regression has occurred with the greatest retreat on the western and northernmost limits of the MPCA shoreline. See **Figure 9**.

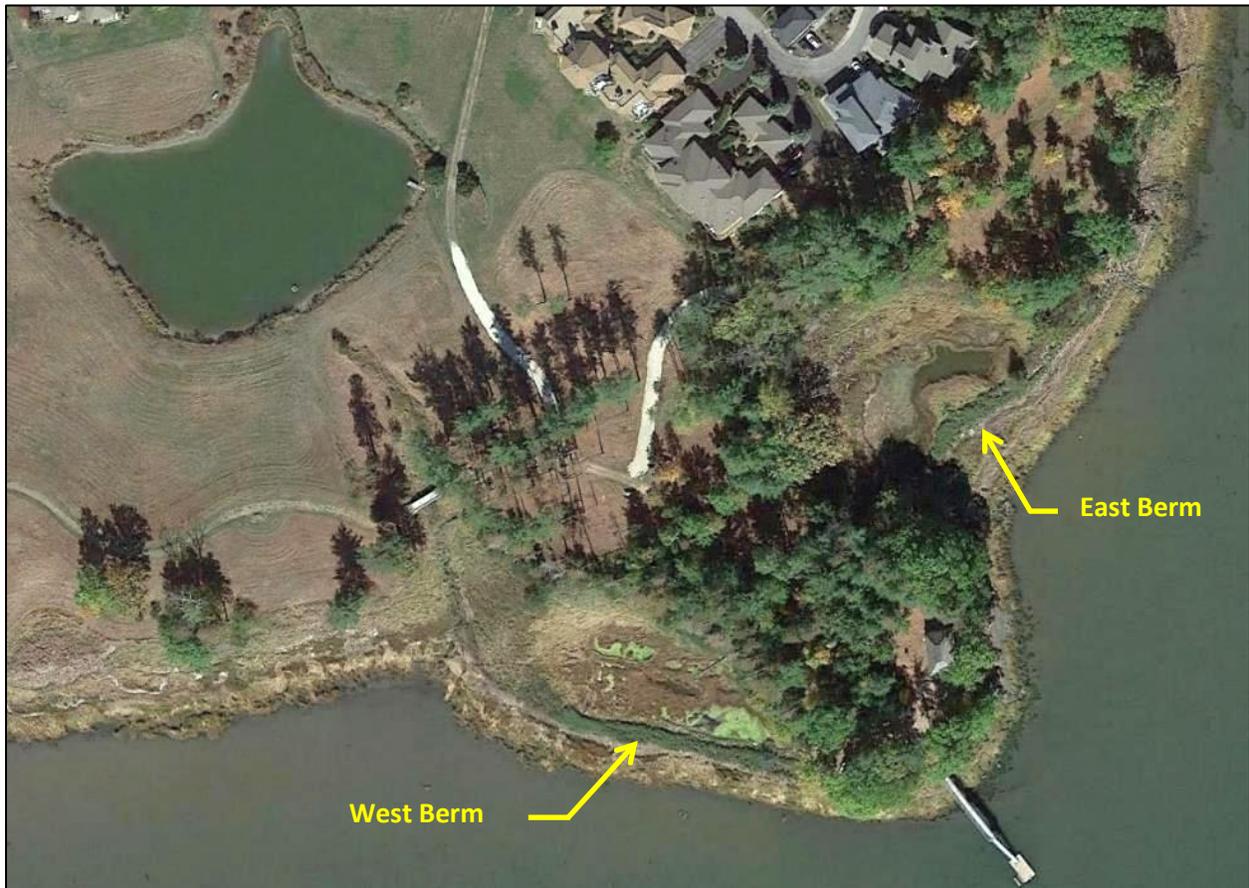
**Figure 10: Anthropogenic Berms, Likely Former Agricultural Berms. (Images Source: Google Earth Pro, 10/10/2020, Newmarket, NH, 43° 4'2.16"N, 70°54'23.12"W elevation 1,497 ft [Accessed 30 November 2020])**

wetlands - the lack of frequent flooding and poor drainage has resulted in standing water or pool development and poor vegetative cover. Recent studies have shown “impacts from berms may impair salt marsh function and resilience to invasive plants and sea level rise” (Mora, Burdick; 2013)<sup>1</sup>.

The berms have created favorable conditions (high salinity and poor drainage) for *Iva frutescens* or marsh-elder, a multi-stemmed woody shrub that is a threatened species in New Hampshire. Stands of marsh-elder have become established along the entirety of both berms. The marsh-elder is known for erosion control and has created a thick tangle of stems along both berms that trap floating debris as it approaches, compounding the lack of tidal flooding and encouraging wrack build-up. Areas of exposed roots, bare soil, and thick mats of wrack were observed along the seaward side of the berms. The wrack build-up smothers vegetation, which leads to bare soil that is easily washed away by tidal influences and storm events, suggesting that the combined effects of the berms and marsh-elder colonies are substantially contributing to large sections of marsh calving. See **Figures 11 through 13**.

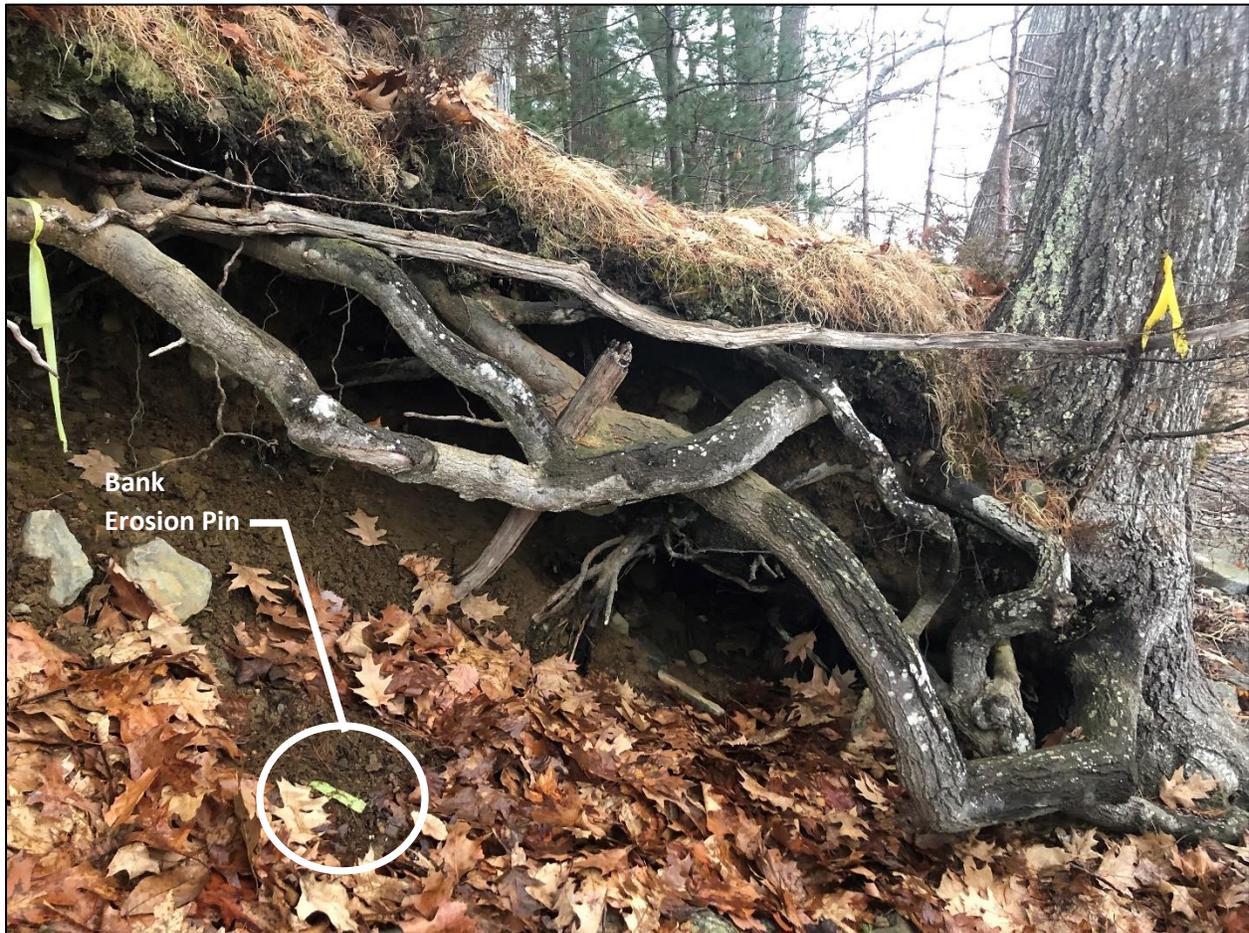
**Figure 14: Example of Slope Erosion above the Coastal Bank Pin (Pin Location 4, Beyond the West End of the Screenhouse Deck, 16 March 2022)**

bar was set horizontally into the bank. One pin was set flush with the face of bank. The other three pins encountered resistance, possible bedrock, and were set with an extension of the reinforcing steel bar protruding from the bank. The length of the extensions was recorded. In March 2022, the erosion pins were located and found to be covered by leaves. Each location had evidence of slope collapse above the pin and the bar extension was either the same or less than it was when the bar was initially set in September. (See the **Appendices**.) Based on this reduction in bar extension and the observations, erosion of the bank is occurring above the pin elevations. This is supported by the significant undercutting present at the easternmost pin set beyond the Screenhouse Deck. See **Figure 14**.

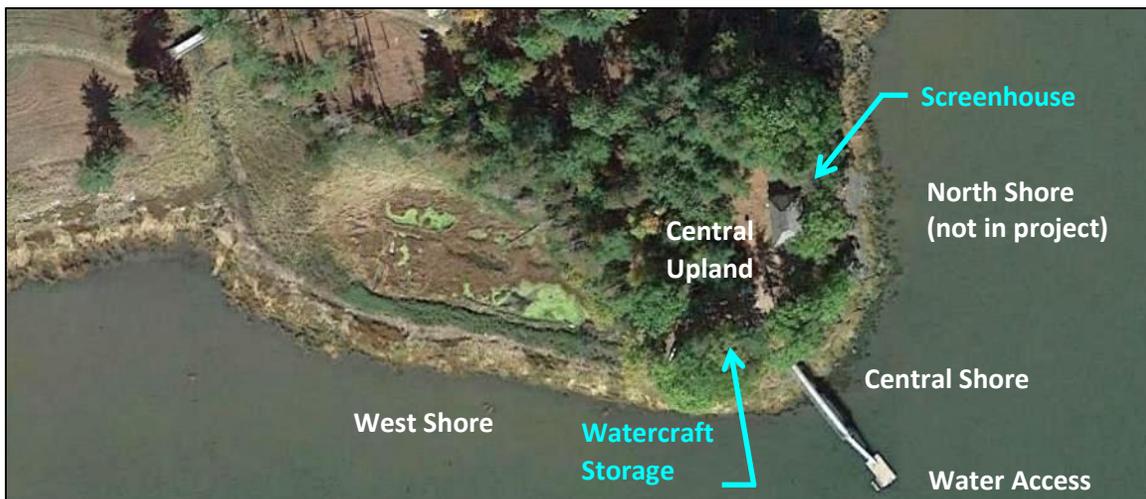
**Figure 15: Project Limits**

In light of the MPCA goals and the project team's ecological goals, the project limits were set with a focus on the community space at the headland and the shoreline immediately adjacent to the space. These limits allow for improvements of the community space (upland and shore) and protection of those improvements and investments. Because of the varied challenges and conditions within this approximate 600 linear feet of shore, the project was categorized into four main focus areas based on geological, ecological, and use considerations. See below and **Figure 15**.

- Central Upland – the upland area defined by the Screenhouse, watercraft storage areas and access to the pier
- Water Access – the fixed pier and seasonal gangway and floating dock
- Central Shore – the coastal bank and shore centered around the pier
- West Shore – the salt marsh located west of the fixed pier and along the back side of the watercraft storage area

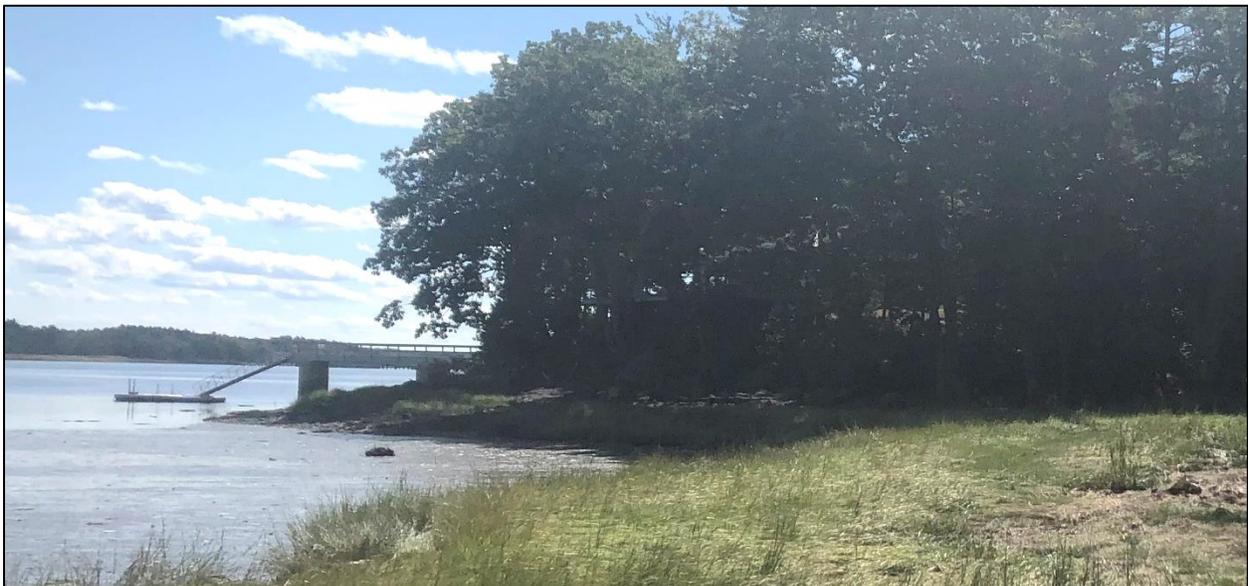
**Figure 16: Existing Gangway Slope nearing the Low Tide Conditions (13 September 2021)**

During meetings with MPCA, challenges with the gangway were highlighted. Its narrow width makes it difficult to carry watercraft on the gangway to/from the float. This is exasperated at low tide by the steep angle of the gangway. See **Figure 16**. Based on limited field measurements, the gangway slope at a MLLW water level is estimated at 1 (vertical) to 2.5 (horizontal). At an extreme low tide, it is steeper at approximately 1 (vertical) to 2.2 (horizontal). While the steepness of the gangway is limited to the time of the low tide conditions, it is steeper than best practices of a maximum 1 (vertical) to 3 (horizontal) slope.

To mitigate the challenges with the gangway width and slope, the gangway could be replaced with a wider and longer gangway. Based on the pier deck elevation, a 45-foot-long gangway would provide an approximate 1 (vertical) to 3.2 (horizontal) slope at extreme low tide. A gangway with a clear width should be adequate for carrying kayaks and similar watercraft without interference from the handrail or gangway framing. In order to have proper placement of the gangway on the float, the float would need to be

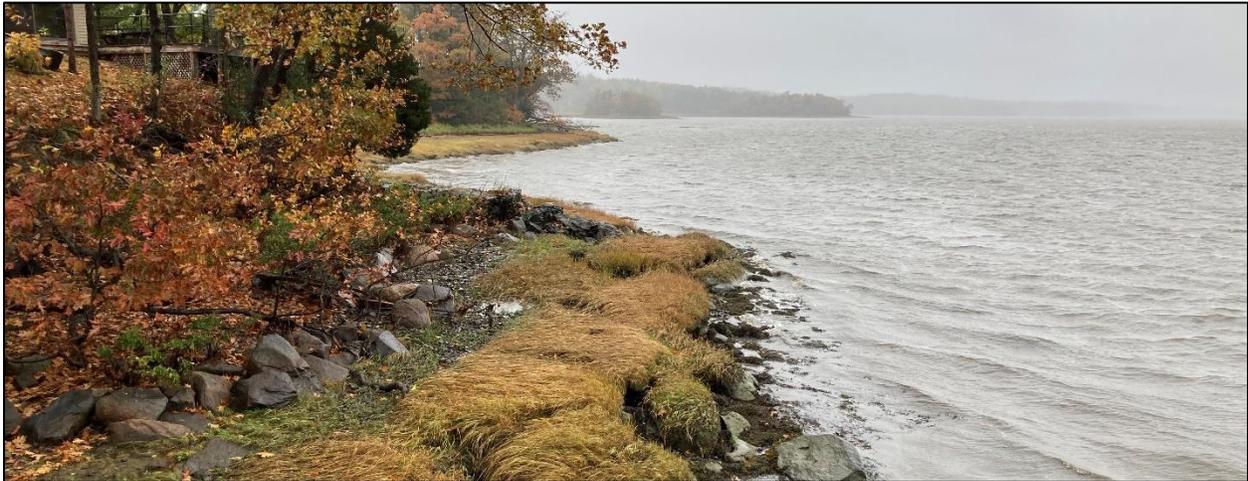
**Figure 17: Coastal Shore to the East of the Pier (26 October 2021)**

The Central Shore consists of a small fringing salt marsh, sparsely vegetated border/spray zone, and a steep bank. The pier extends from the upland over the central shore and into Great Bay. The fringing marsh in this area is narrow with areas of salt-marsh patches interspersed with exposed bedrock, gravel, and sand. The marsh is significantly impaired by wrack accumulation; deep channels bifurcating the marsh; and disturbances from wave action, seasonal ice movement and unmanaged stormwater runoff from the central upland. The steep bluff immediately adjacent to the fringing marsh also shows evidence of active erosion in the form of undercutting and exposed soil and tree roots. See **Figure 17**. It is noted that a mud flat extends from the existing salt marsh to approximately the low tide elevation, and therefore, the seaward limit of the salt marsh does not experience tidal interaction at low tide.

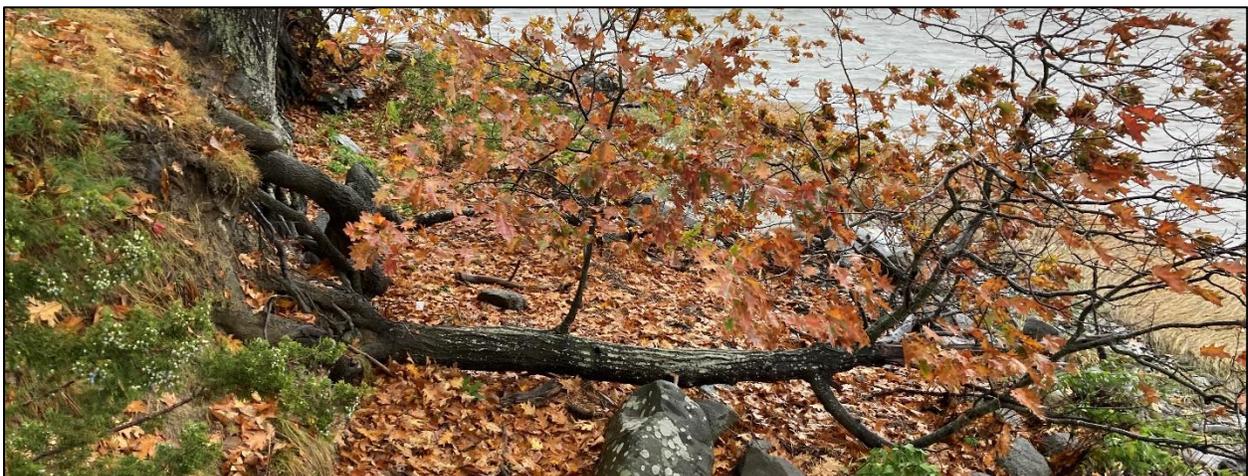
**Figure 18: Coastal Bank to the East of the Pier (26 October 2021)**

The access to the fixed pier is flanked by areas of severe erosion that threaten the stability of the central shoreline. Steep slopes with areas of bare, eroded soil are evident. Roots of large trees are exposed, and trees lean significantly seaward, creating a potential hazard and suggesting additional erosion and/or bank failure is likely. The erosion continues along the central shoreline, including areas of exposed bedrock very near the foundation columns of the deck at the Screenhouse. See **Figure 18**.

The fabric encapsulated soil solution on either side of the dock is a basic technology solution to minimize further bank erosion and marsh degradation. The solution proposes coir fiber fabric wrapping soil, stacked in a staircase-like formation to dissipate tidal and wave energy to promote and maintain the shoreline position. The substrate would subsequently be planted with native vegetation.

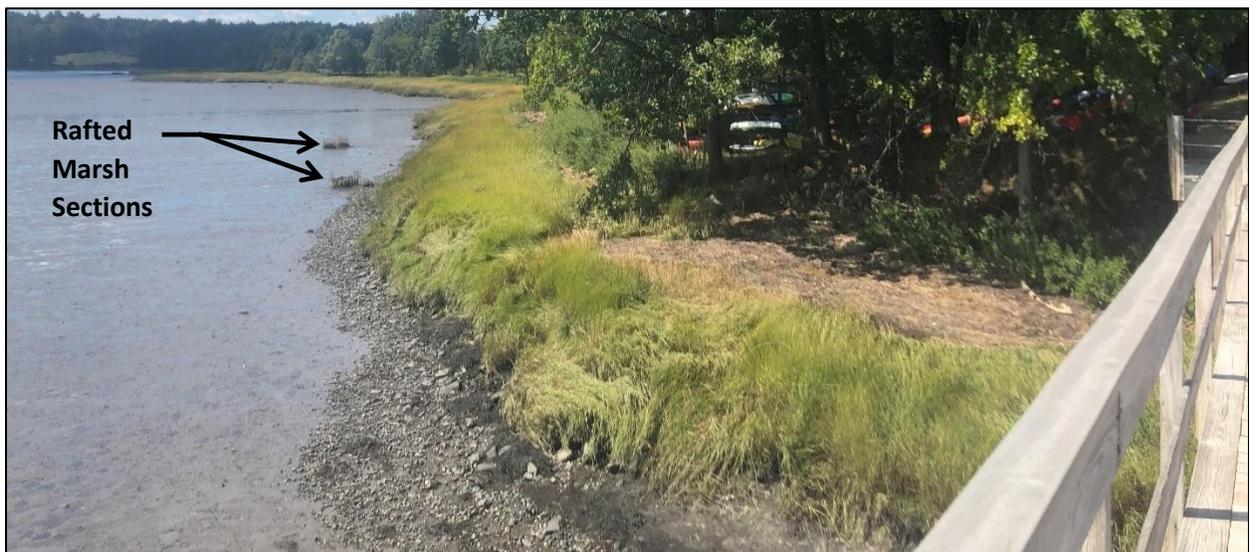
**Figure 19: West Shore with Sections of Rafted Marsh (9 September 2021)**

The West Shore consists of a fringing marsh, anthropogenic berm, and perched wetland on the back (landside) of the berm. Evidence of marsh erosion was observed, including undercut sections of marsh, fragmented sections of marsh along the seaward toe of the berm, and rafted pieces of marsh that calved off and were carried waterward by the tide. See **Figure 19**. Similar to the Central Shore, a mud flat extends from the existing salt marsh to approximately the low tide elevation, and therefore, the seaward limit of the salt marsh does not experience tidal interaction at low tide. However, the vitality of the marsh is impaired by the wrack buildup along the berm. The wrack material smothers marsh vegetation, causing die-off which leads to bare soil, a weakening of the marsh platform, and its subsequent erosion. In addition, the berm is a barrier to tidal circulation and has created the perched wetland. The perched wetland lacks water flushing and has poor vegetative cover.

Overwinter storage of the seasonal float along the shoreline immediately to the west of the pier is likely intensifying the saltmarsh die-off from tree shading and bank runoff in this area. See **Figures 20**. The area of the float storage corresponds to the compromised salt marsh area in **Figure 19**.

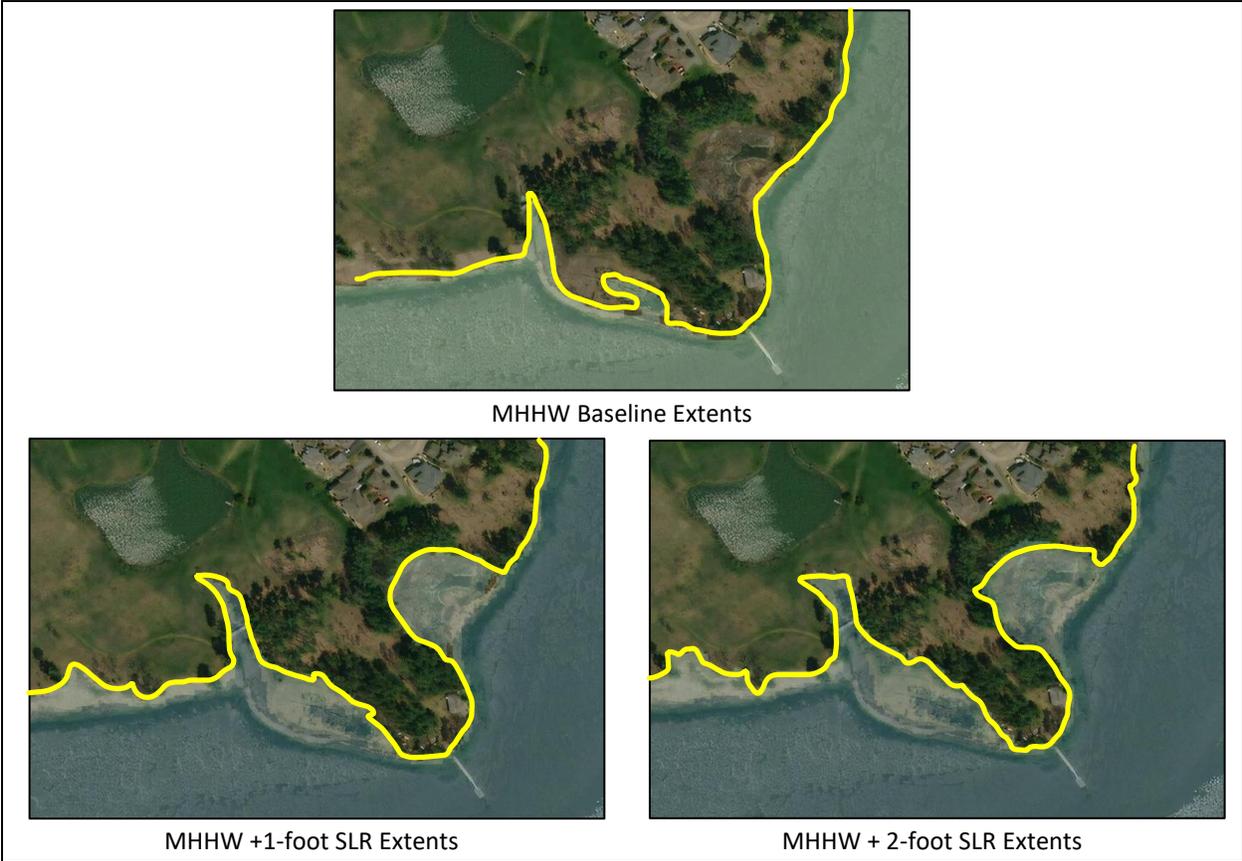
**Figure 21: NH Coastal Viewer Screening Maps of MHHW Extents under Sea Level Rise Scenarios**

NH Coastal Viewer is an online mapping tool of coastal resources and hazards-related spatial data. It provides an initial screening tool developed and managed by NH GRANIT in partnership with NHDES Coastal Program. **Figure 21** compares MHHW water level for a 2014 Baseline condition, MHHW +1' SLR, and MHHW +2' SLR. **Figure 22** depicts potential salt marsh landward migration for 2050 as compared to 2014 conditions. See the **Appendices** for full-sized versions of the mapped images.

Both of the visualization tools suggest a landward migration of the salt marsh. With that comes an increased reach of tidal waters and the potential realization of the above listed anticipated impacts to the shore and coastal bank. Improving the current salt marsh conditions and addressing the coastal bank erosion are measures to integrate potential mitigation and resilience. Summary of the preliminary design for each of the project areas is presented below.

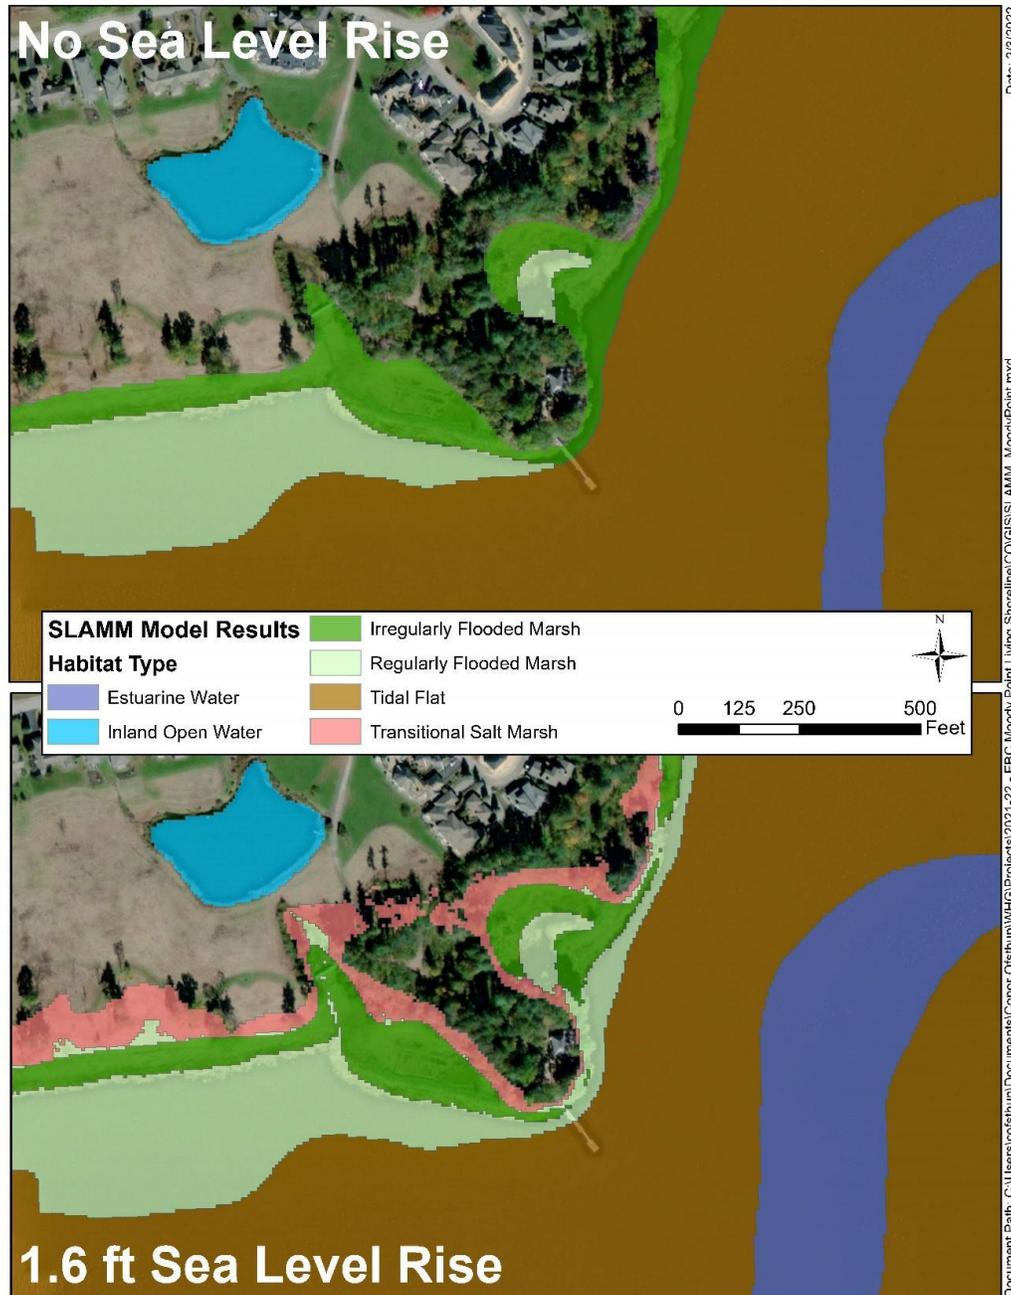
**Figure 23: NH Coastal Viewer Screening Maps of Salt Marsh Landward Migration**

Sea Level Affecting Marshes Model (SLAMM), initially developed by the Environmental Protection Agency (EPA) in the 1980s, simulates the dominant processes involved with wetland conversion due to sea level rise. It incorporates parameters including LiDAR elevation data, mapped wetland classifications, sea level rise, tide range, accretion, and erosion rates. The SLAMM results for the +1.6-foot SLR scenario shows the development of transitional marsh along the much of the shore. The fringing high marsh (“Irregularly Flooded Marsh”) around the headland converts to low marsh (“Regularly Flooded Marsh”) but is limited by the steep coastal bank. See **Figure 23**.

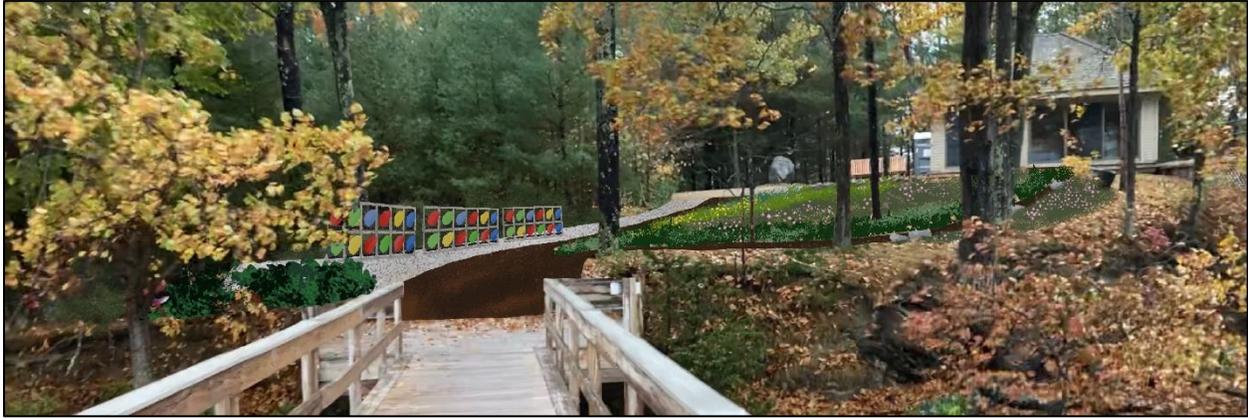
**Figure 24: Central Upland Preliminary Design**

- Plant native plants between the Screenhouse and the shore. Plants would be of varieties that do not grow too tall so that they will not obstruct the water views. Plantings on the new berm would be woodier in nature so as to encourage birds and blend with the natural landscape.

- Add a 16' to 22' ribbon of crushed stone along the western side on which to store kayaks and to help with drainage.

Solutions provided by the Central Upland Preliminary Design are summarized below and are depicted in the **Appendices** and **Figure 24**:

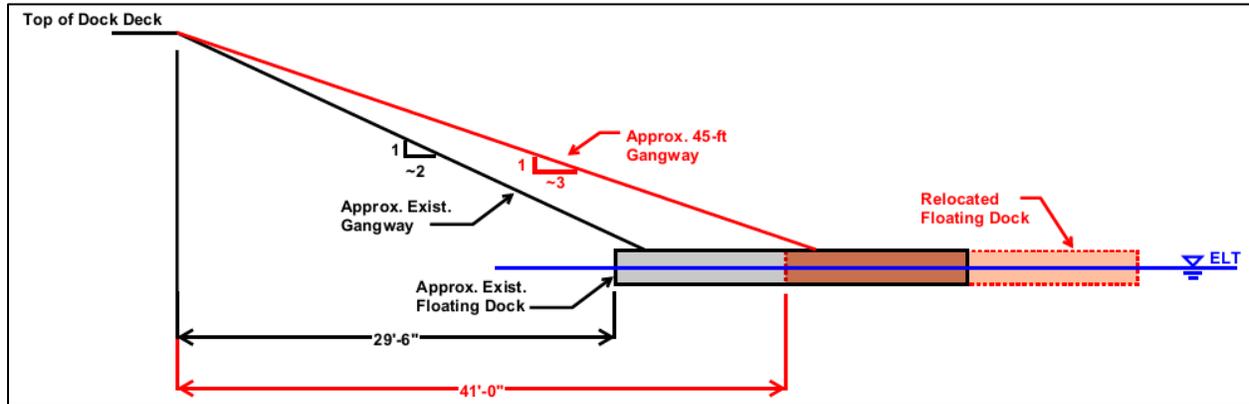
**Figure 25: Comparison of Approximate Existing Gangway Slope and a Proposed 45-foot Long Gangway at Extreme Low Tidal Conditions.**

relocated father waterward approximately 11.5 feet. See **Figure 25**. The proposed gangway replacement and float relocation would require approval from regulatory agencies. However, a cursory review of mapped eel grass and the proximity of the navigation channel did not identify potential conflicts. See the **Appendices** for additional information.

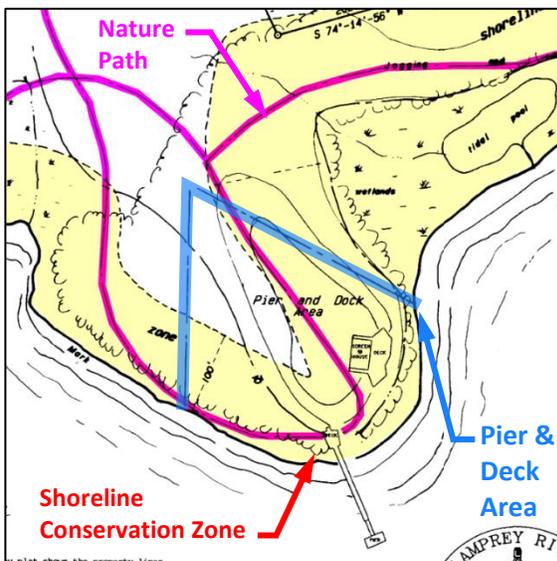
**Figure 26: Excerpt, Moody Point Site Plan Screen House Deck & Pier, Plan No., A-1769, Sheet 2 Of 3, Frederick E. Drew Associates, Jan, 1990.**

MPCA indicated that they would like to explore the potential for an alternative water access. The land deed for the property established a Pier and Deck Area in which the community has the “right to build such improvements within the “pier and deck” area... as are permissible and in compliance with all Federal, State and Town of Newmarket requirements.” Based on review of the site plan associated with the deed, the “pier and deck” area appears to encompass the shoreline from the east side of the Screenhouse toward the west beyond the pier and current watercraft storage area. See **Figures 26 and 27**. While the deed may allow for another water access location, the area within the “pier and deck” area is within an environmentally sensitive region. Before advancing with an alternative water access, preliminary discussions with NH DES is advised.

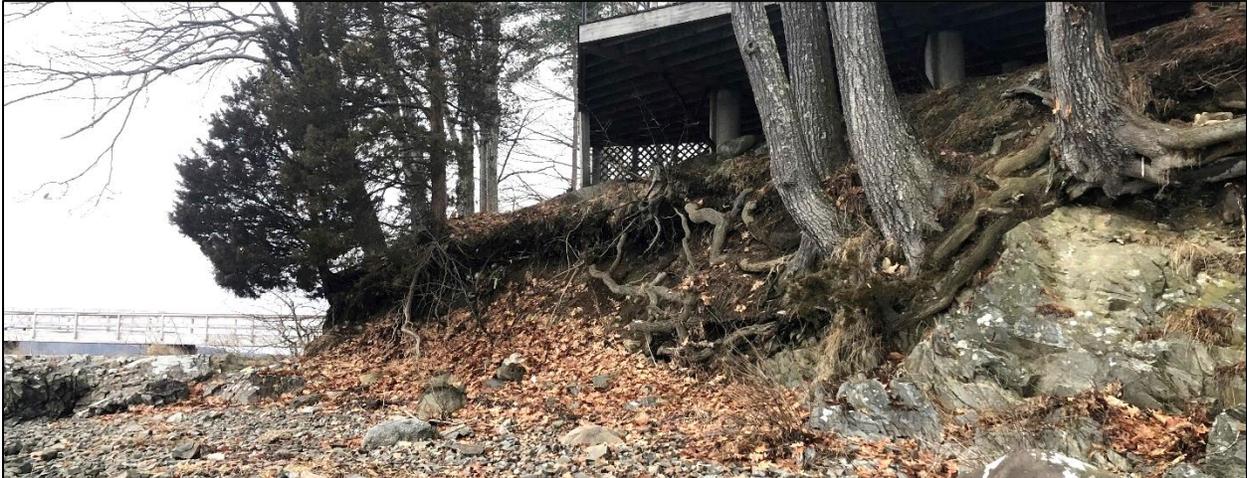
**Figure 28: North Shore, Along Screenhouse Deck (Looking West, 16 March 2022)**

The North Shore of the site was characterized as a transition from the fringing salt marsh and steep headland of the Central Shore to a low elevation, marsh platform. Observations during site visits found evidence of coastal bank erosion with undercutting and salt marsh erosion through calving. Causes of marsh erosion are likely a combination of the similar factors affecting the West Shore and Central Shore: wave damage and removal of marsh sediment; ice damage; wrack accumulation leading to vegetation die-off; and tree shading leading to vegetation die-off. Further north, the agricultural berm acts as a barrier between the inland marsh area and Great Bay, similar to the conditions of the West Shore.

Along the North Shore, the Screenhouse and deck are located at the top of the coastal bank within the area of erosion and undercutting with exposed bedrock. (See **Figures 28 and 29.**) The foundation of the deck appeared to be fronted by the exposed bedrock, however, an assessment of the deck foundation was not included in the project. Given that improvement solutions along this section of shoreline would require a deck foundation assessment, bedrock quality and stability evaluation and further study that was beyond the scope of the GBLS project, the North Shore was excluded from the living shoreline preliminary design project. However, the solutions provided for the West and Central Shores may form a part of the engineered solutions for the North Shore as related to the agricultural berm and shore erosion.

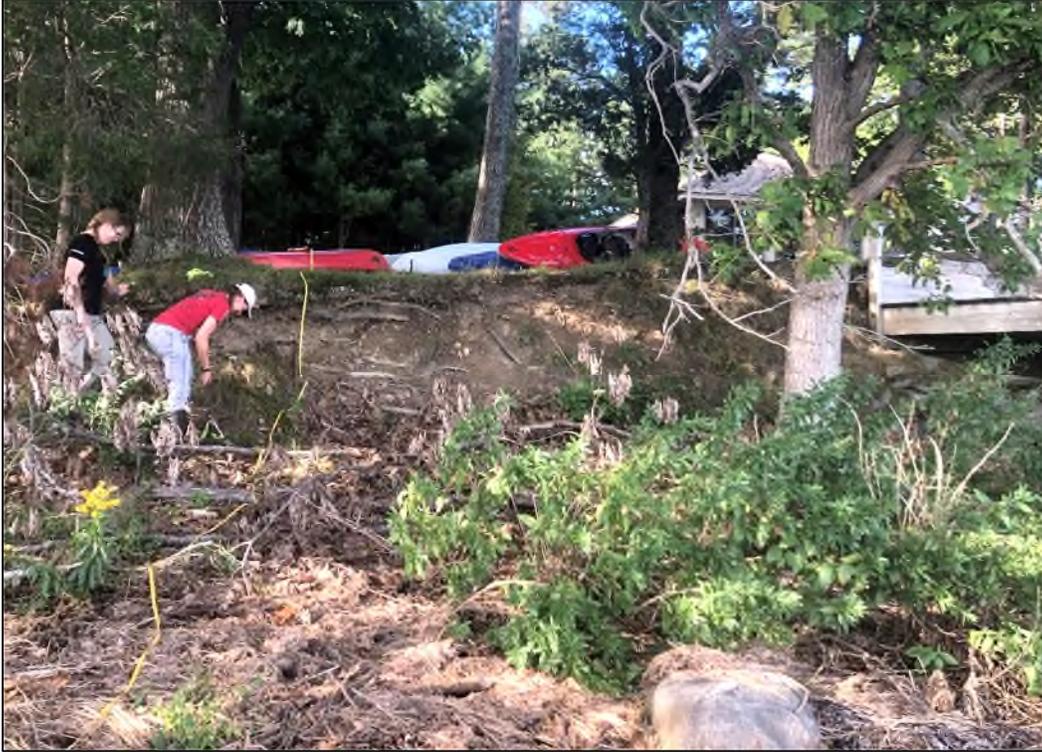
**COASTAL BANK EROSION PIN NO. 1:**

Location: west side of pier, approx. at apparent High Tide Line and aligned with large tree. Set flush with slope on 13 September 2020.

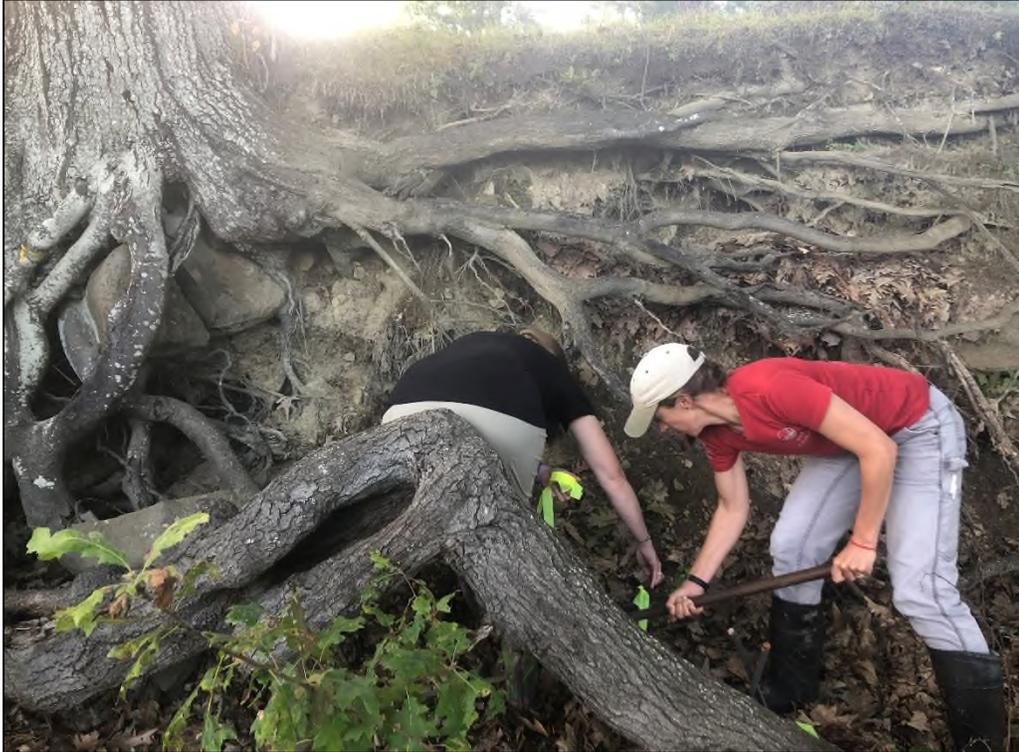
**COASTAL BANK EROSION PIN NO. 2:**

Location: east side of pier, near tree with exposed roots on rock. Set with 2.5" of bar protruding from slope on 13 September 2020.

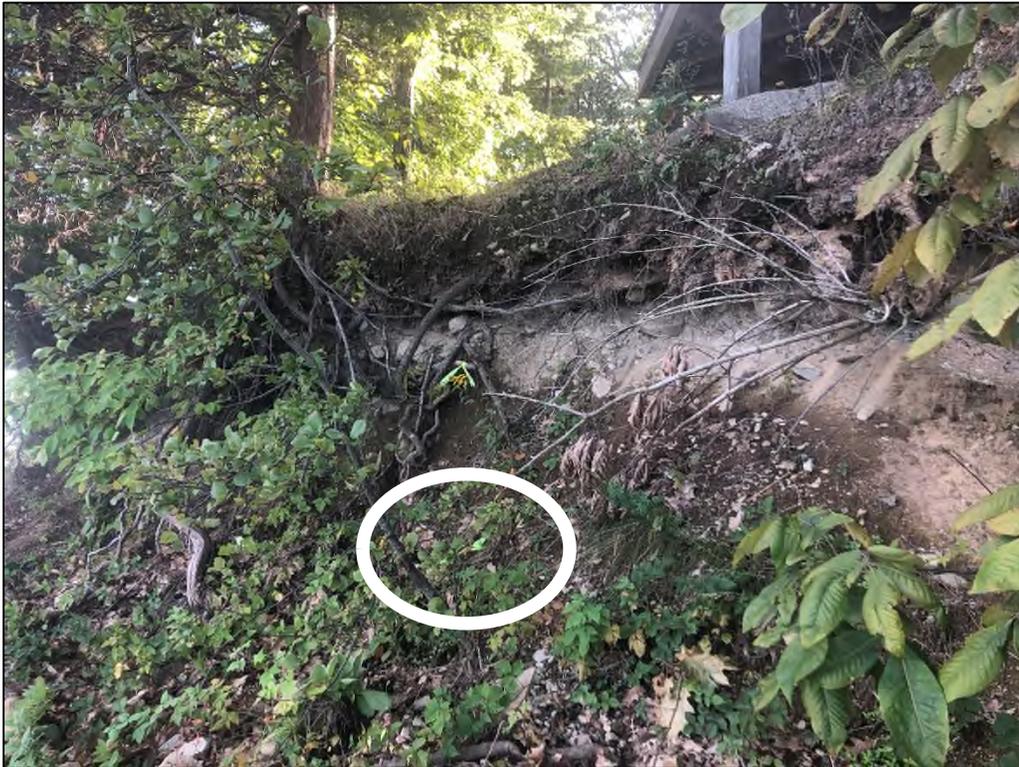
**COASTAL BANK EROSION PIN NO. 3:**

Location: east of the pier, approx. aligned with deck timber post at top of bank. Set with 2.3” protruding from slope on 13 September 2020.

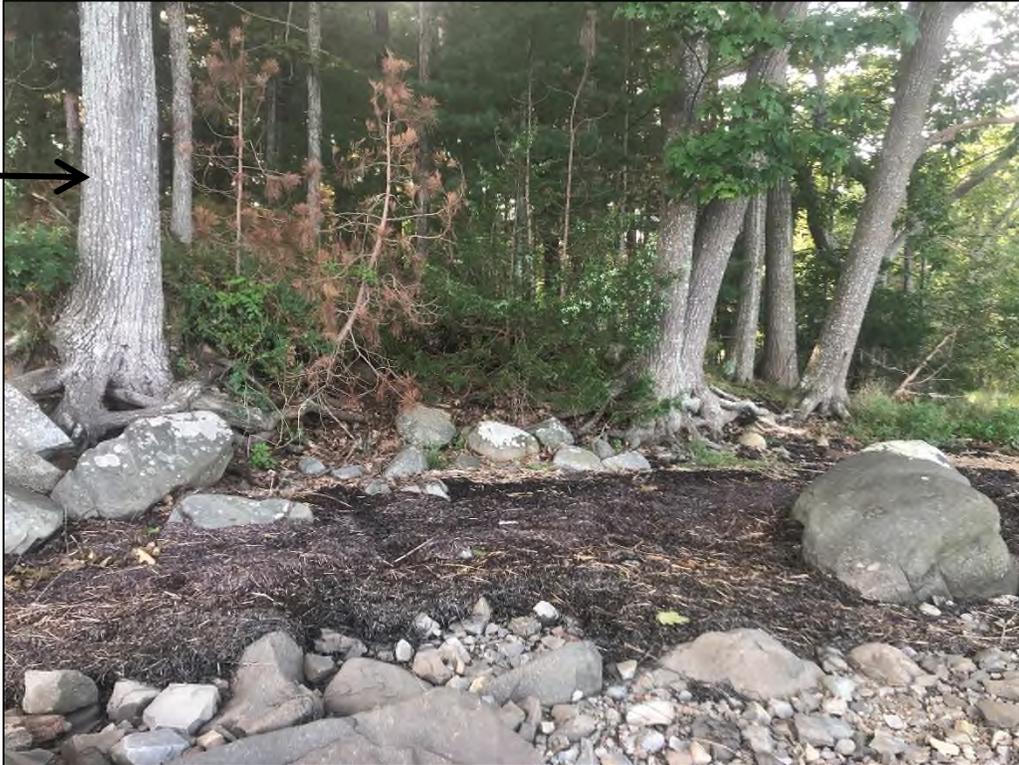
**COASTAL BANK EROSION PIN NO. 4:**

Location: east of east end of screenhouse deck, aligned with small pine trees. Set with 3” protruding from slope on 13 September 2020.

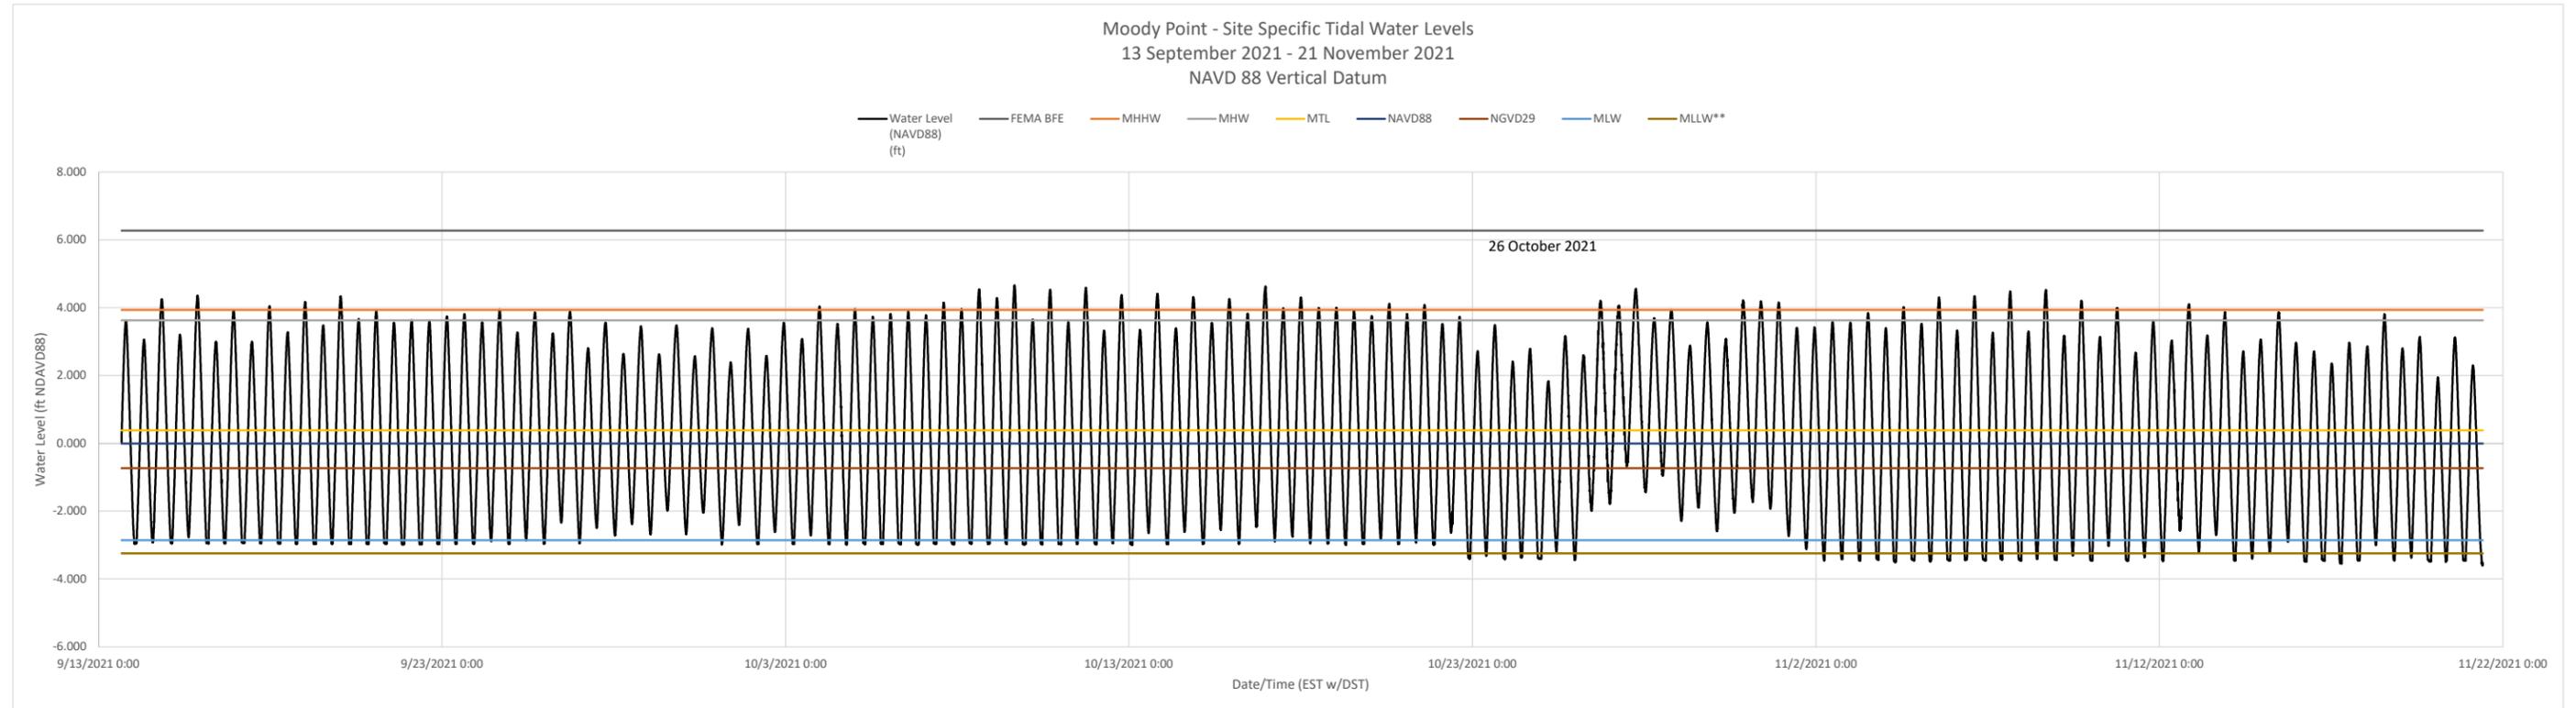
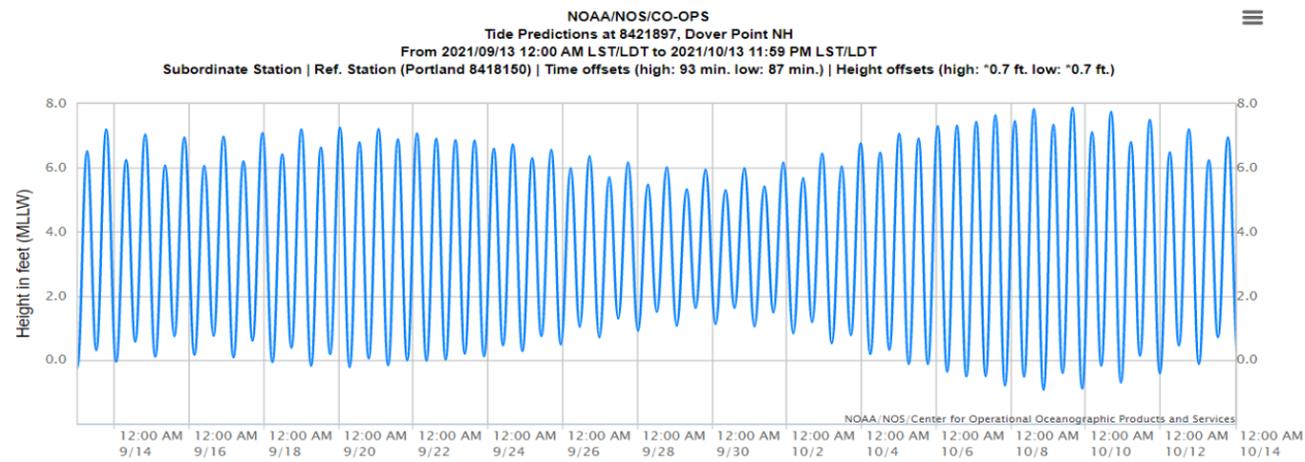
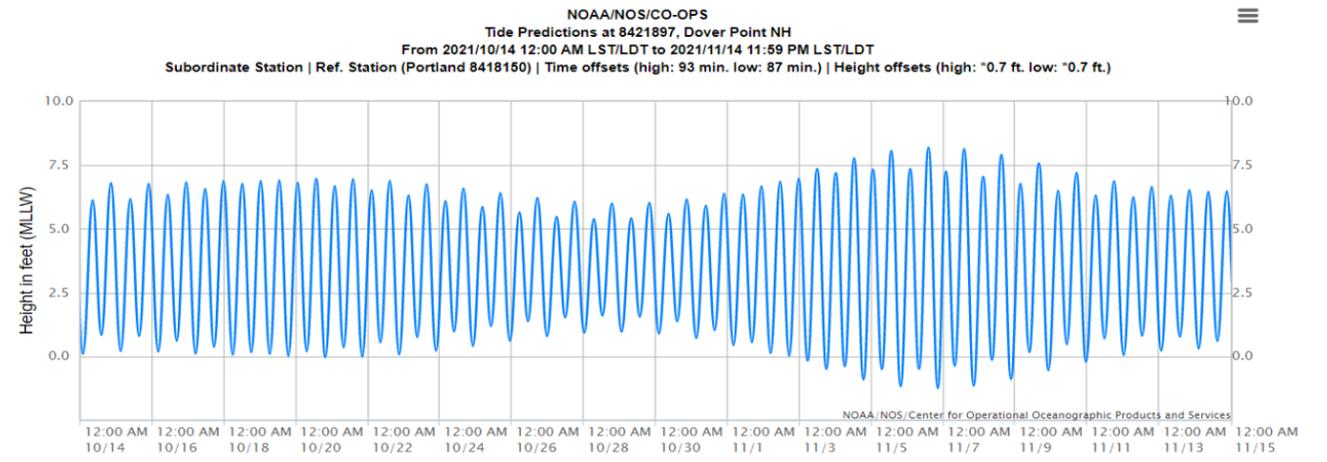
The tidal water level plot of the collected data has similar trends as the predicted tide plots, except around the time of the 26 October 2021 Nor'easter storm. This is a reasonable deviation because the tide predictions are not adjusted for weather.
