**GREAT BAY LIVING SHORELINE PROJECT**

**MOODY POINT – NEWMARKET, NEW HAMPSHIRE**  
**PRELIMINARY EROSION MITIGATION**  
**AND LIVING SHORELINE**  
DESIGN REPORT

**April 1, 2022**

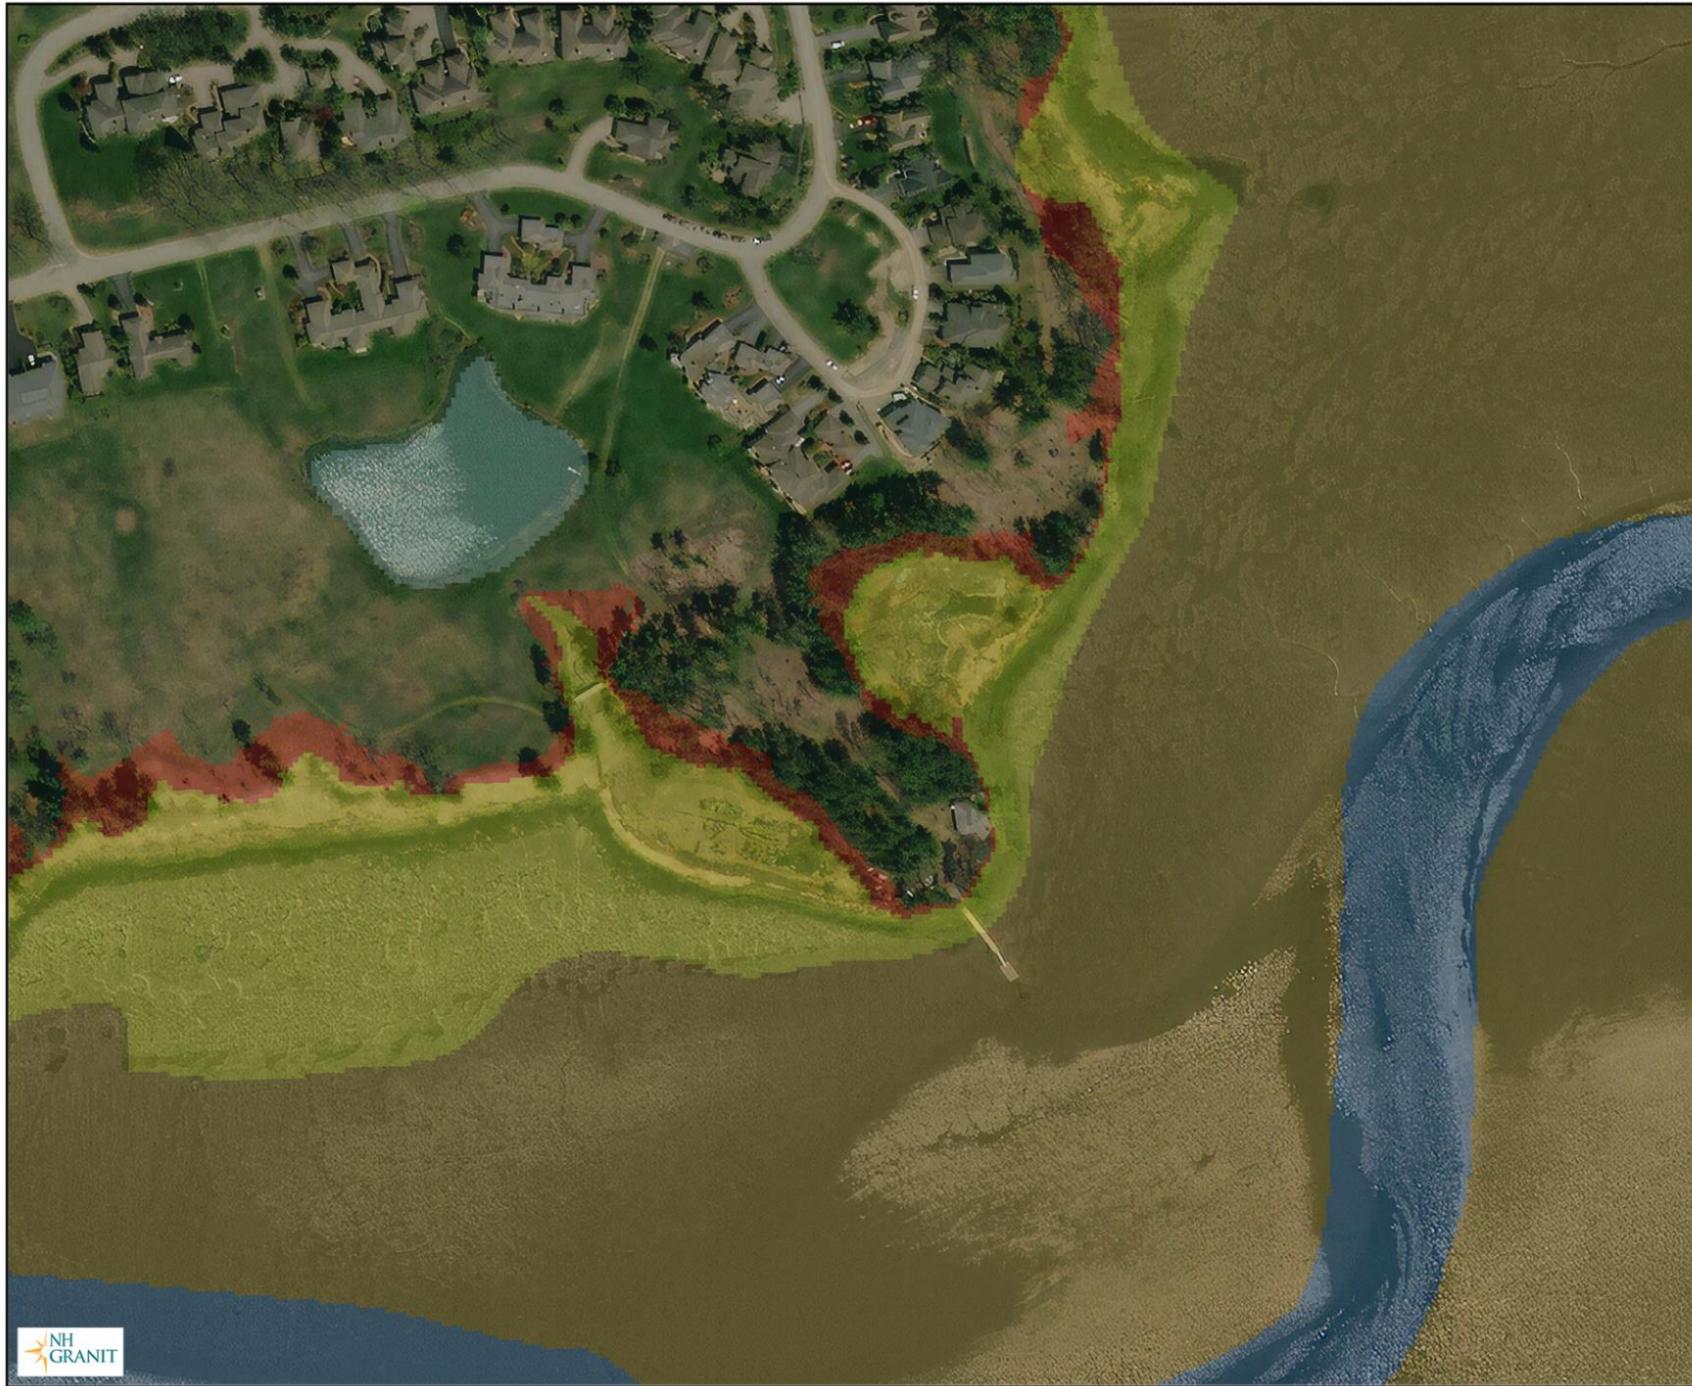
Predicted 2050 Salt Marsh with 3.9' SLR by 2100 (which is consistent with 1.6' SLR at 2050 for medium tolerance for flood risk per NH Coastal Risk Summary Part II)

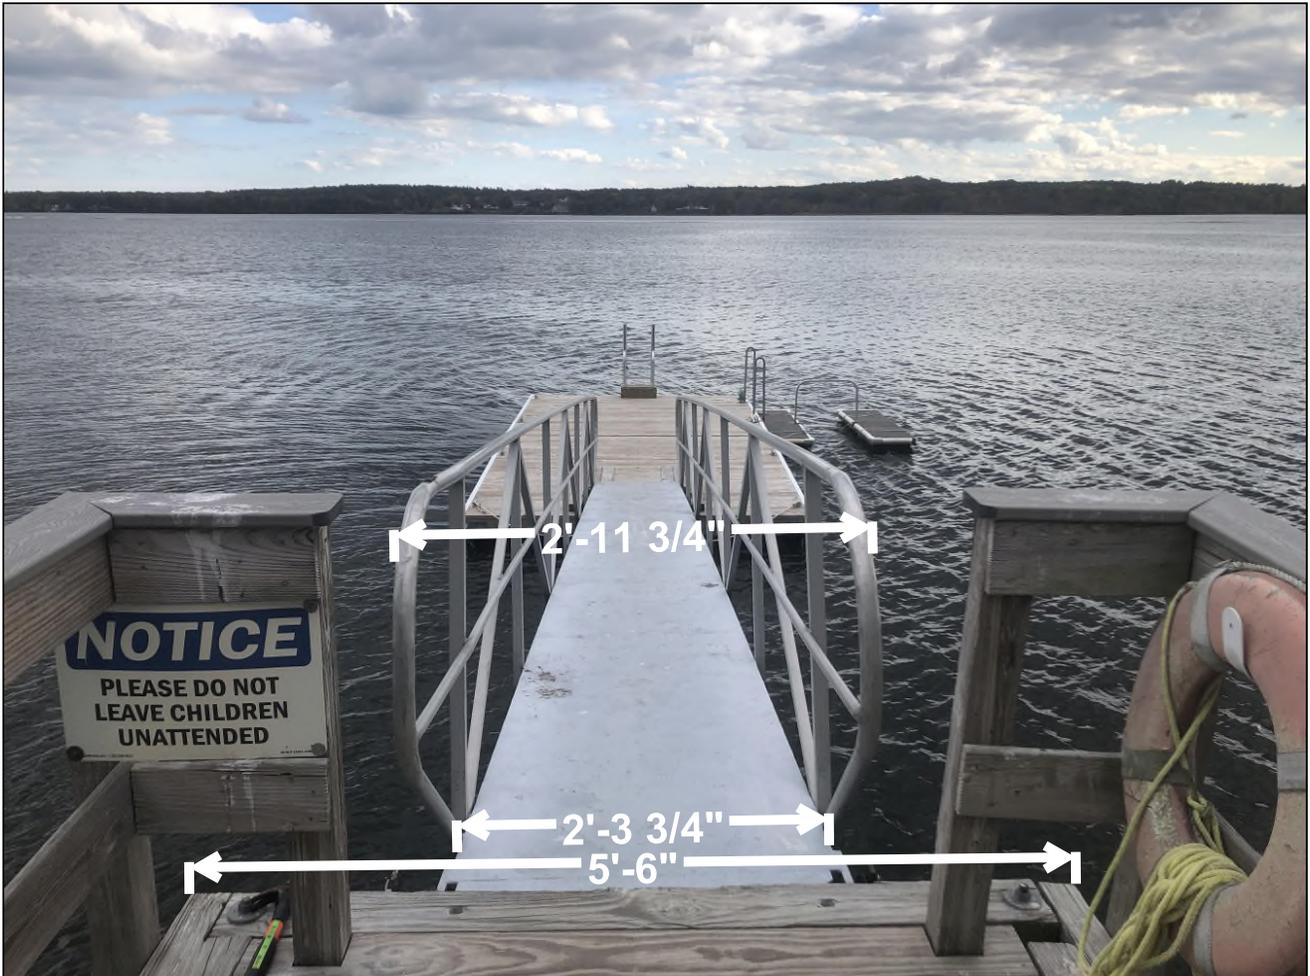
Estimated Gangway Width

Using approx width using the pier width (previous page) and scaling from photograph (22 October 2021)

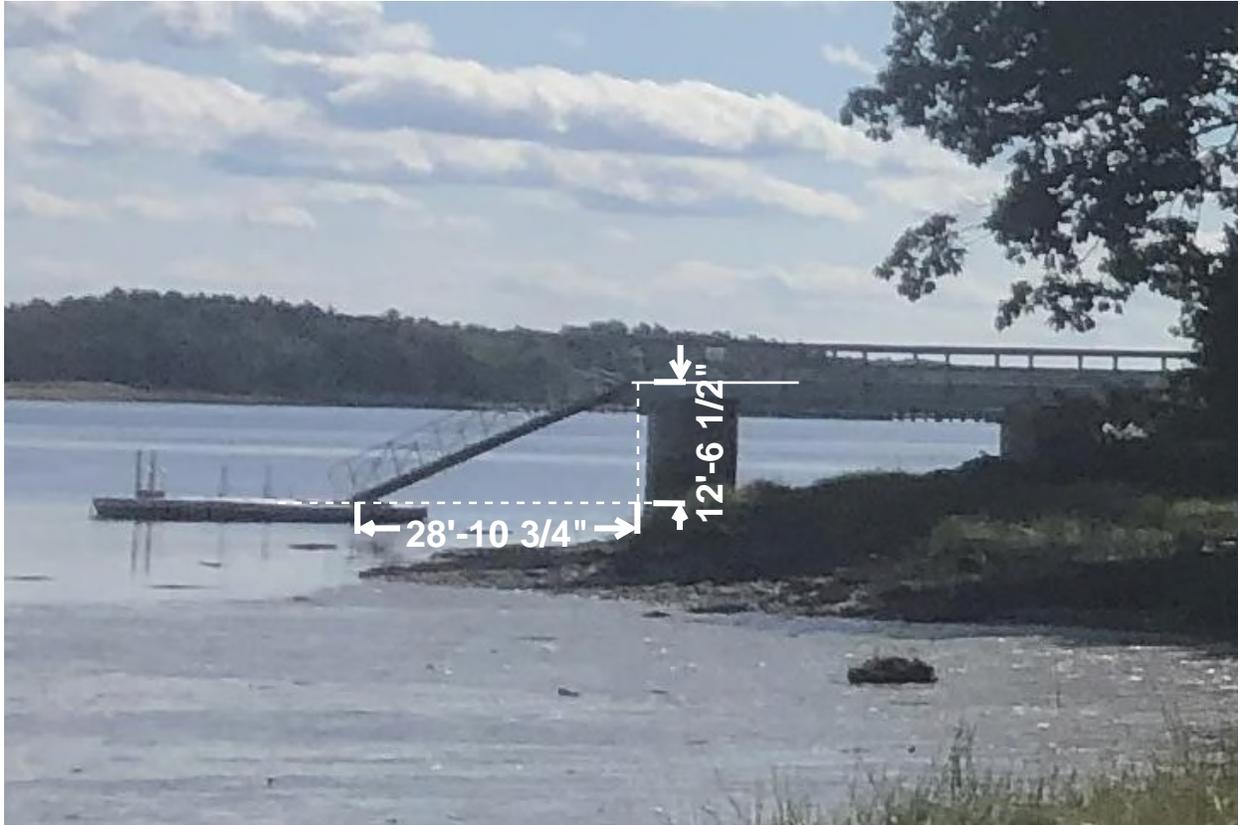
Therefore, on 13 September '21, low tide at Moody Point was approximately at 11:53 AM + 20 minutes = 12:13 PM. Photo below is approximately at 2 hours after low tide.

Scaled measurements in the photograph may not be "actual" distances. The photo perspective is skewed relative to the alignment of the pier and dock. However, the scaled measurements are relative to one another and provide an approximate gangway slope.

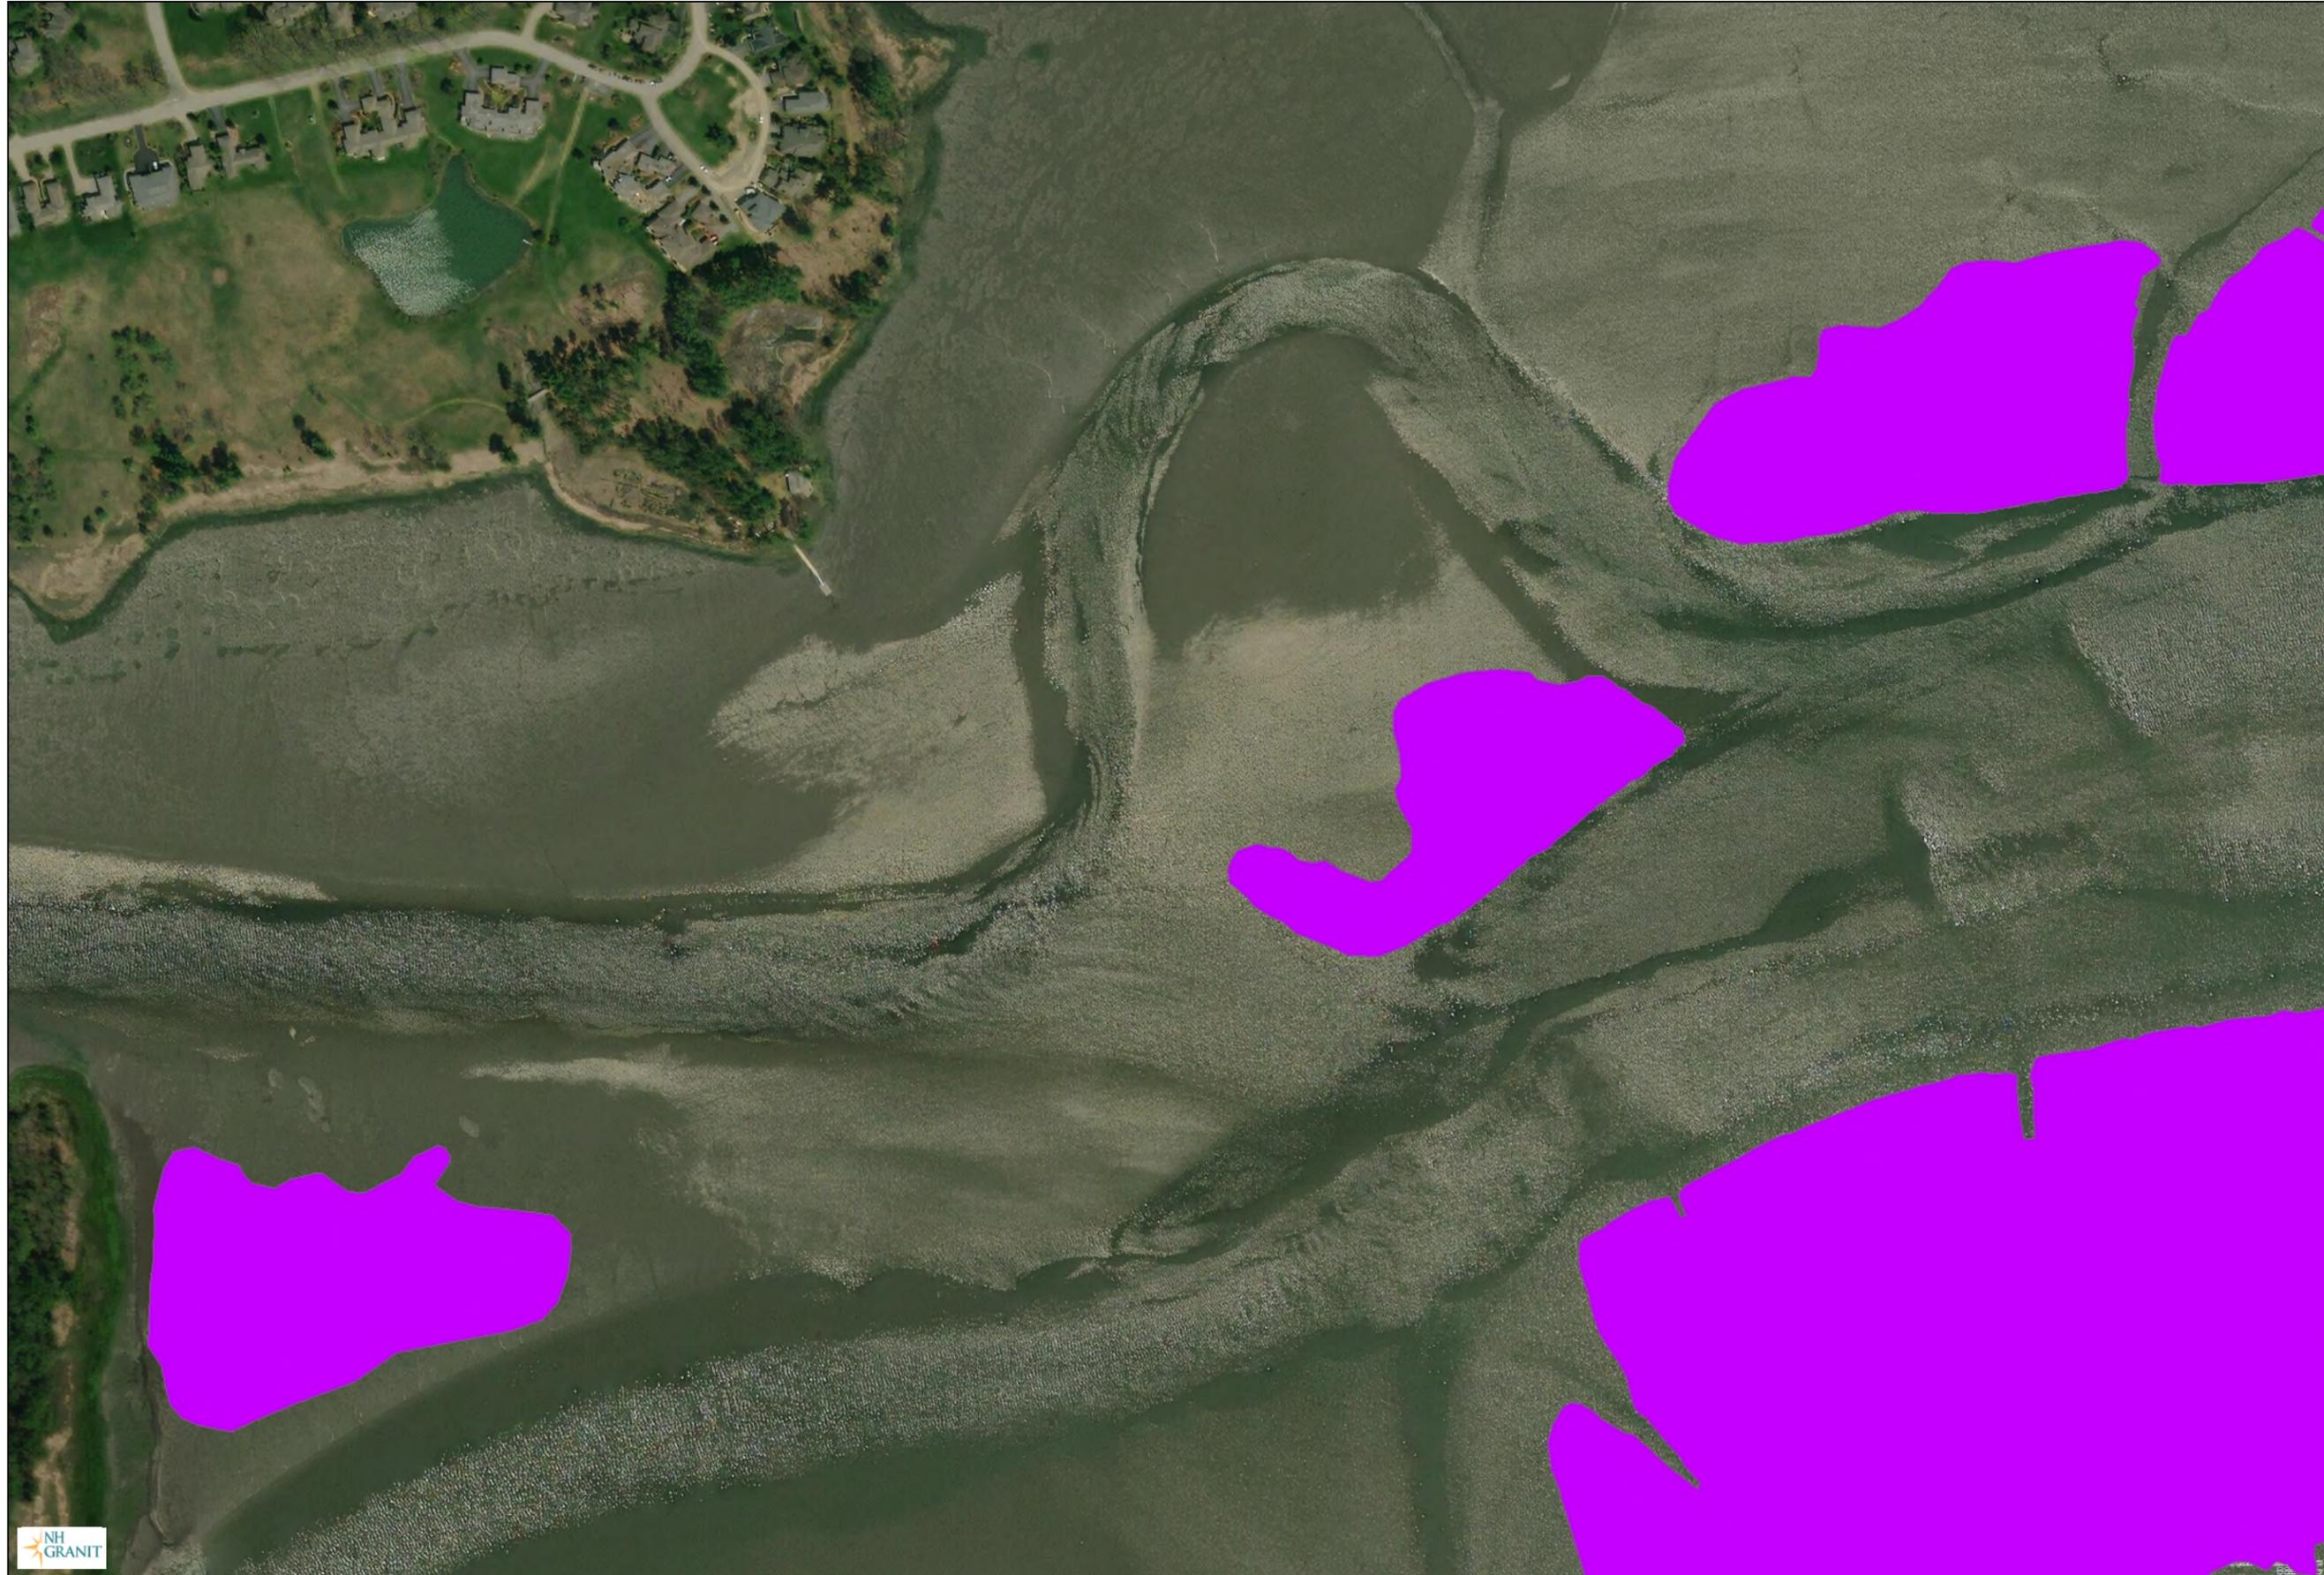
2019 Eel Grass

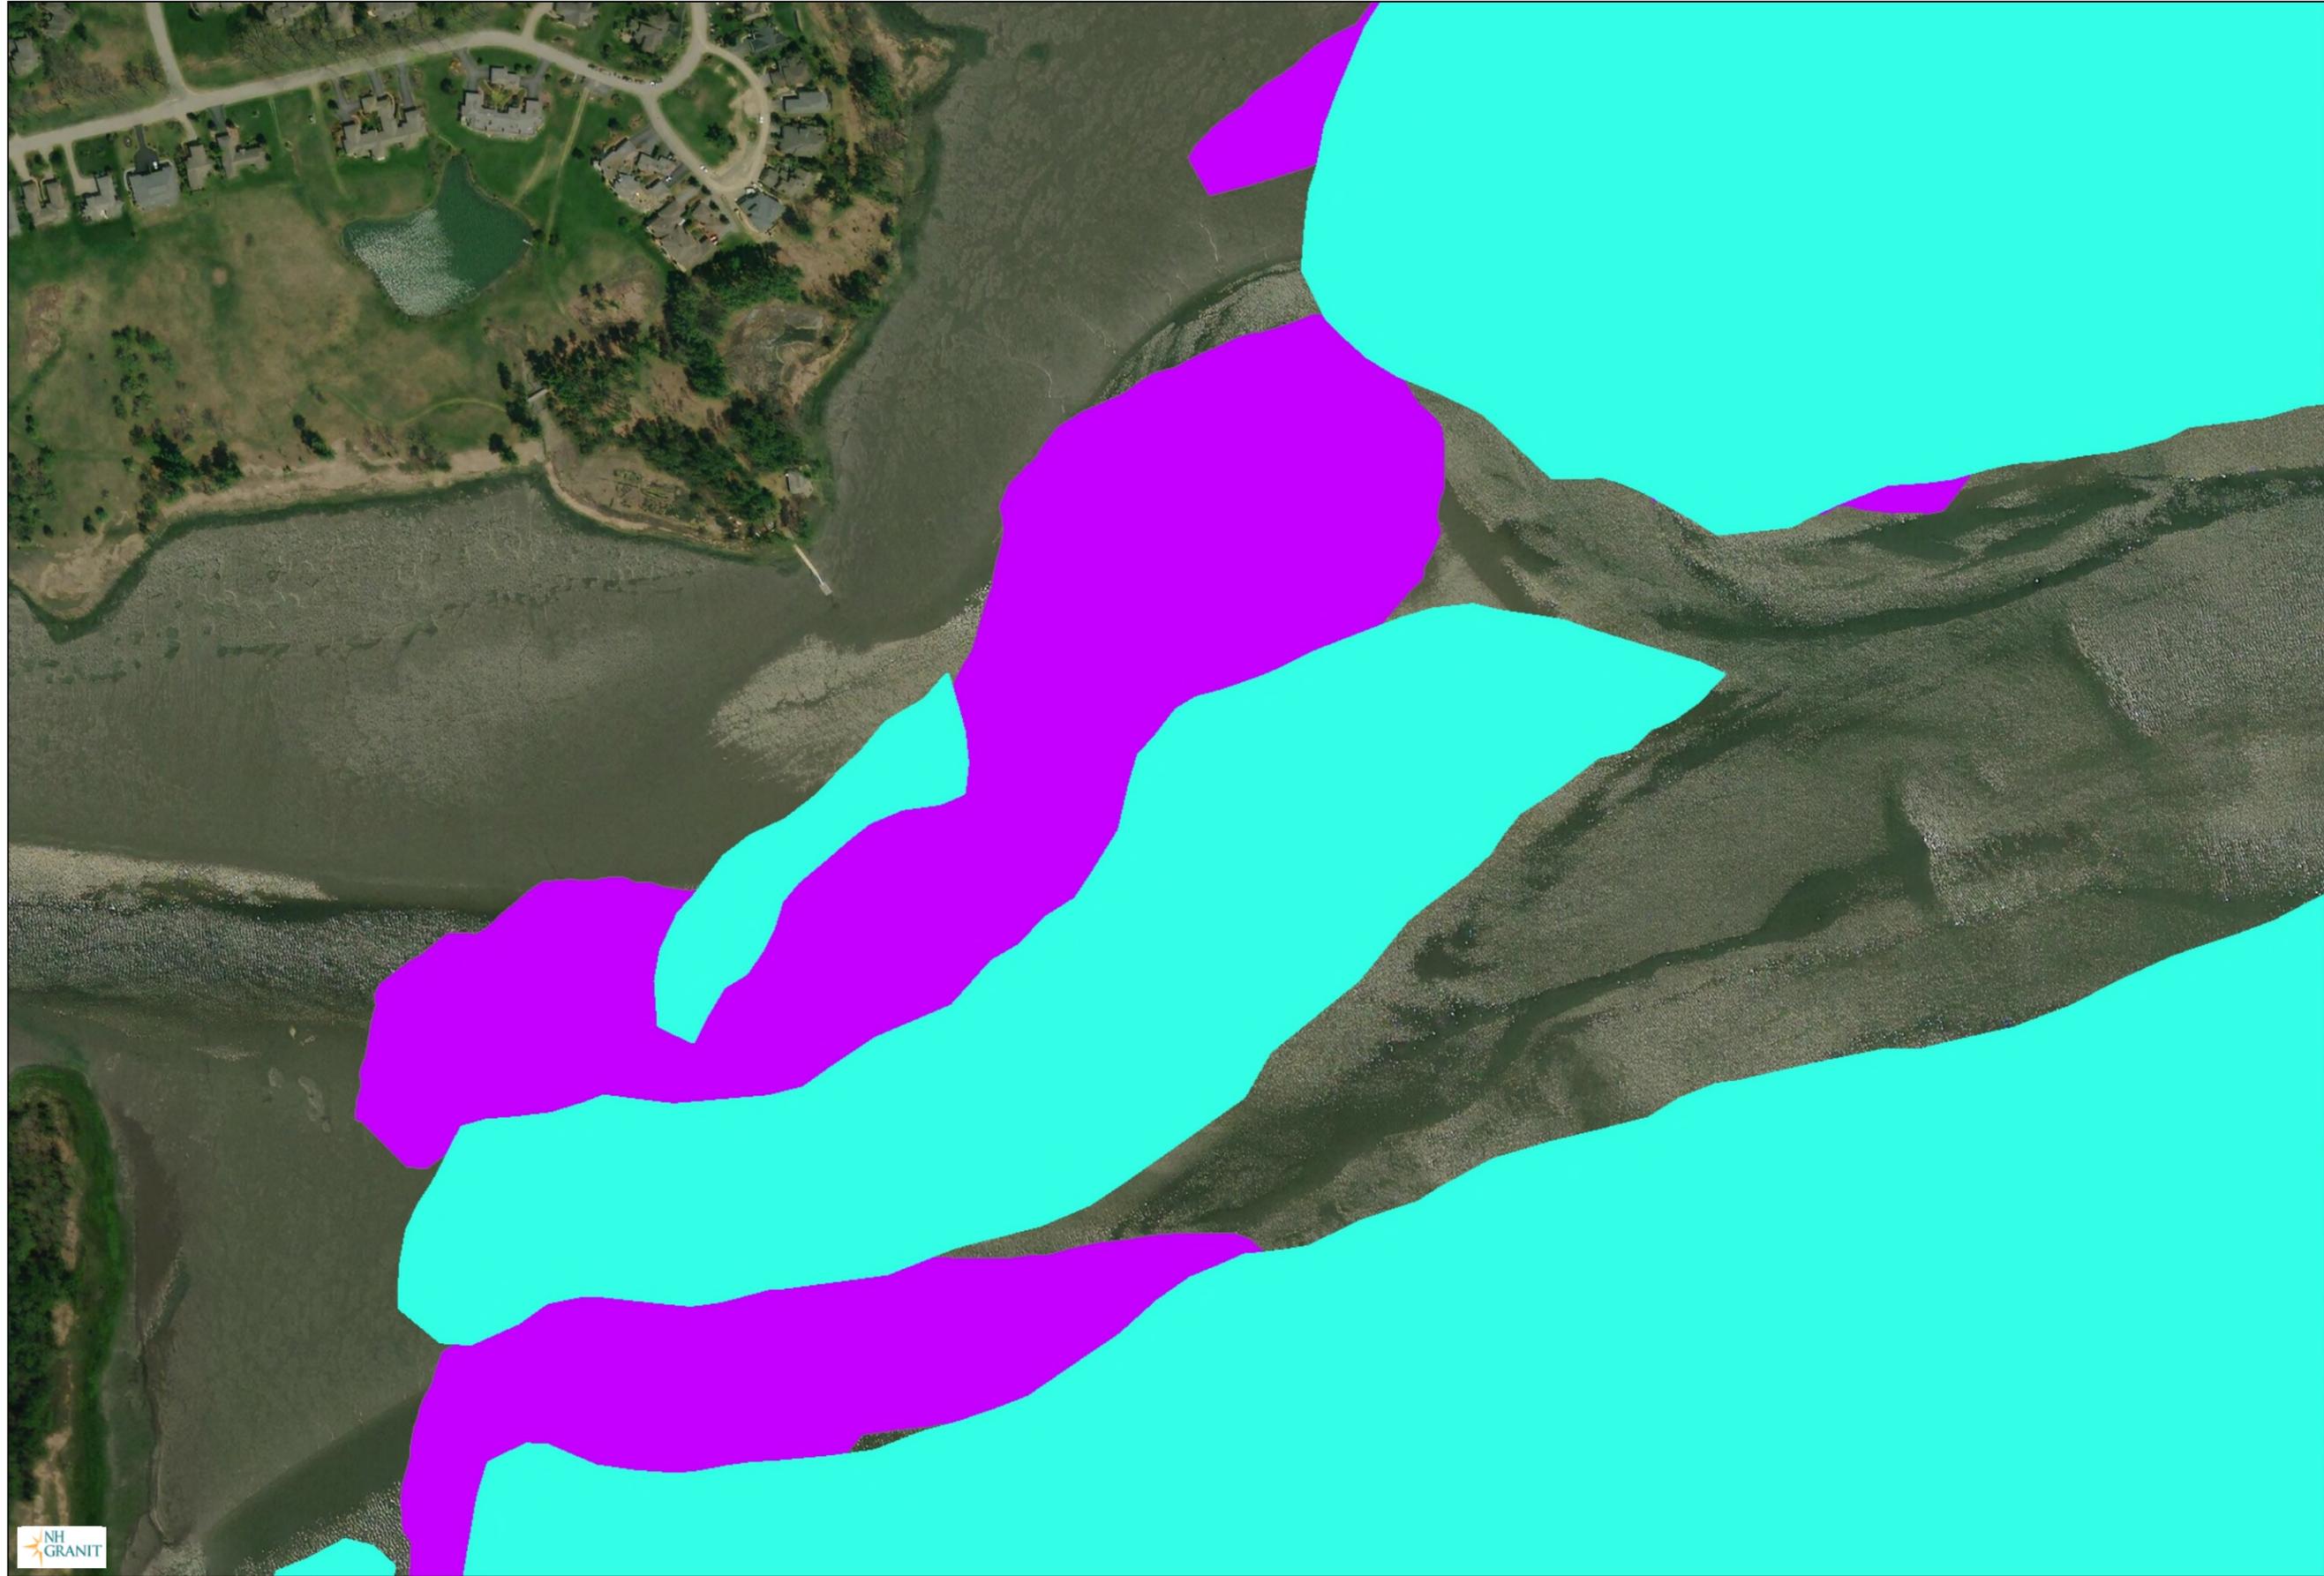
1996 and 1986 Eel Grass
