# LIVING SHORELINE PRELIMINARY DESIGN

Bellamy River, Spur Road, Dover, NH

FINAL REPORT

APRIL 2022

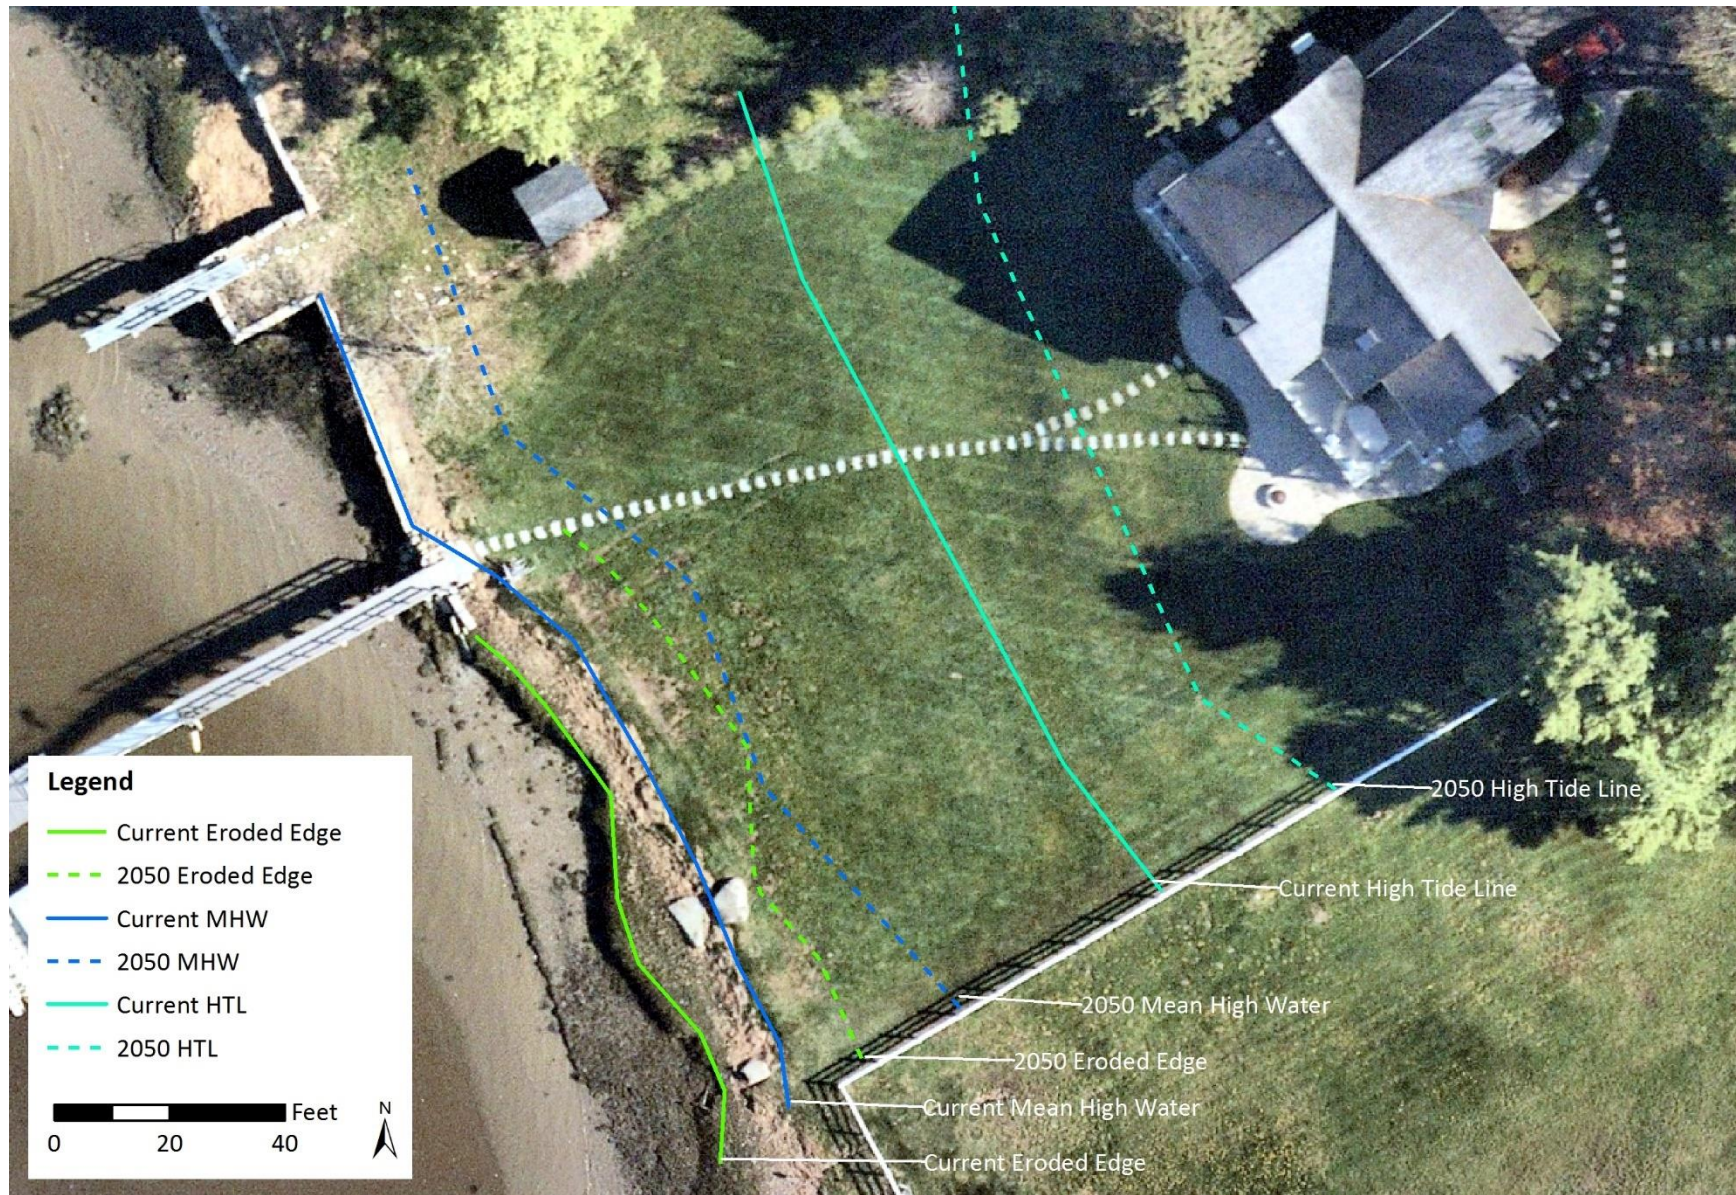
**Figure 3-1: No Action Alternative (Approximate 2050 Projections)**

Note: Existing shoreline Transect #3 (from Figure 2.4.1-3) in the area of the most significant erosion is shown for reference.

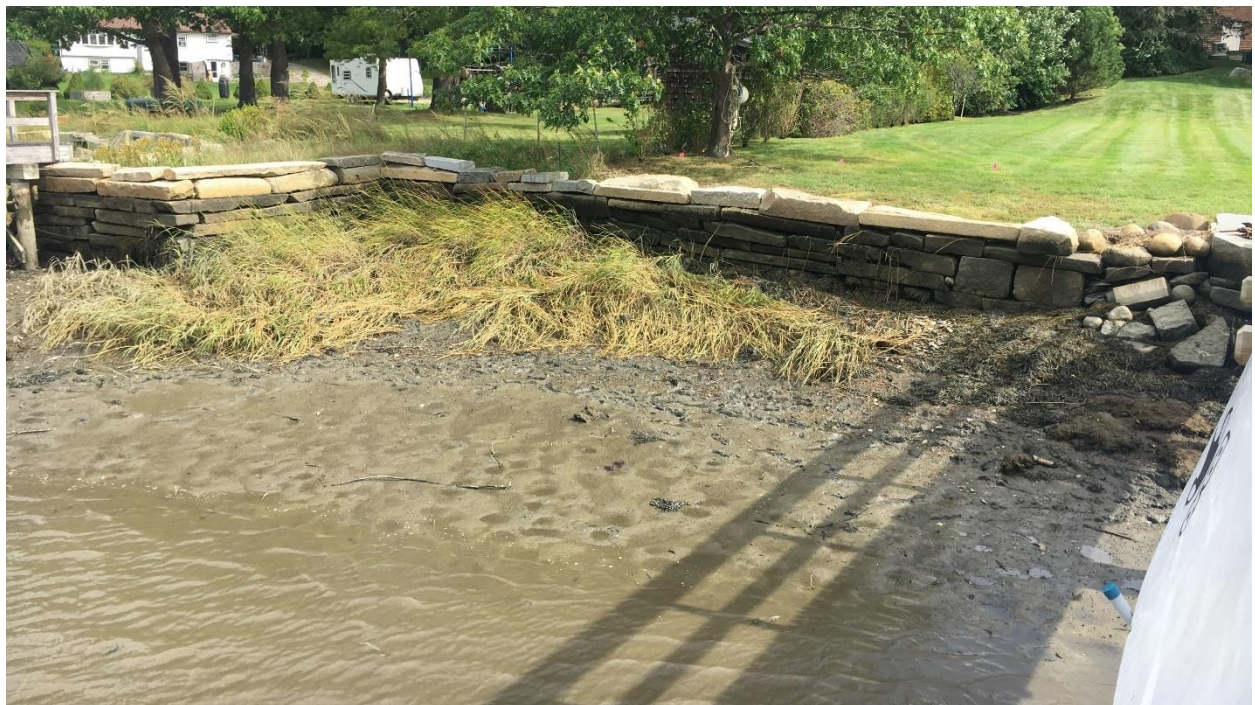
*Retaining wall north of pier*

The retaining wall is approximately 40 feet long (30 feet on the property) and 4 to 5 feet high. It extends about 10 feet beyond the property line before meeting a perpendicular retaining wall section that extends waterward. The wall is primarily built of large, cut granite blocks. At the southeast end of the wall, a less structured formation of loose granite blocks and stones armors the shoreline under and adjacent to each side of the pier.

According to the landowner, the wall was rebuilt in recent years to address structural issues, but it appears to be currently out of alignment (leaning toward the water). A stormwater drainpipe from the yard outlets about halfway up the wall near its center. Additional stormwater from a swale through the yard flows over the top of the wall during storms.

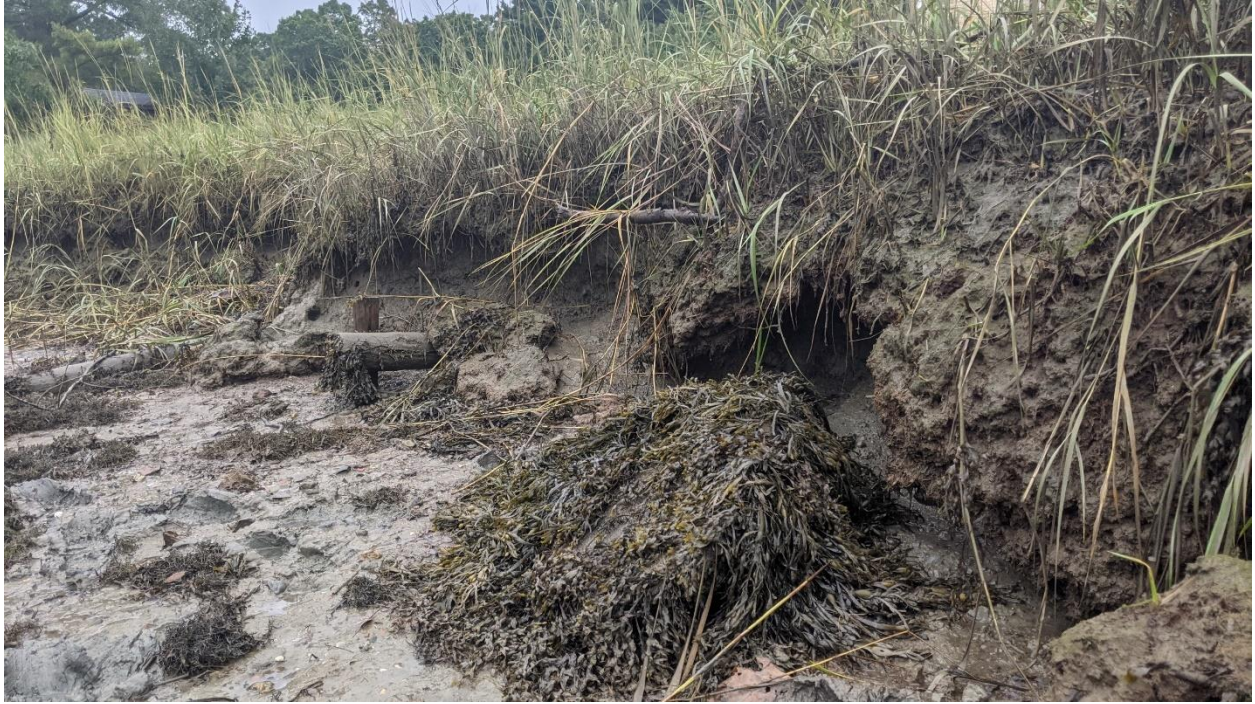
*Areas of undercut/sloughing bank near Transect #3*

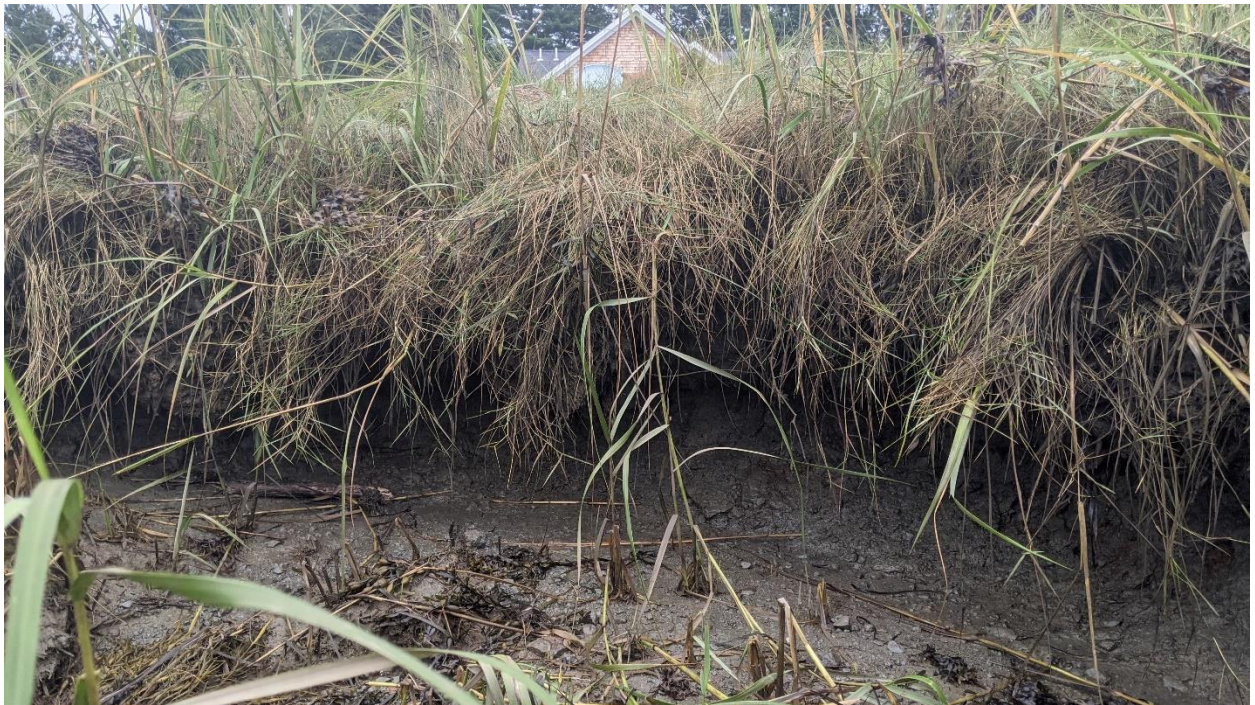
*Undercut bank near Transect #3*

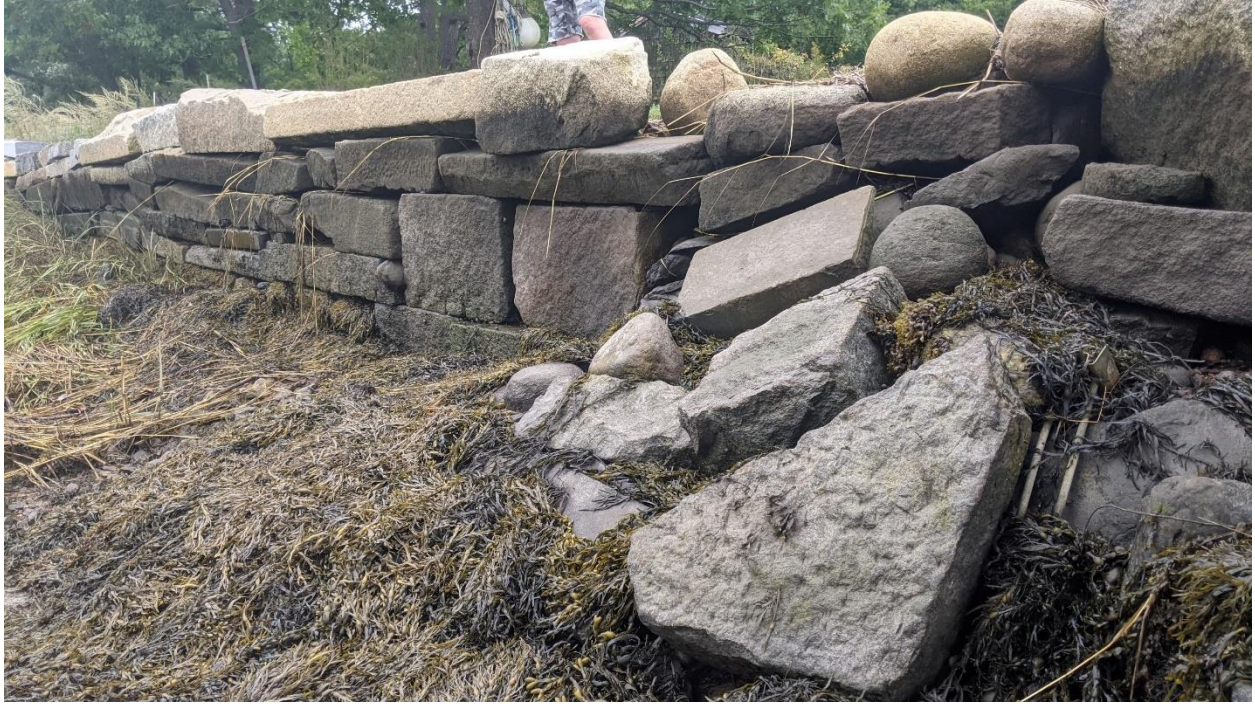
*Stone retaining wall (looking north from under pier)*

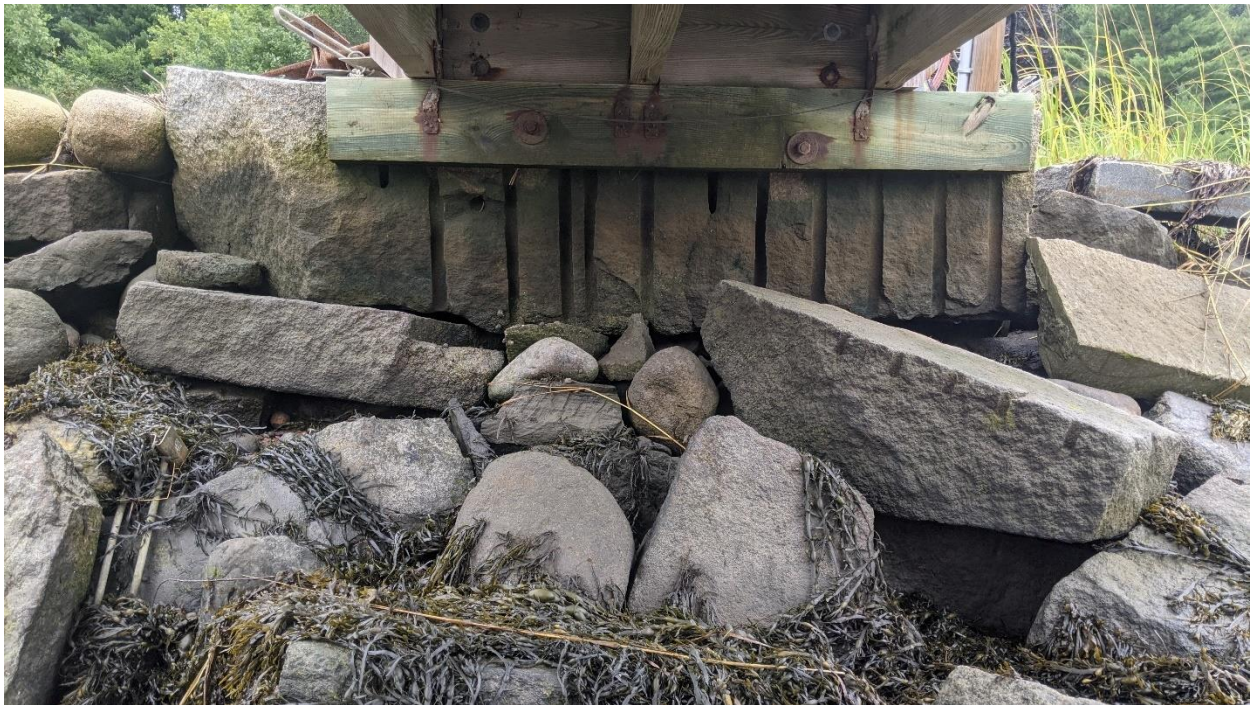
*Stone armoring under pier*

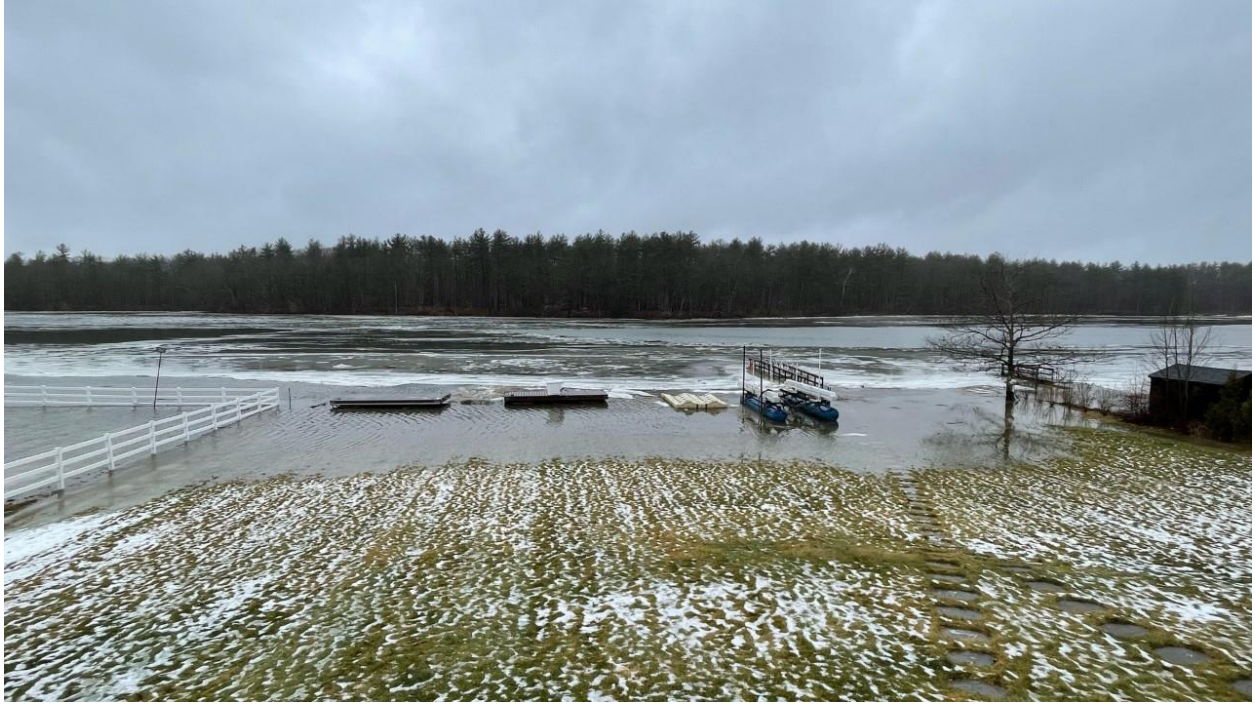
*King Tide (January 17, 2022). Observed to be approximately 2.65 feet higher than MHHW at Seavey Island Station.*
