# GREAT BAY LIVING SHORELINE PROJECT

## SCHANDA PARK – NEWMARKET, NEW HAMPSHIRE

### DESIGN MEMO REPORT

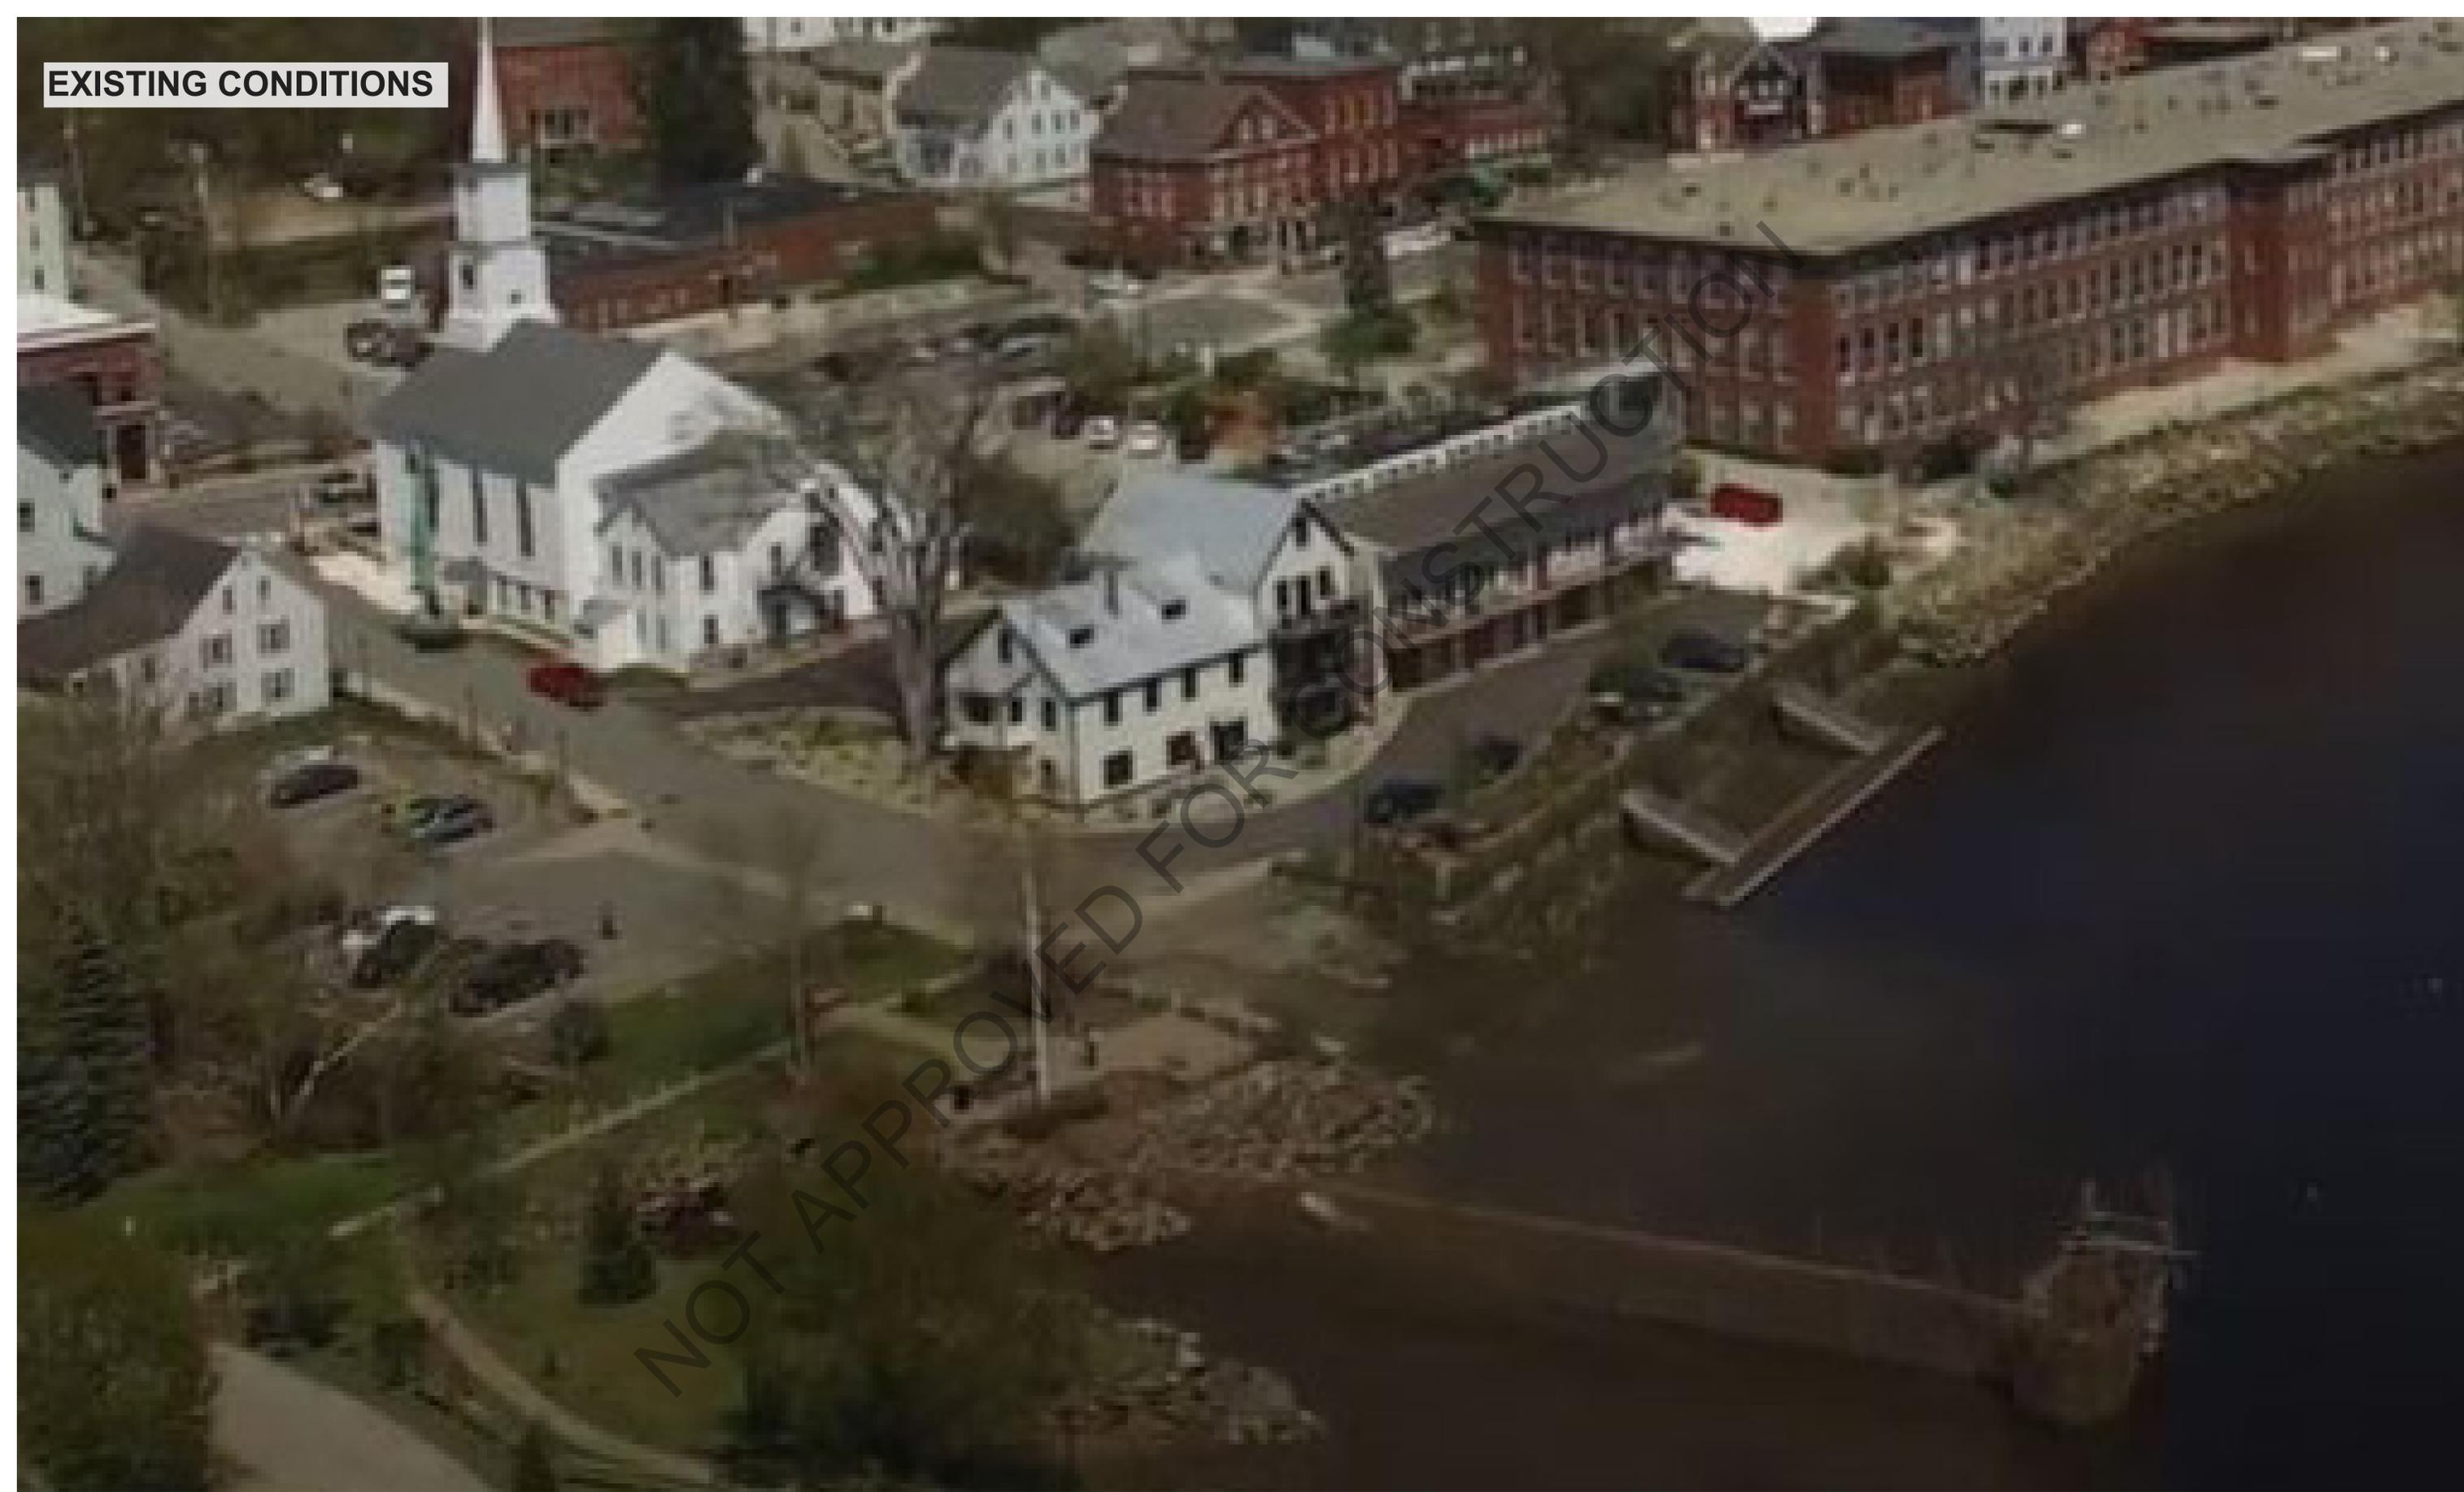
**EXISTING CONDITIONS**

- BOAT RAMP
- PARKING LOT
- MOONLIGHT BROOK CULVERT AND EARTHEN LEVEE PARK CONNECTOR
- STONE RUBBLE WALL
- MOONLIGHT BROOK
- KAYAK STORAGE
- WATERFRONT PLAZA
- FIELDSTONE WALL
- STONE REVETMENT
- COLLAPSING STONE RUBBLE WALL
- EXTENT OF PROPOSED LIVING SHORELINE
- FISH WEIR
- STONE REVETMENT
- BLUFF
- EXISTING TIDAL MARSH SLOPE
- FLOATING DOCK AND RUBBLE ABUTMENT

LAMPREY RIVER  
EBB FLOW

The northern portion of Schanda Park centers around a landscaped plaza bound by the public boat launch to the north, the Lamprey River to the east, the Moonlight Brook outflow to the south, and the combined park and boat launch parking lot to the west. Below are descriptions of the points of interest comprising this portion of the park and the concerns and/or limitations associated with each.

The brick paved plaza is bound to the north by a vertical stone retaining wall associated with the adjacent boat ramp, which transitions to sloped bank stabilized with stone revetment that runs along the eastern and southern sides of the plaza below overgrown planting beds that are obstructing views of the river. Small patches of tidal marsh are perched in bare areas of the revetment off the southeastern corner of the plaza. The vertical retaining wall adjacent the boat ramp is in good condition, but discussions with Town representatives and assessment during the initial site visit reveal the revetment stabilizing the sloping bank is deteriorating due to action by water, particularly along the southern side of the plaza. Addressment of this deteriorating revetment has been highlighted as a primary item of concern for the Town and an interest in incorporating greener bank stabilization methods has also been expressed. However, the Town also indicated that due to the plaza's small size and high utilization for large community events, there is reluctance to losing accessible square footage of the plaza area.

The 40' wide boat ramp at the very northern end of the park is aligned to the centerline of Water Street, sloping from the private parking lot driveway to the north and down to the water line. The boat ramp is bound to the north and south by vertical stone retaining walls, both of which are in fair condition. However, the pavement of the ramp is broken near the high-water line and transitions to gravel upon entering the water. Discussion with the Town representatives revealed this gravel washes into the river and is regularly replaced by US Fish & Game, which manages the ramp. Additionally, the boat ramp is considered overly wide, and consideration has been given to renovating the ramp.

Sandwiched between the Moonlight Brook outflow and the unofficial kayak launch, the upland lawn extends towards the river to form a bluff, which hosts a bench looking out on the river as well as a large tree. This bluff is bound by steep banks on all three sides stabilized by revetment, with the revetment on the northern side extending along the bank all the way to the Moonlight Brook culvert.

At the southern end of the waterfront, the upland lawn slopes downward and transitions to a muddy slope approximately 12' wide between the revetment off the southern side of the bluff and the revetment associated with the abutment for the floating public dock. At the bottom of the slope, within the intertidal zone, there is existing salt marsh vegetation including rare plant species extending approximately 6' up the slope from the water line. A narrow path trampled through the plants was noted during the initial site visit, presumably due to the launching of kayaks which are available for rental upslope. Additionally, discussions with Town representatives indicate the historical fish weir installed in the Lamprey River just north of the Moonlight Brook outflow is removed from the water and stored above the high-water line on this slope, further impacting existing vegetation. Finally, during the October 18<sup>th</sup> site visit, it was noted there was evidence that Canada geese and other waterfowl had damaged the vegetation during foraging activities, a common issue in New England salt marsh systems.

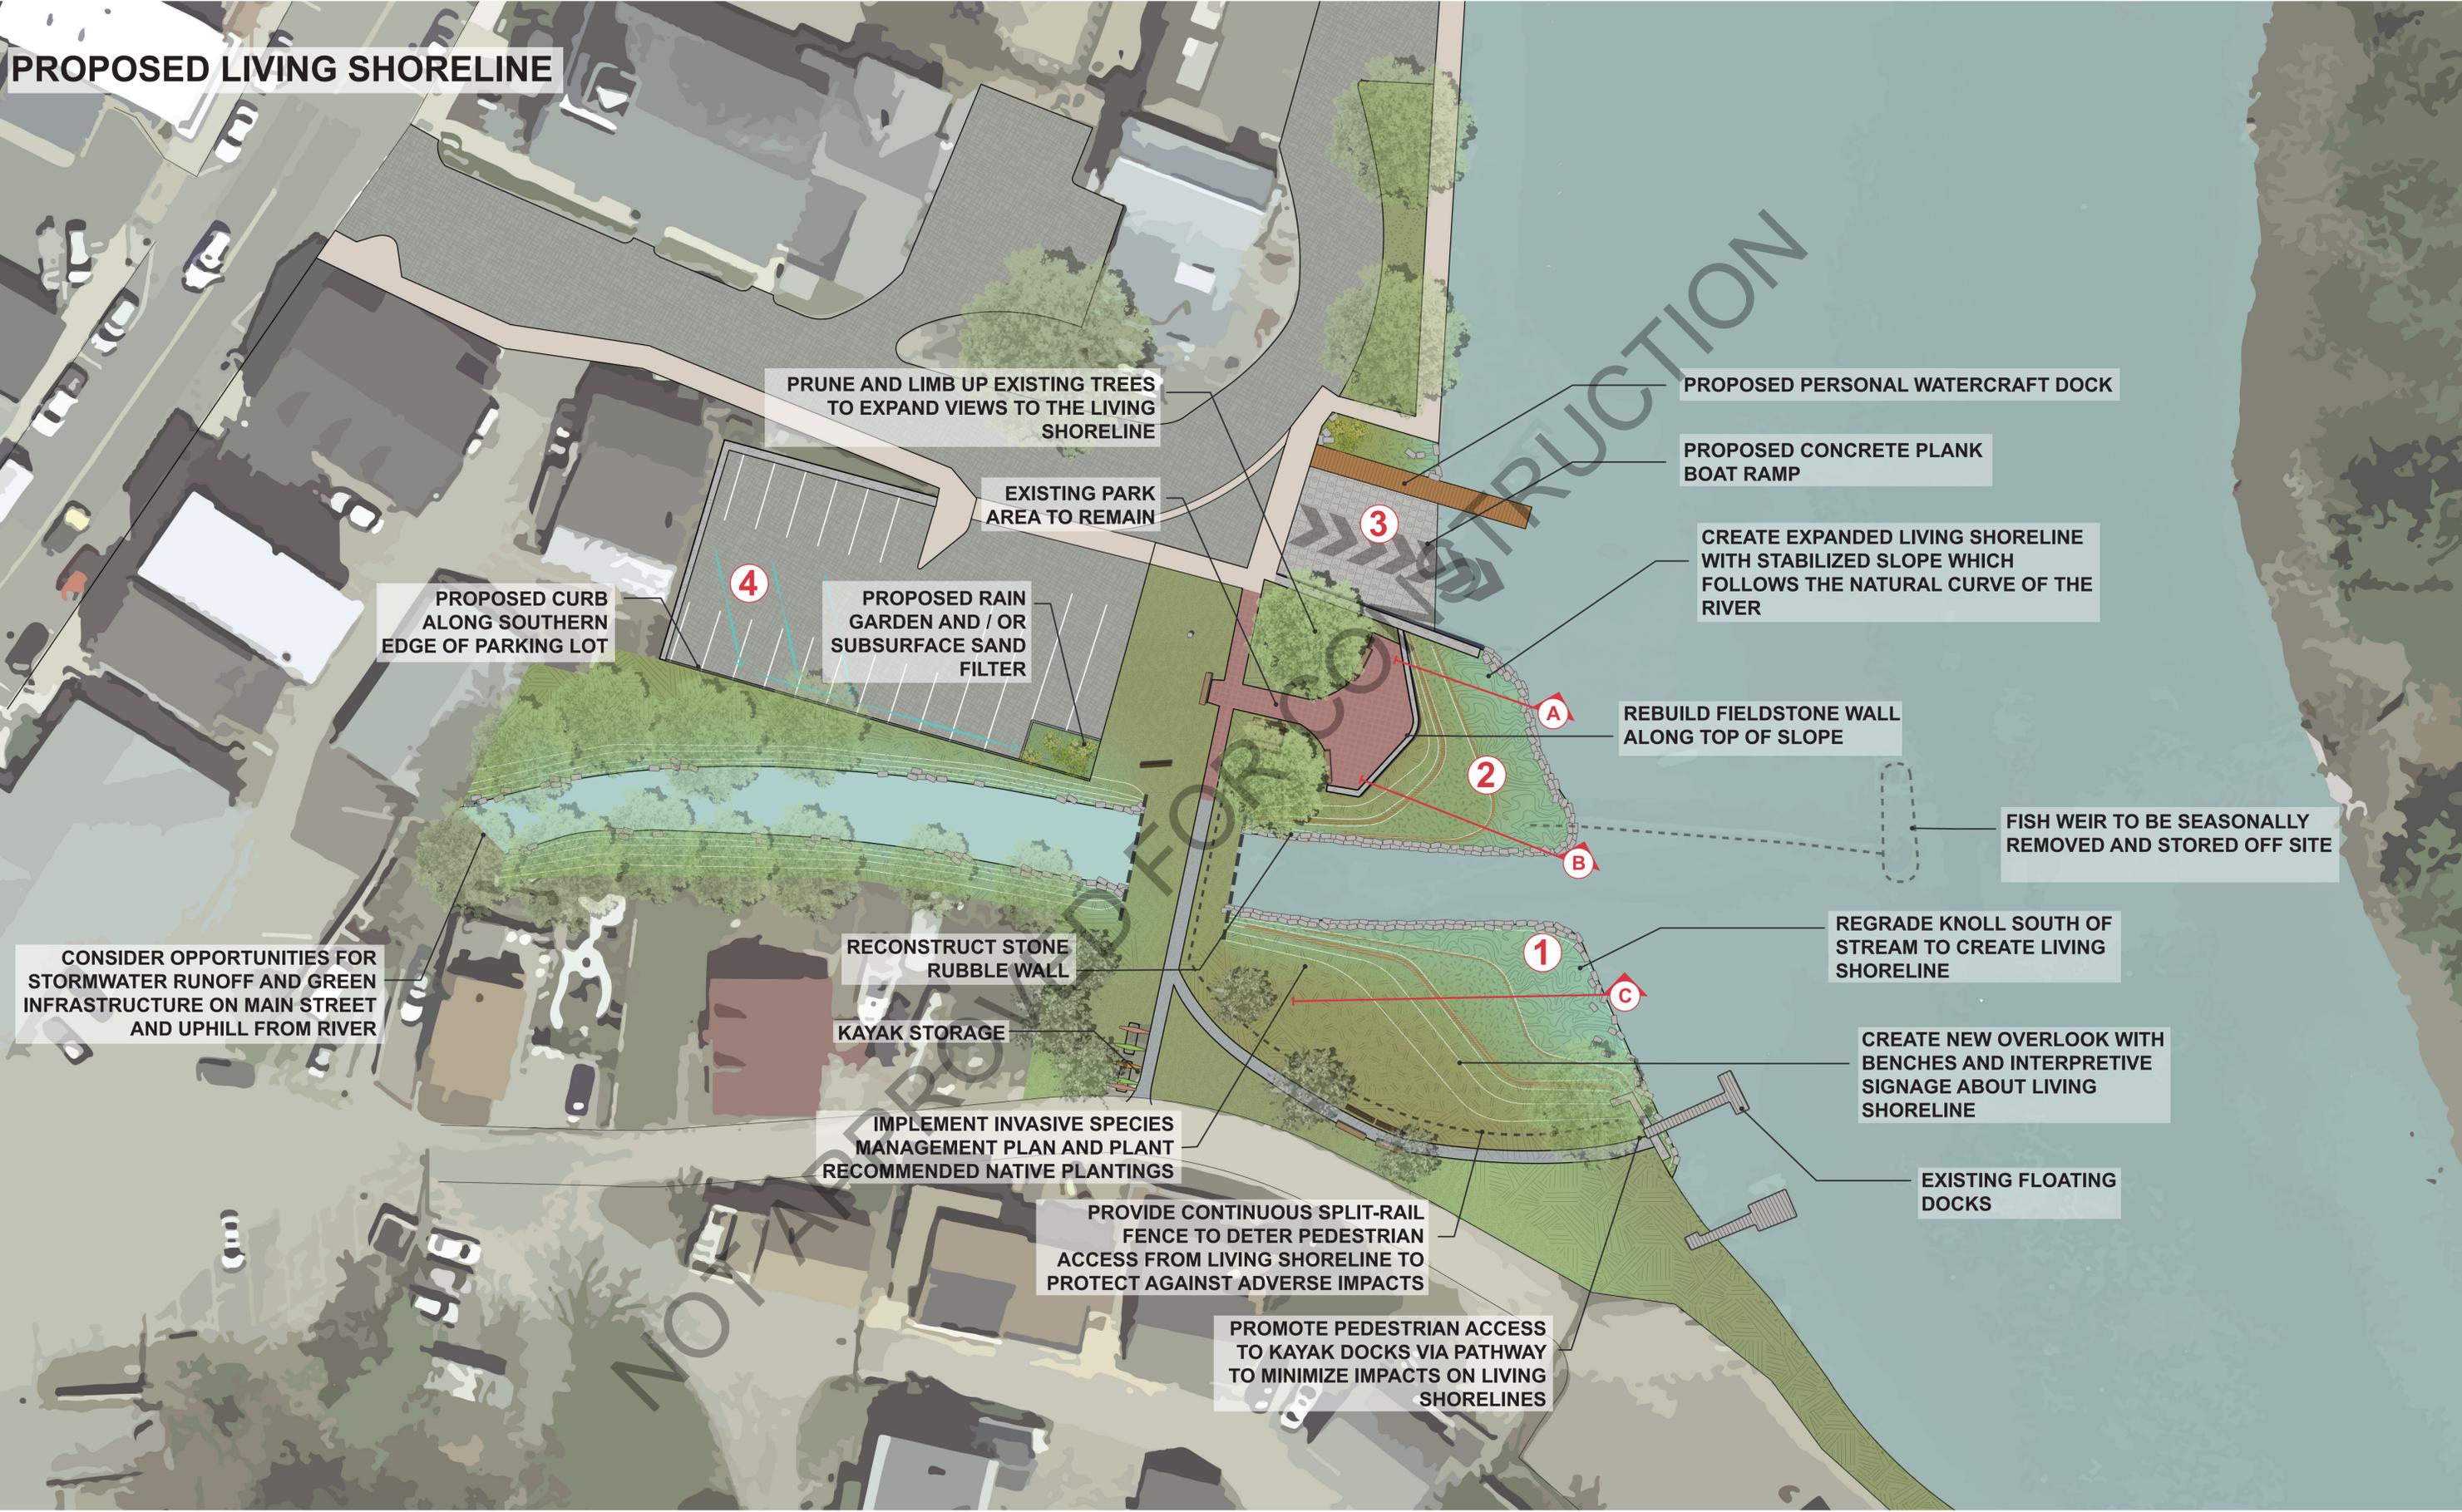
# PROPOSED LIVING SHORELINE

PRUNE AND LIMB UP EXISTING TREES TO EXPAND VIEWS TO THE LIVING SHORELINE

EXISTING PARK AREA TO REMAIN

PROPOSED PERSONAL WATERCRAFT DOCK

PROPOSED CONCRETE PLANK BOAT RAMP

CREATE EXPANDED LIVING SHORELINE WITH STABILIZED SLOPE WHICH FOLLOWS THE NATURAL CURVE OF THE RIVER

PROPOSED CURB ALONG SOUTHERN EDGE OF PARKING LOT

PROPOSED RAIN GARDEN AND / OR SUBSURFACE SAND FILTER

REBUILD FIELDSTONE WALL ALONG TOP OF SLOPE

FISH WEIR TO BE SEASONALLY REMOVED AND STORED OFF SITE

RECONSTRUCT STONE RUBBLE WALL

REGRADE KNOLL SOUTH OF STREAM TO CREATE LIVING SHORELINE

CREATE NEW OVERLOOK WITH BENCHES AND INTERPRETIVE SIGNAGE ABOUT LIVING SHORELINE

IMPLEMENT INVASIVE SPECIES MANAGEMENT PLAN AND PLANT RECOMMENDED NATIVE PLANTINGS

PROVIDE CONTINUOUS SPLIT-RAIL FENCE TO DETER PEDESTRIAN ACCESS FROM LIVING SHORELINE TO PROTECT AGAINST ADVERSE IMPACTS

PROMOTE PEDESTRIAN ACCESS TO KAYAK DOCKS VIA PATHWAY TO MINIMIZE IMPACTS ON LIVING SHORELINES

In the northern half of the park our proposed design would remove most of the stone revetment along the waterfront surrounding the plaza except for the vertical retaining wall along the southern side of the boat ramp, which is good condition. Currently, there is no way to sufficiently reduce the vertical grade off the southern side of the plaza to allow for a green form of bank stabilization, as laying back the slope

Off the eastern and southeastern sides of the plaza, there is a possibility for tidal marsh establishment as an alternative to grey infrastructure for bank stabilization. However, while small patches of tidal marsh vegetation are currently perched in bare areas of the revetment, establishment of a healthy and sustainable tidal marsh requires a shallower slope than the current grades would allow. Again, the need to retain the upland plaza area in its entirety without any loss of square footage prevents the slope from being laid back in a manner similar to the Phase I work proposed south of Moonlight Brook. Thus, we suggest reducing the grade by extending the slope into the river through the installation of clean fill. We believe this a viable option because a review of the site in aerial imagery shows the bank off the southeast corner of the plaza does not align with the overall curvature of the river. The proposed slope extension would require infilling a portion of the river channel off the southeastern corner of the plaza. This would bring that portion of the bank in alignment with the rest of the riverbank along the Schanda Park waterfront and produce the shallower grades more suitable for tidal marsh creation.

As stated above, the boat ramp is currently wider than it needs to be. We propose to remove the existing paved and gravel surface of the existing boat ramp and install 18' wide precast concrete planks, the standard for NH Fish & Game boat ramps. The concrete planks would be installed in the southern half of the boat ramp, leaving 24' of extra width to be utilize for installation of a narrow floating dock alongside the boat ramp for utilization by kayakers and canoers.

Our proposed stormwater management improvements to the parking lot are relatively simple but can potentially provide a great benefit to Moonlight Brook and the park. The parking lot is already sloped to a single point, the southeast corner, so there is no need to regrade or repave the parking lot. The only required site work would be to install a curb along the southern edge of the parking lot to meet the curb that already exists along the eastern edge. At the corner, we propose a curb break to allow the parking lot runoff to be directed to a stormwater management best management practice designed according to New Hampshire Department of Environmental Services (NHDES) regulations. This would most likely be a subsurface sand filter, which would appear as a shallow depression in the lawn area, requiring minimal maintenance. An outlet pipe would need to be installed to Moonlight Brook, with care taken with regard

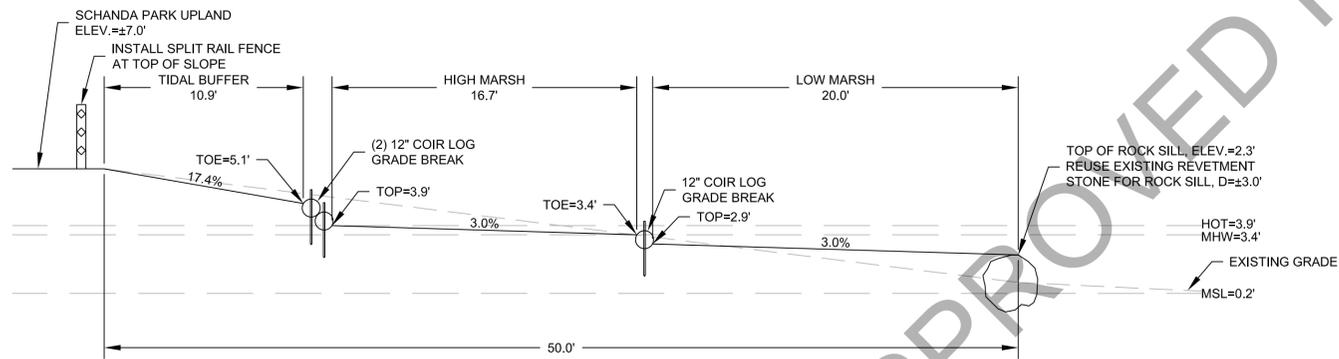
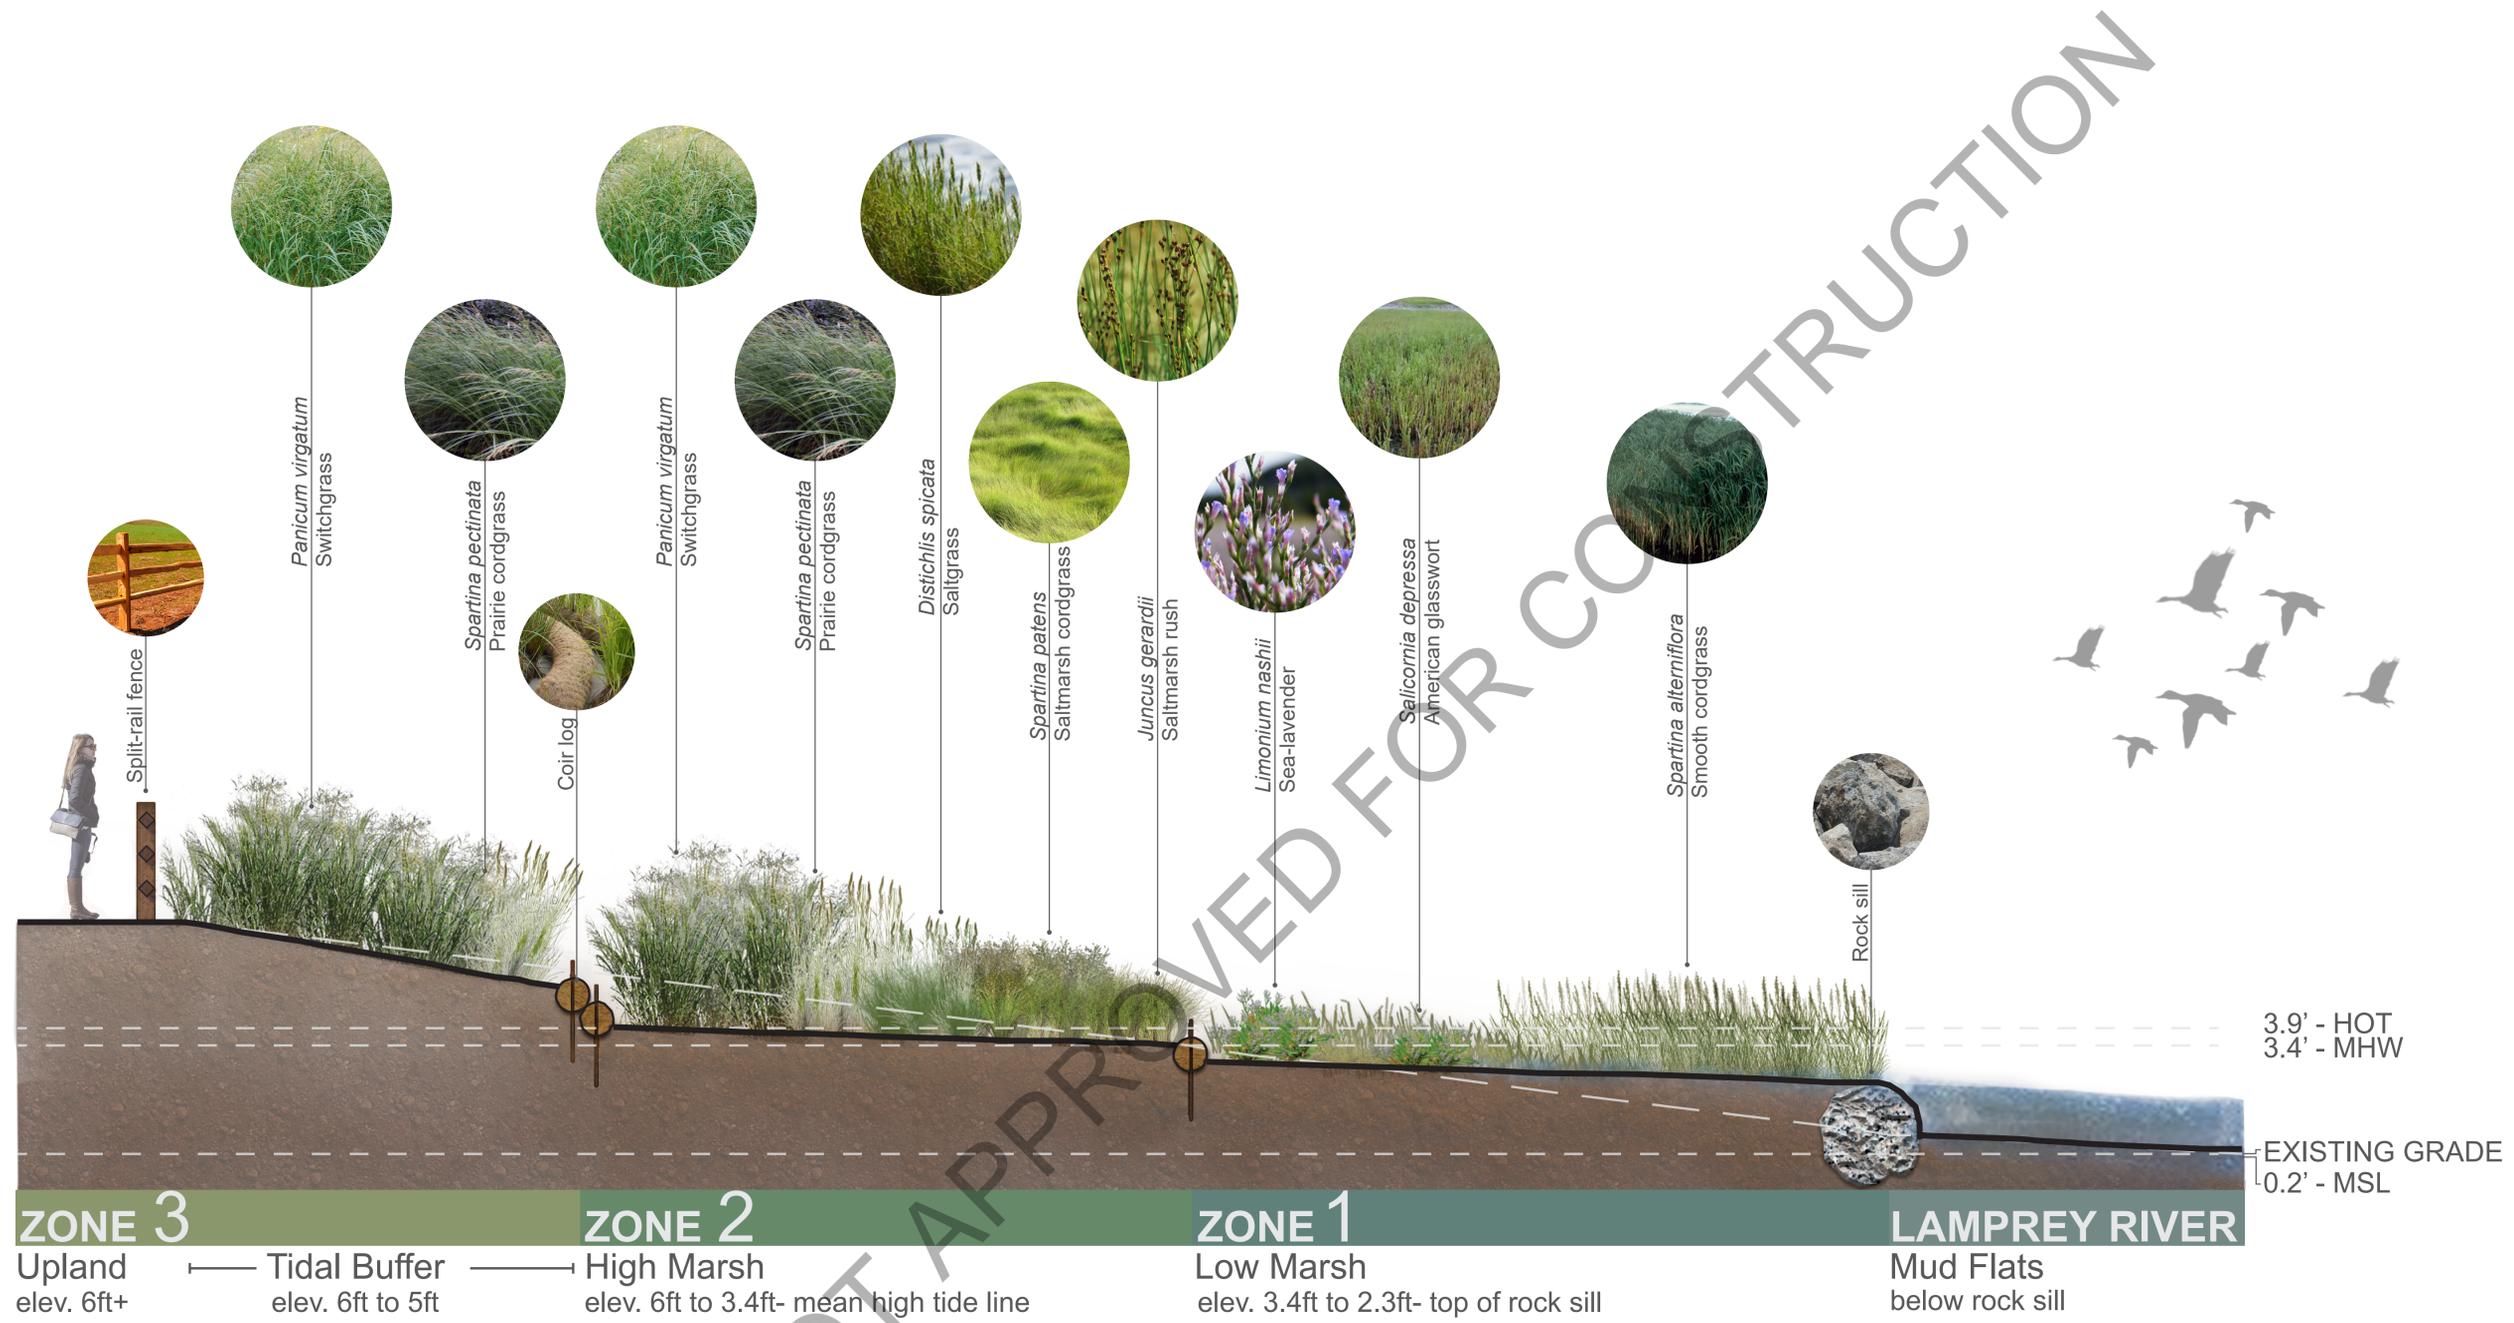
SECTION C  
SCALE: 1"=5'

1. WATER LEVELS BASED ON PRESSURE TRANSDUCER DATA GATHERED BETWEEN 9/2/21 AND 11/16/21.
2. WATER LEVEL DATA TIED TO NAVD88 BY SURVEYING WATER SURFACE ELEVATION AT 6:25 PM ON 10/11/21.
3. HIGHEST OBSERVABLE TIDE BASED ON HIGHEST TIDE RECORDED DURING THE DATA COLLECTION PERIOD.

MLLW	NAVD88
HOT	7.1'	3.9'
MHHW	6.9'	3.7'
MHW	6.6'	3.4'
MSL	3.4'	0.2'
NAVD88	3.2'	0.0'
MLW	0.1'	-3.3'
MLLW	0.0'	-3.4'
